SAFETY ANALYSIS OF EMCIP DATA

ANALYSIS OF MARINE CASUALTIES AND INCIDENTS INVOLVING CONTAINER VESSELS

SUMMARY REPORT

September 2020

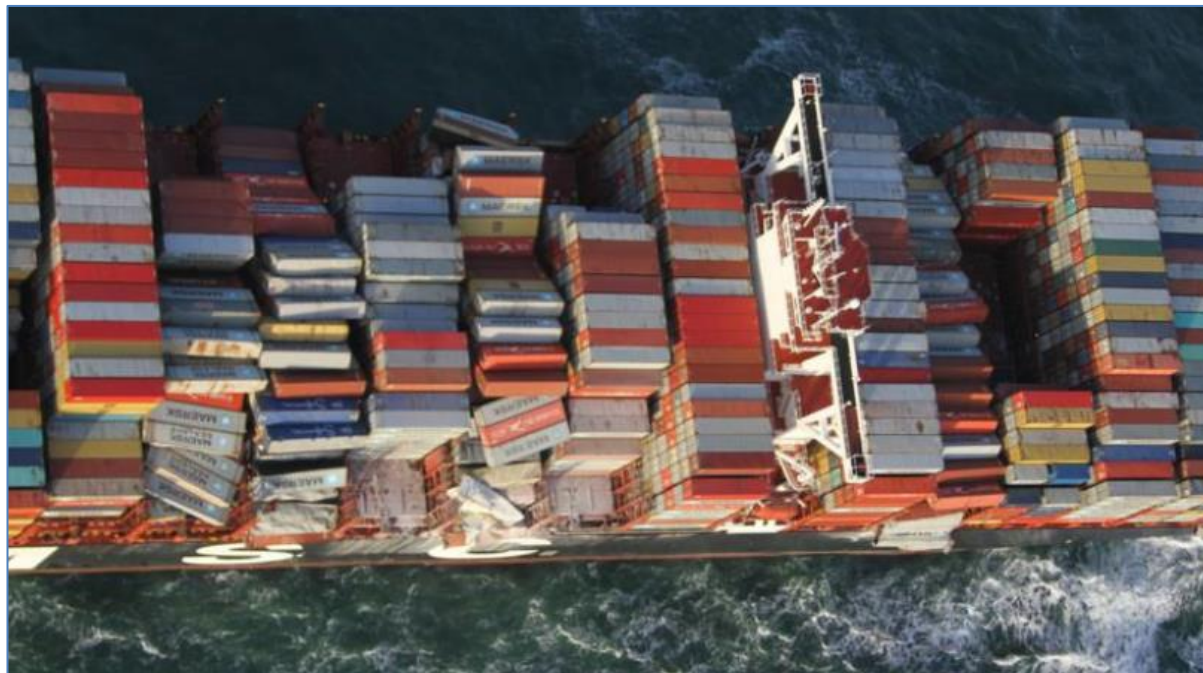
Figure 1 - Top view *MSC Zoe* following the loss overboard of containers (Source: BSU / Netherlands Coastguard)

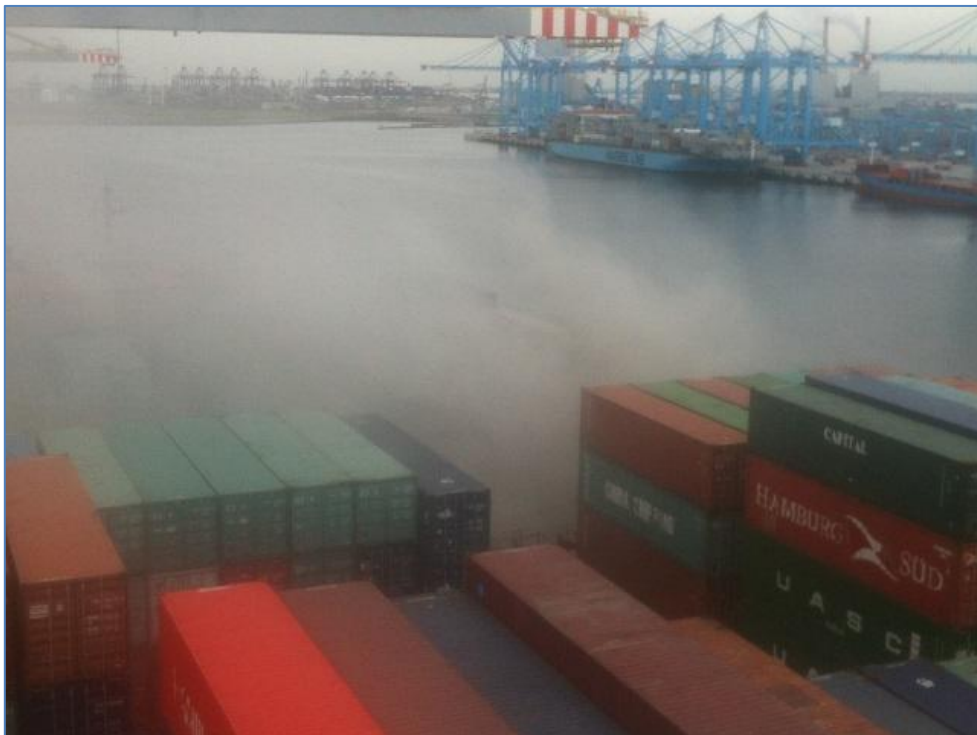
Figure 2 – Smoke from cargo hold nr.2 of *MV Barzan* on 07/09/2015 (MSIU)

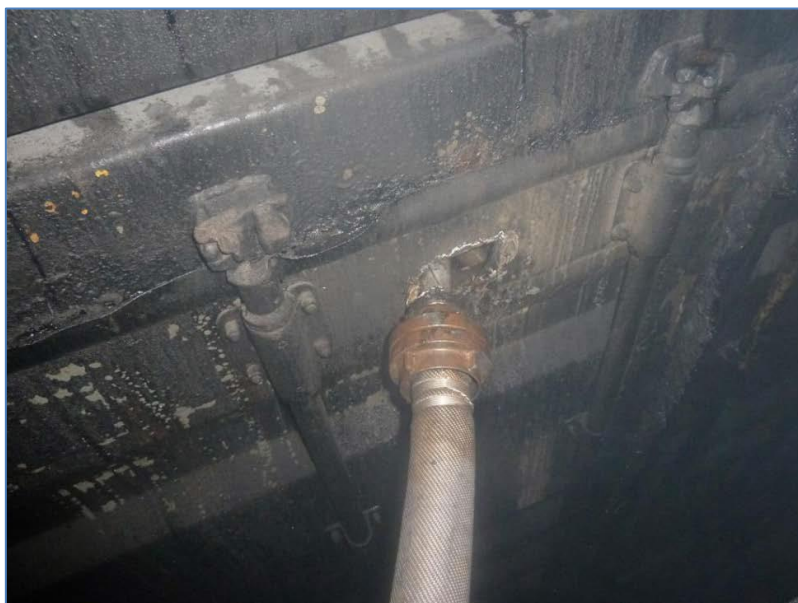
In the afternoon of 26 August 2015, a fire broke out in a container in a cargo hold on board the container ship Caroline Mærsk. At the time of the accident, the ship was positioned approximately 50 nm from the coast of Vietnam. The fire broke out as a result of charcoal self-igniting in a cargo container below deck. According to the cargo manifest, the contents were described as 'tablet for water pipe'. The IMDG Code states that charcoal is a Class 4.2 cargo, which covers substances liable to spontaneous combustion; however, the cargo of the burning containers had not been declared as dangerous cargo. These facts indicate that the container contents should have been declared as dangerous cargo from the shipper's side, but they were not.

Figure 3 - Burning container on board of *Caroline Mærsk* with spike nozzle inserted (Source: Source: DMAIB / MÆRSK Line)

Mis-declared or missing documentation regarding the nature of the containerized cargo have an impact on both its correct storage/separation and the effective response of the crew in case of an emergency, particularly fire.

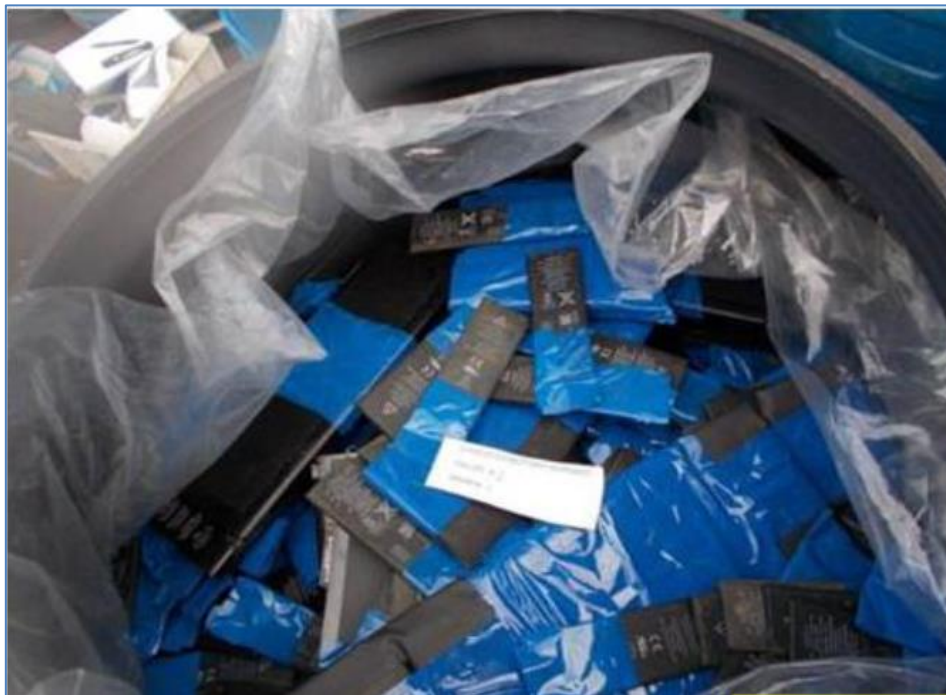
On 15 June 2016 *CMA CGM Rossini* was loading cargo at Colombo (Sri Lanka) when two sailors in charge of lashing securely containers detected a burning smell when they arrived at bay 30 starboard. An explosion occurred coming from the containers loaded in bay 34, in the hold 5 starboard. The officer of the watch was immediately informed and the firefighting procedure enforced. Less than 30 minutes later, a harbour firefighter team arrived on board and the firefighting strategy implemented by the crew was carried on. The source of the fire was one of two 40-foot containers, loaded at Sydney and destined for Antwerp. One of these contained 26 pallets of 104 drums loaded with lithium-ion batteries, which net weigh was 16.692 metric tons.

Figure 4 – Example of used lithium-ion batteries cargo loading (source: BEA Mer / CMA CGM)

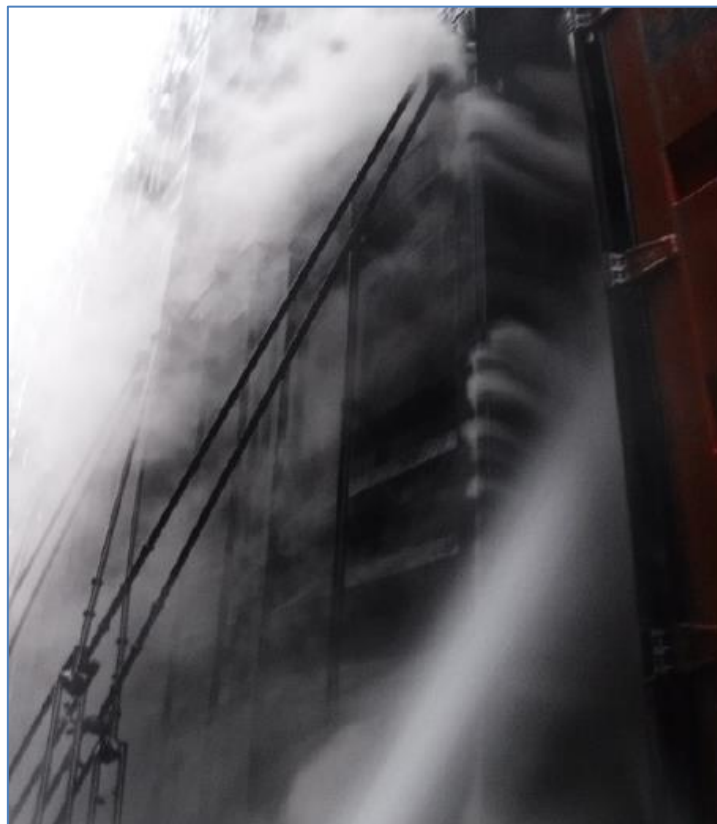
The ship's command sounded the general alarm immediately after the fire was discovered. After it was mustered, the crew began to fight the fire in bay 12. Prevailing wind strengths of 8-9 Bft and low temperatures made the conditions for fighting the fire extremely challenging. The crew of the *Yantian Express* continued to fight the fire with passive measures, such as aligning the nozzles so as to cool down the area and for hydro shields, even though the weather conditions deteriorated further.

Figure 5 - Firefighting at bay 12, row 3 - *Yantian Express* (Source: BSU)

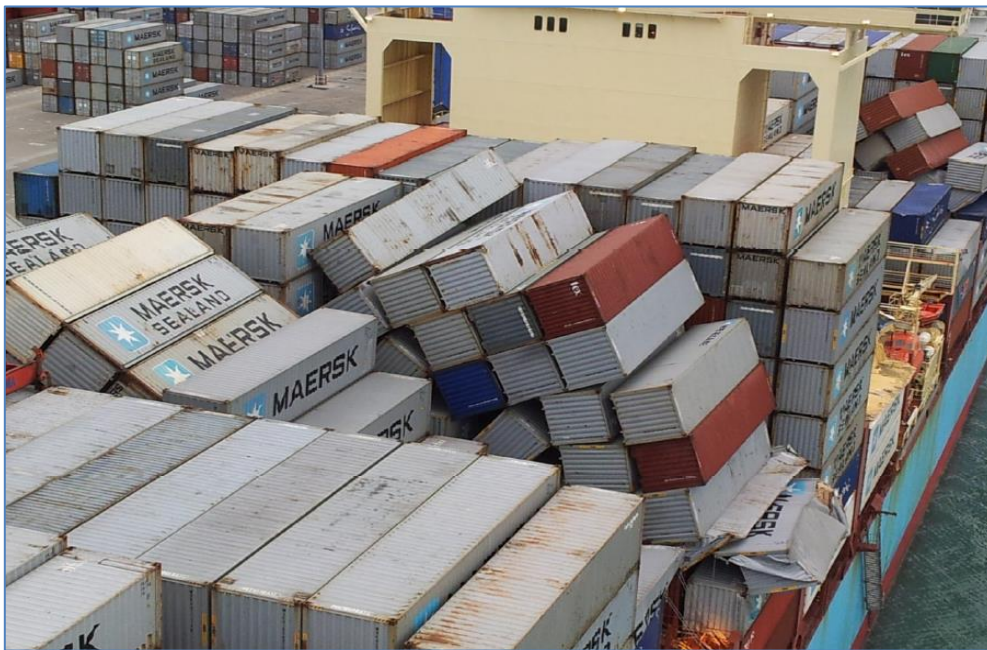
The following day, as the ship had left the outer English Channel the weather conditions started deteriorating. In the afternoon, the ship suddenly and without warning rolled to extreme angles and a large number of cargo containers fell overboard.

In the early evening, the ship again suddenly rolled violently, reaching an extreme angle of roll of 41° to port. Again a large number of containers were lost over board and the master considered the situation to threaten the safety of the ship. The master sounded the general alarm to muster the crew members. Later in the evening he assessed that the weather no longer posed an immediate danger to the ship.

Figure 6 - *Svendborg Mærsk*, aft deck at arrival (Source: DMAIB / MÆRSK)

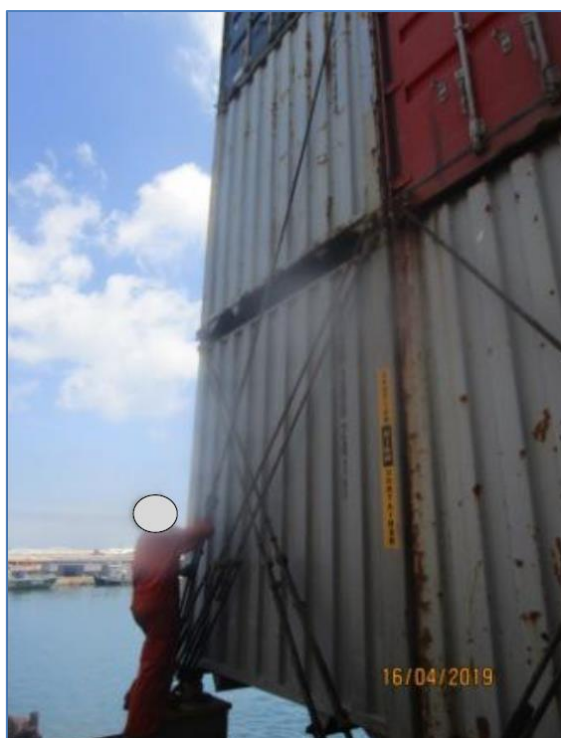
The lower end of a long lashing bar had fallen onto the seafarer's right foot, cutting through his safety footwear. One toe on the seafarer's right foot was severely injured and had to be amputated.

Figure 7 - Connecting a lashing bar to a turnbuckle (Source: MSIU)

Companies were also recommended to install physical barriers in dangerous areas and to study the viability of placing guard rails on lashing platforms.

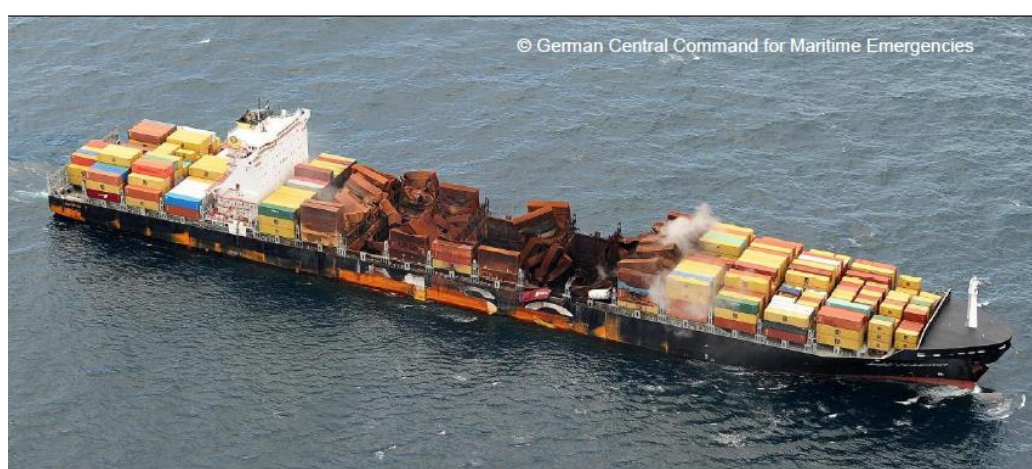
The alarm indicated smoke in cargo hold 4. The lookout sent from the bridge to the cargo hold confirmed there was fire in the hatch. CO₂ was discharged into the affected cargo hold to fight the fire. The area around cargo hold 4 was to be cooled down later. A team of seven crew members was working in this area to make the necessary preparations when a heavy explosion occurred. This was accompanied by the rapid development of the fire and the ship's command decided to abandon the vessel due to the overall circumstances. The occurrences resulted in three fatalities, two severely injured crew members, structural and cargo damage due to fire. The flag State, Germany, took responsibility for granting a place of refuge on 15 August 2012.

Figure 8 - Fire and explosion on board the *MSC Flaminia* on 14/07/2012 in the Atlantic Ocean (Source: BSU / German Command for Maritime Emergencies)

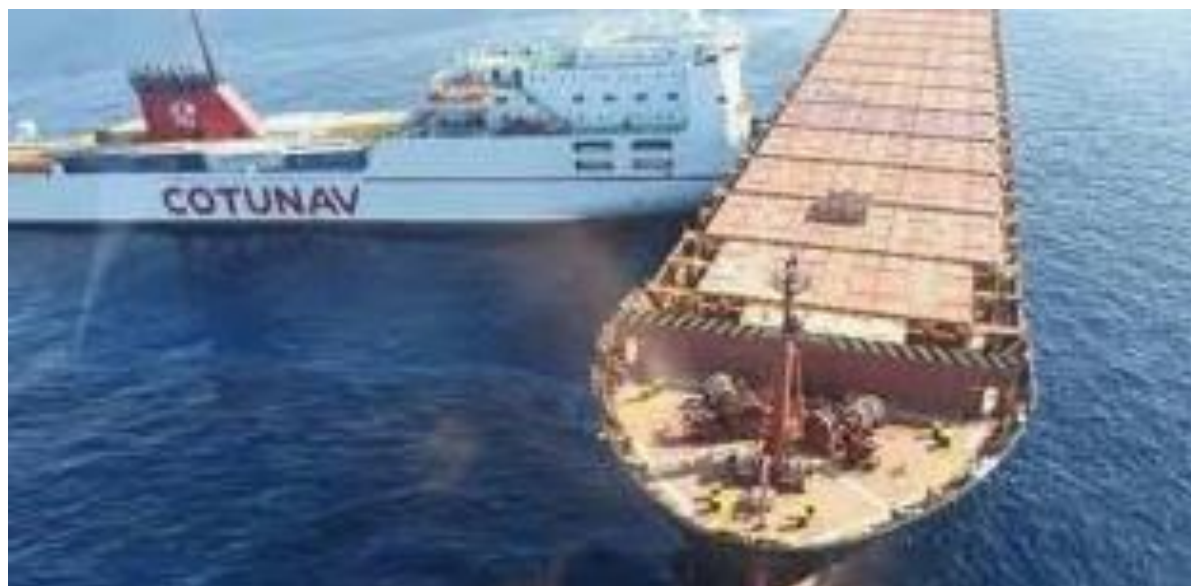
Figure 9 - Collision *CSL Virginia - Ulysse* on 7 October 2018, off cap Corse (Source: BEA Mer / Prefecture maritime de la Méditerranée)
