### SAFEMED III Seminar on IMO Audit Scheme

### CleanSeaNet

Marc Journal  
Unit C3 – Satellite based monitoring services

- The European satellite oil pollution and vessel detection and monitoring system
- Linked into national/regional response chain strengthening operational pollution surveillance and response for deliberate and accidental spills.

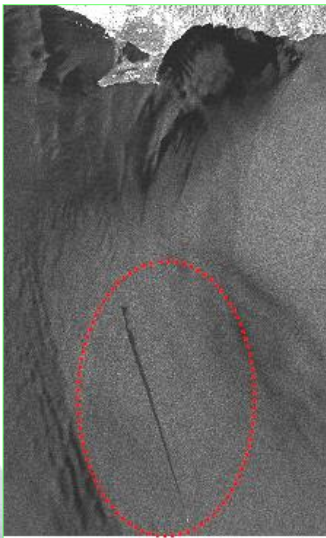
## Oil Slick Detection Principle using SAR

- Synthetic Aperture Radar (SAR) emits electromagnetic pulses
- Radar signal bounced back by sea ripples created by the wind
- SAR sensor measures the level of the backscattered signal i.e. Ocean's roughness
- **Oily films**
  - smooth the sea surface
  - reduce the backscattered signal
  - **appear as darker areas**

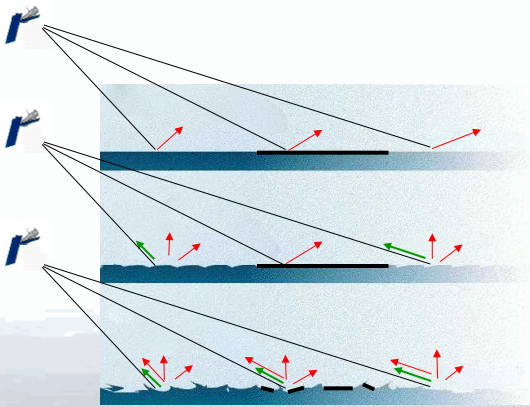
## Oil Slick Detection in SAR images

### Moderate winds favourable for oil slick detection

**Low wind:** Weak backscattered signal - Low contrast between oil slick and surrounding waters

**Moderate winds:** strong contrast between oil slick and surrounding waters

**High winds:** Useful signal lost in the ambient noise - Oil slicks often broken and dispersed into the water column

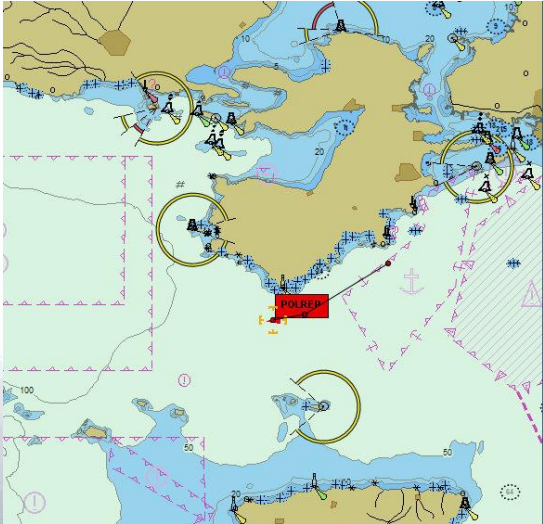
## SafeSeaNet – Alert – e.g.: POLREP

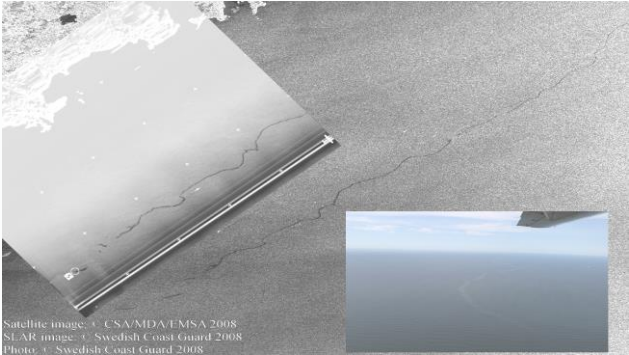
- CleanSeaNet detection initiates the action

Satellite image: © CSA/MDA/EMSA 2008  
SLAR image: © Swedish Coast Guard 2008  
Photo: © Swedish Coast Guard 2008

- On Site follow-up brings actionable evidence
- Satellite brings corroborating evidence

Full extent of the spill – Link between spill and polluter

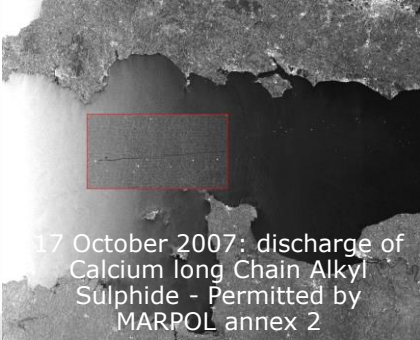
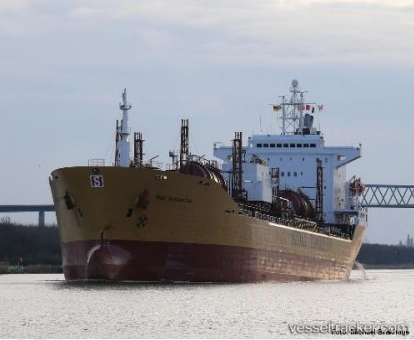
17 October 2007: discharge of Calcium long Chain Alkyl Sulphide - Permitted by MARPOL annex 2

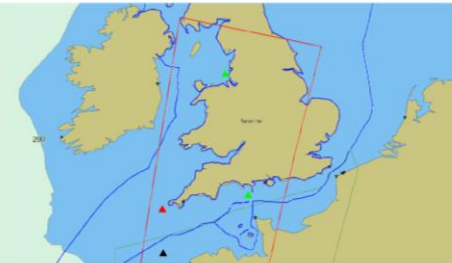
CleanSeaNet Alert Report

Acquisition: 2012-02-25 10:37:49 UTC

ENVISAT - ASAR/WS

Spill # on map	Spill Identifier	Centre Position		Area (km²)	Length (km)	Width (km)	Alert	Oil Spill Warning Issued	Possible Source	
		Latitude	Longitude						Detected	Identified
1	OS_19294_2	49° 59' 37" N	006° 00' 12" W	20.79	36.4554	8.8846	Red	N/A	Yes	No
2	OS_19294_3	53° 38' 47" N	003° 14' 03" W	7.34	4.1814	2.5221	Green	N/A	Yes	No
3	OS_19294_4	50° 22' 58" N	002° 14' 32" W	1.72	5.396	0.7452	Green	N/A	Yes	No
