Network of Standby Oil Spill Response Vessels

Drills and Exercises Annual Report 2015

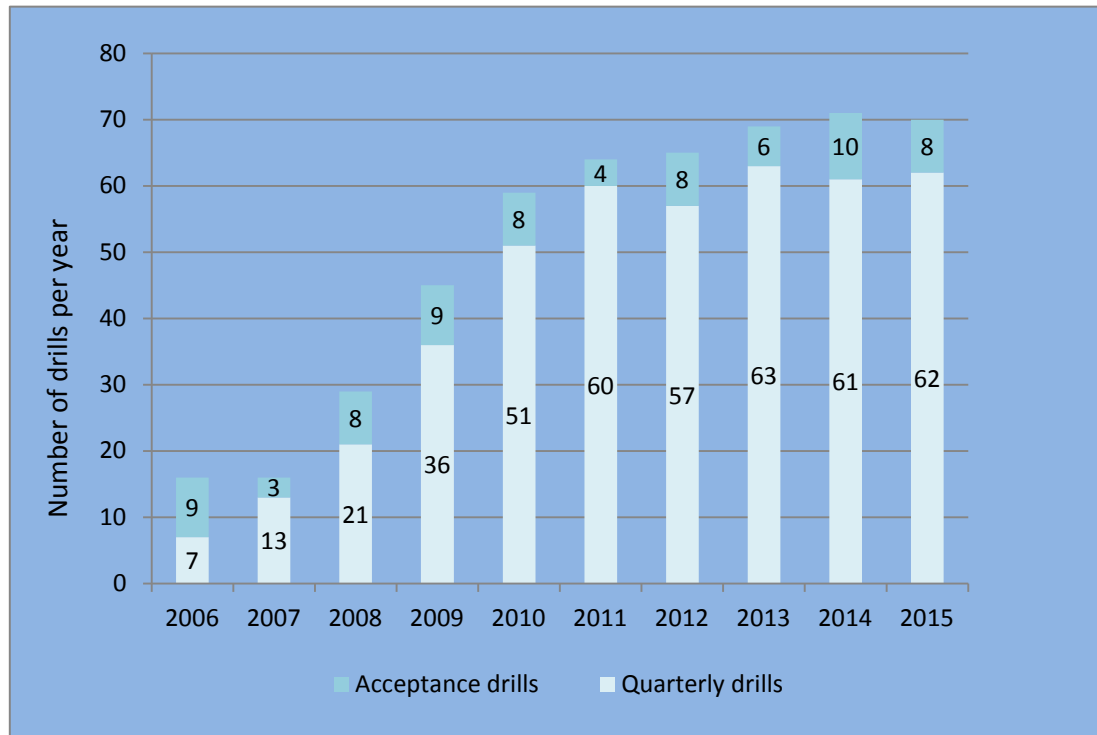
Chart 1. Number of drills 2006-2015

Over recent years the Network has been maintained at its maximum planned size, and the number of drills and exercises occurring each year has remained relatively stable. A summary of drills performed by EMSA contracted vessels during the period 2006-2015 is shown in the chart below.

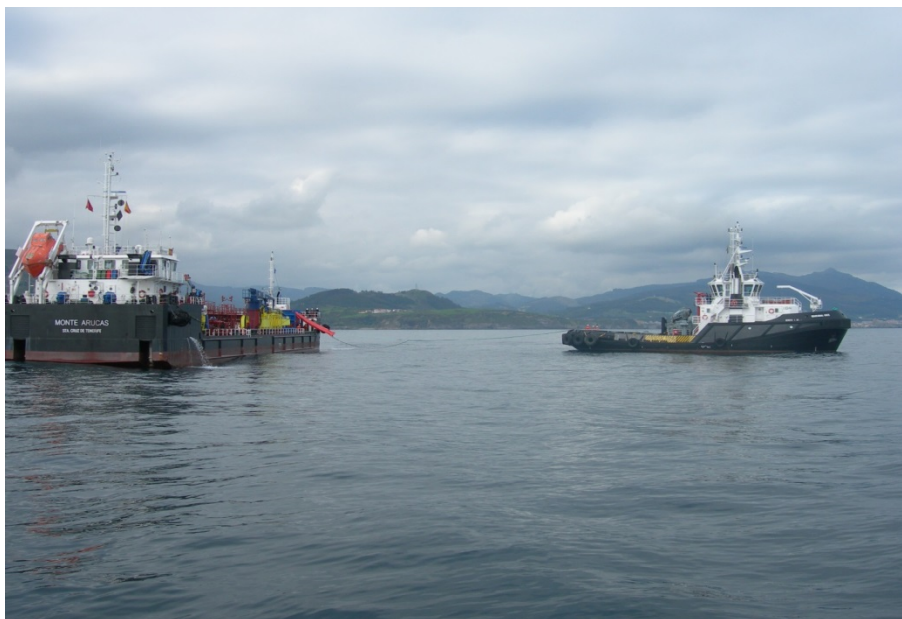
Fig.1. *Monte Arucas* and *Ibaizabal 11* deploying the boom

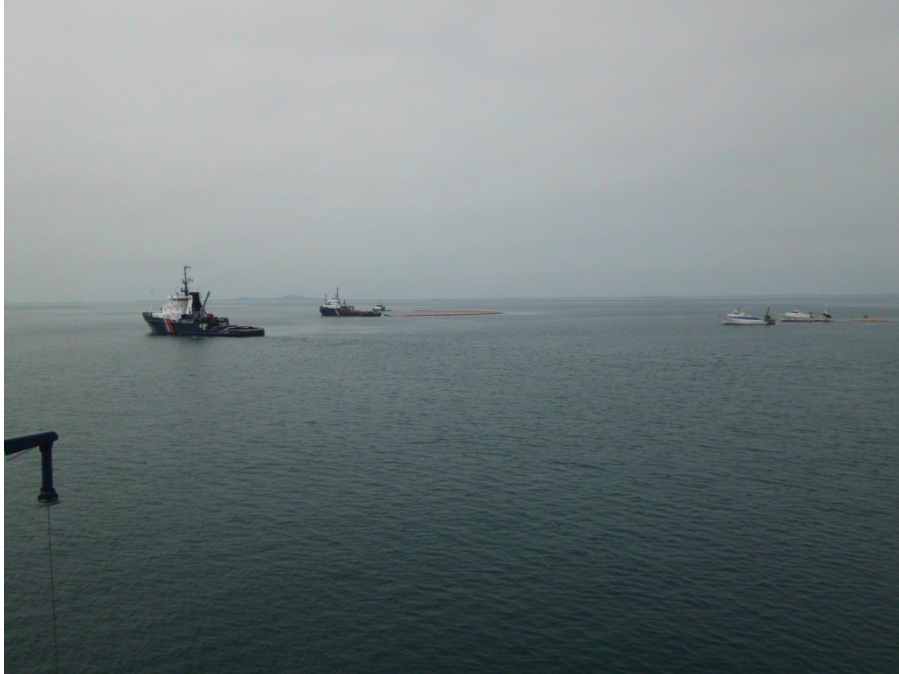
Fig.3. POLMAR MER 2015 - French vessels exercising oil recovery seen from the deck of the *Brezzamare*

The *Brezzamare* performed well. The vessel found the oil slick using the on board slick detection system. Oil was successfully recovered by means of sweeping arm system. *Brezzamare* fulfilled the role assigned by the exercise commander and also met the expectations of the Agency.

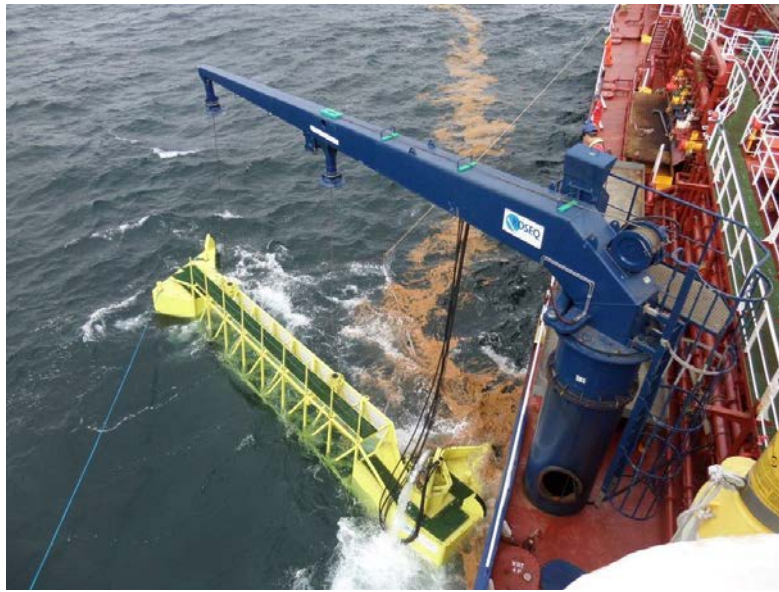
Fig.5. *Forth Fisher* recovering the oil simulant

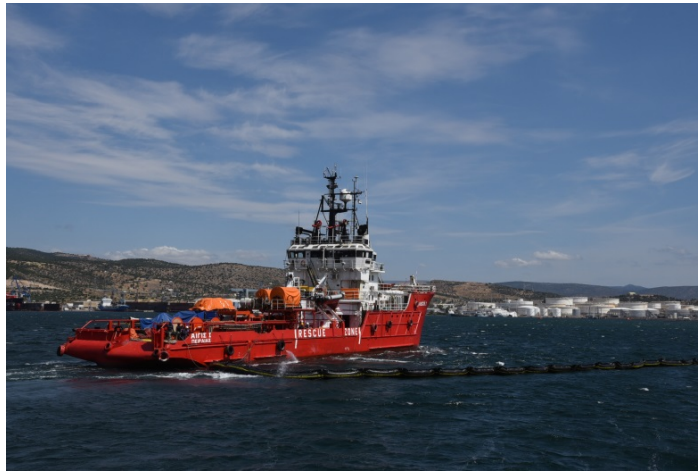
Fig.6. *Aegis I* towing the boom in J formation

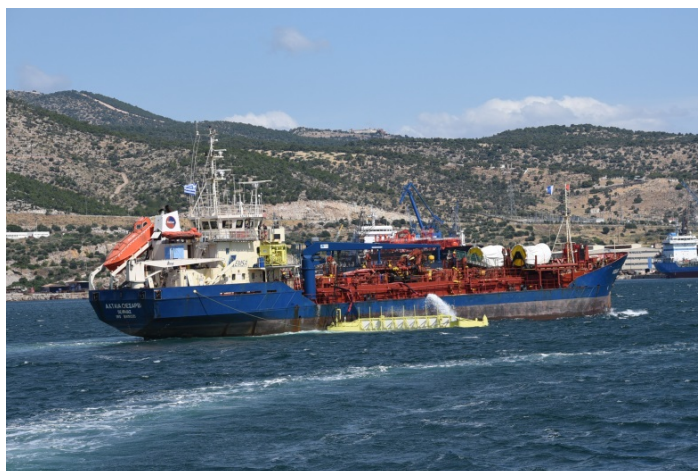
Fig.7. *Aktea OSRV* collecting oil with sweeping arm system

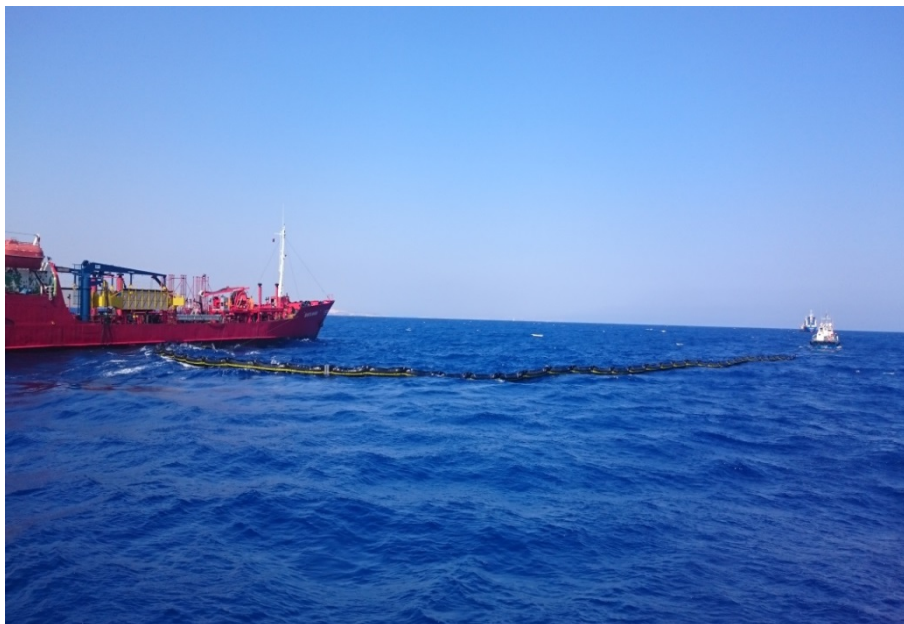
Fig.10. *Santa Maria* (EMSA) – Desmi Ro-boom 2000 in “J” formation

Although the weather conditions were not ideal, with waves measuring approximately 1 - 1.5 metres in height and increasing wind, the manoeuvres executed by EMSA vessels at speeds around 1 knot were successfully conducted. *Balluta Bay* and *Santa Maria* fulfilled the roles assigned by the Member State organising the exercise and also met the expectations of the Agency. The EMSA contracted vessels and their crews performed well.

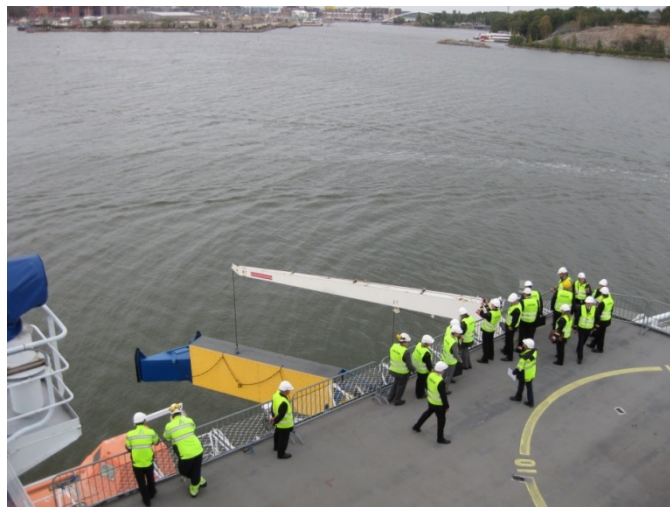
Fig.11. Visitors on board *Kontio* observing the sweeping arm deployment
