European Maritime Safety Agency

**Network of Stand-by  
Oil Spill Response Vessels:  
Drills and Exercises**

**Annual Report 2011**

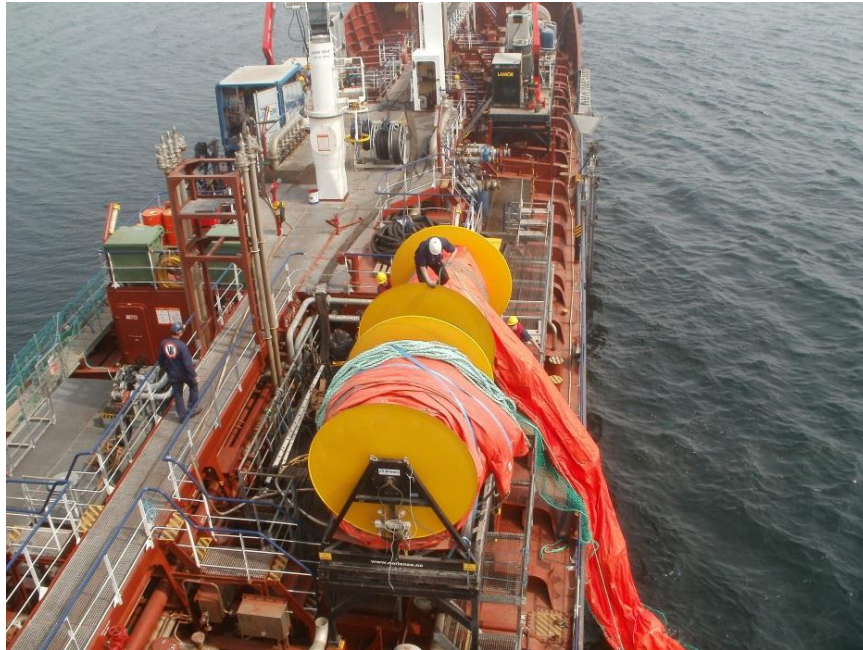
**Picture 2. Example of unsafe behaviour**

A limited number of cases of unsafe behaviour of the crew deploying or recovering equipment were observed. For example:

- Walking on the rigid sweeping arm hanging overboard with no railing or any other safety measure;
- Climbing on the top of boom reel without a safety harness;
- Crowded boom deployment platform.

Examples of unsafe behaviour were especially observed when technical problems with the equipment deployment occurred such as incorrectly attached or stacked lines, boom jammed on the reel, or difficulties locating the sweeping arm on the stand.

To date there have been no reports of accidents or casualties related to the quarterly drills. Safety on board during the equipment deployment remains a vitally important aspect which requires a consolidated approach. Firstly there is a need for continual safety training. This issue should be addressed particularly during briefings before and de-briefings after each quarterly drill. Secondly, additional measures should be considered to secure the work place for responders (railings, markings, warning tables, personal safety equipment, etc.). Thirdly, any case of safety deficiencies noted by the EMSA observers should be immediately reported to the vessel's captain for immediate rectification. As safety on board is the responsibility of the captain it is his/her obligation to instruct the crew members and/or to implement the necessary safety measures.

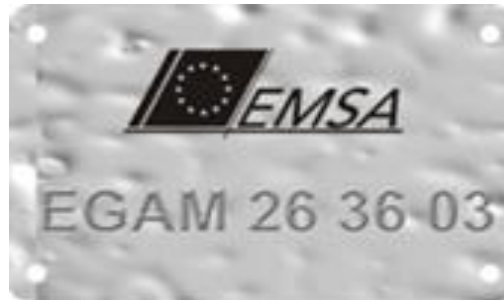
**Picture 4. Equipment label**

The "Pollution Asset Management System (PAMS)" set up in 2010 in order to strengthen the management of the oil pollution response equipment assets was completed in 2011

for the current contracts. The project will be continued for new vessel arrangements contracted in the future.

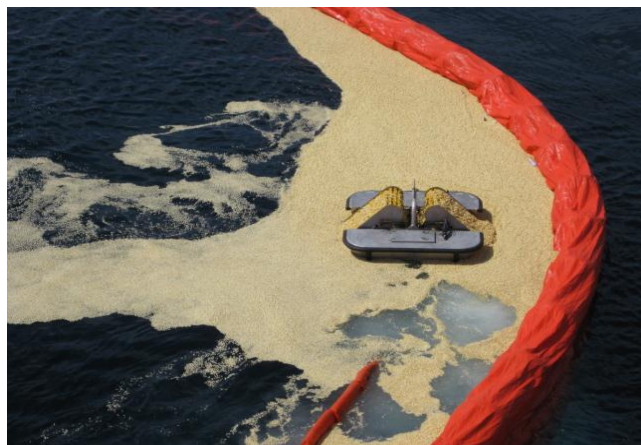
Picture 7: Skimmer recovering oil simulant (popcorn)

The exercise was based on the collision of a merchant vessel with the north pier port of Figueira da Foz. As a result of the accident, the vessel suffered significant damage to her hull. A spillage of about 500 m<sup>3</sup> IFO180 occurred. Following the activation of the Portuguese Contingency Plan and request for assistance to MIC/EMSA, oil recovery operations were undertaken together with a shoreline clean-up.

The FOZ 2011 exercise was a positive experience for all the participants. The exercise scenario was considered to be very realistic and the role of the *Bahia Tres* as oil recovery vessel was successfully implemented. The 'oil recovery operations' were well executed and the crew of the EMSA contracted vessel showed a high level of motivation. *Bahia Tres* fulfilled the role assigned by the Member State for this exercise and the Agency was also satisfied by its performance.

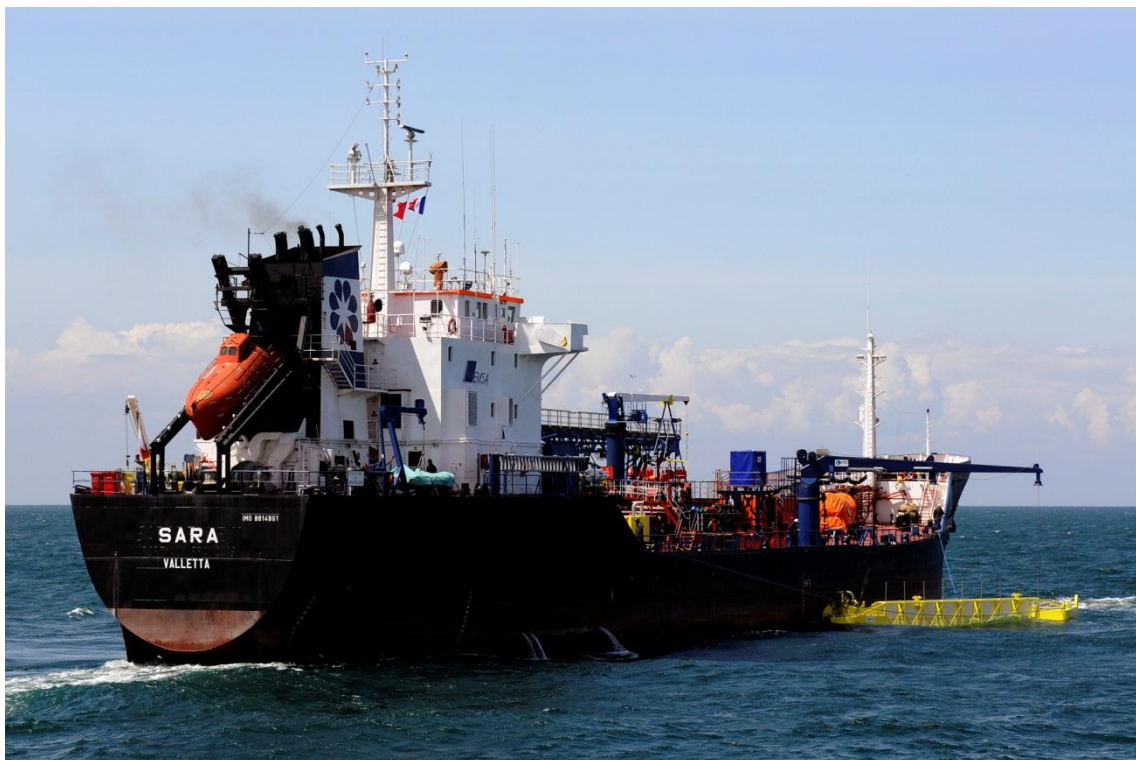
**Picture 8: Sara during the ORSEC POLMAR 2011(North Sea) exercise**

The oil recovery operations were carried out in adverse weather conditions. With a wind force between 5 to 6 Beaufort and a wave height of over 2m, the waves created a splashover the sweeping arms at even the lowest sweeping speed. In such weather conditions the skimming of the water surface could not be carried out correctly. The popcorn used to simulate the oil spill was not observed in the exercise area and the aircraft also failed to identify the 'oil spill.' The reasons for this could be the small quantity of popcorn dropped or that the popcorn sank due to the weather conditions.

The exercise was nevertheless a positive experience for all the participants in challenging circumstances and the coordination between the different units was positively tested. The EMSA contracted vessel *Sara* nevertheless fulfilled the role assigned to it by France, the organising Member State, and also met the Agency's expectations.

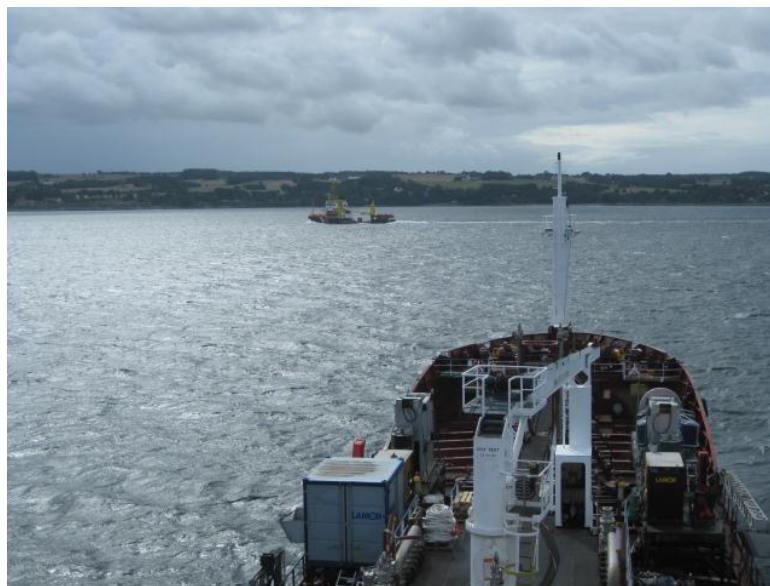
**Picture 9: OW Copenhagen during the BALEX DELTA 2011**

units. Each of the masters were also given the freedom to choose to deploy oil spill recovery equipment or just to simulate recovery operations. Given the weather conditions and in particular the wind direction, it was decided that the EMSA contracted vessel, *OW Copenhagen*, would deploy its sweeping arms individually, keeping the deployed arm in the water from the lee side of the vessel only. It should be noted that the *OW Copenhagen* was one of the few vessels that actually deployed its oil recovery equipment given the weather conditions.

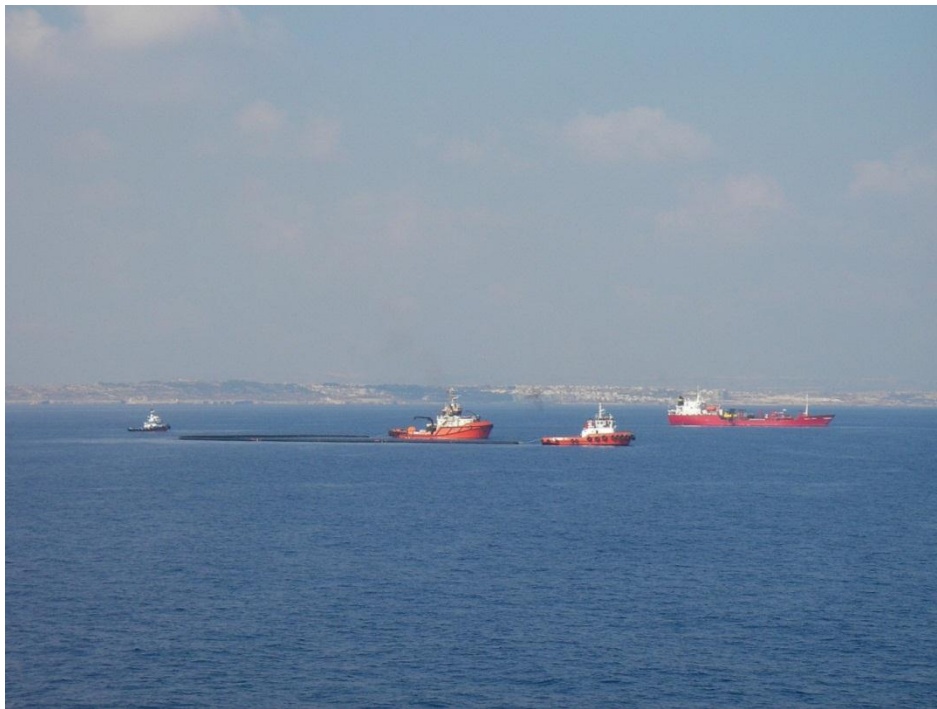
**Picture 10: Maltex 2011 Exercise**

deployment, *Balluta Bay* and *Santa Maria* were ordered to deploy their sweeping arms and simulate oil recovery in parallel to the other formation.

EMSA vessels performed at their best during this exercise. The equipment deployment and crew performance was satisfactory. The coordination with other units, led by the *Balluta Bay*, was good. Overall, the exercise was a good opportunity for the participating units to improve coordination during oil pollution response operations. MALTEX 2011 was a positive experience for all the participants.

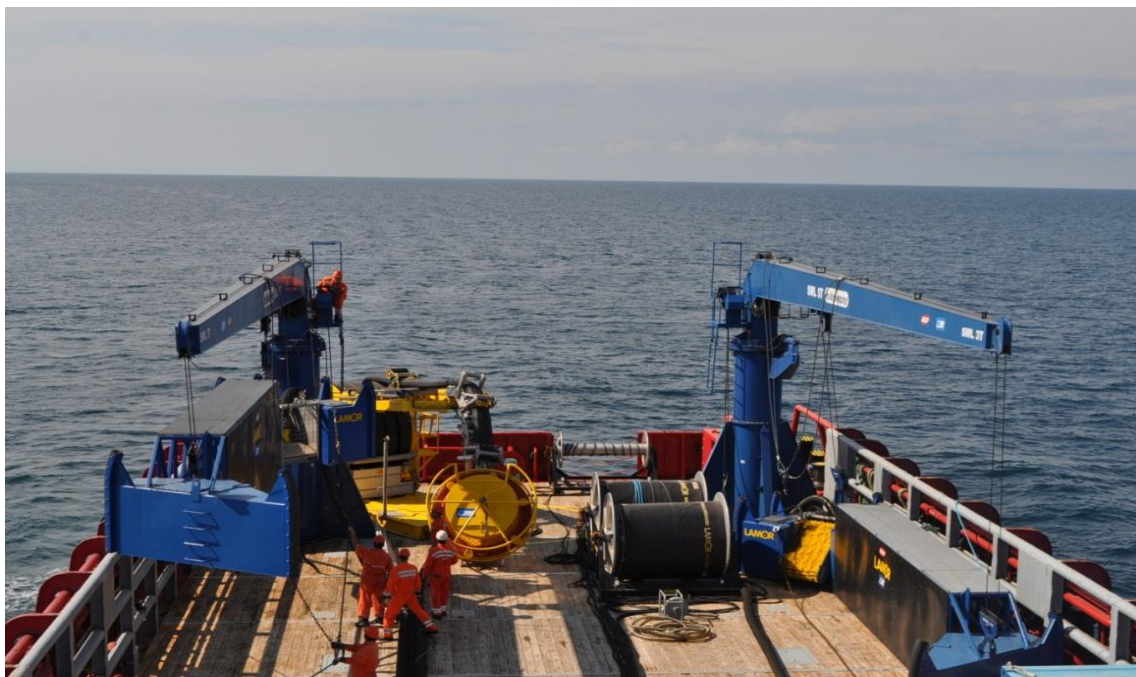
**Picture 11: Equipment on the deck of the *GSP ORION* during GEODELTA 2011 Exercise**

In total 12 ships (oil pollution response and ancillary ships) and one helicopter participated during the GEODELTA exercise. The participating fleet was made up of Georgian response ships, supporting ships from the Black Sea coastal states and the EMSA vessel *GSP Orion*. The ship agent of *GSP Orion* was acting as a liaison officer between the Local On Scene Commander (LOSC) and pollution response coordinator on board the *GSP Orion*. It took approximately 15 minutes for the EMSA contracted vessel to deploy both sweeping arms and to fall into position in line with the instructions received from the LOSC.

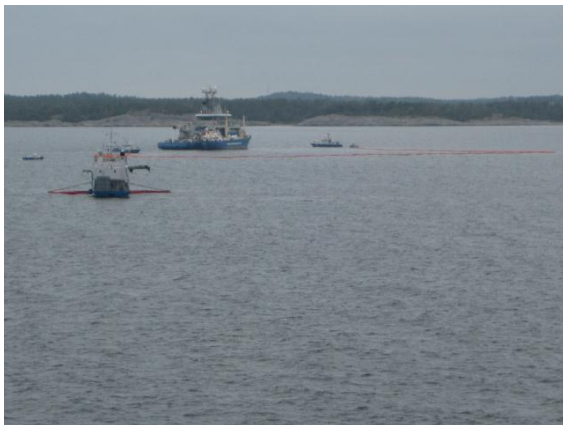
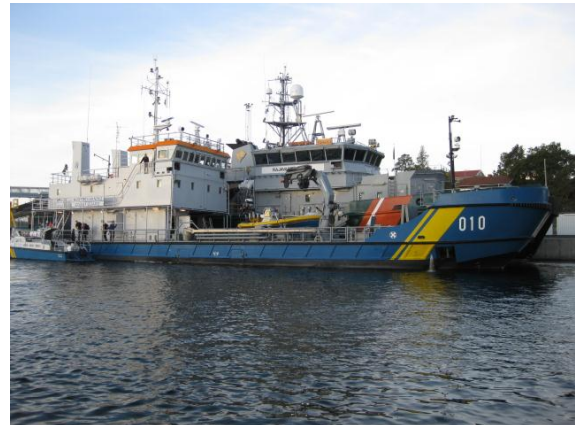
**Pictures 12 & 13: CEX 11 Exercise**

The exercise was a success despite the challenge of coordinating a large number units in a relatively narrow exercise area. The EMSA contracted vessel *Kontio* fulfilled the role assigned to it by the Member State organising this exercise, Sweden, and also met the expectations of the Agency. The *Kontio* also participated in an unforeseen ship-to-ship transfer operation and this experience provides useful input to the ongoing project assessing the ship-to-ship transfer capabilities of the EMSA Network, in particular as regards the compatibility of the connectors, the use of grounding cables and the wearing of gas masks by the crew.

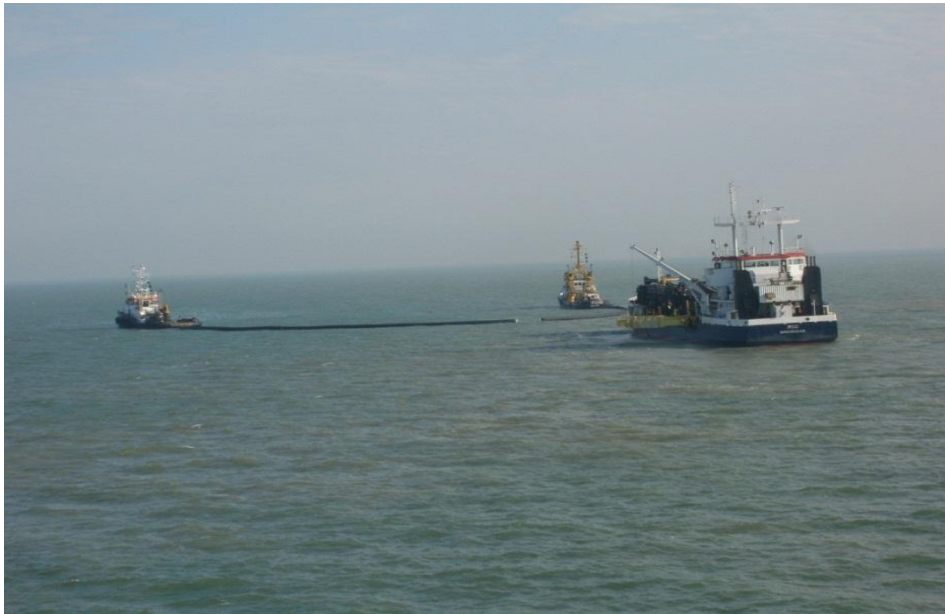
**Picture 14: Dredger with deployed sweeping arms following open U formation**

The exercise programme envisaged testing the 'U' formation of the boom towed by the Belgian tugs followed by the *DC Vlaanderen*, *Interballast III* and a third DC Industrial vessel (contracted by the Rijkswaterstaat Nordzee) skimming oil with their sweeping arms. The oil slick was simulated by oil dispersant 'Radiagreen' spilled on the water surface (150 litres). The exercise programme was completed with success. During the Exercise, the EMSA contracted vessels *DC Vlaanderen 3000* and *Interballast III*

performed well and fulfilled the role assigned by the Netherlands, the Member State in charge for this Exercise and also met the expectations of the Agency.

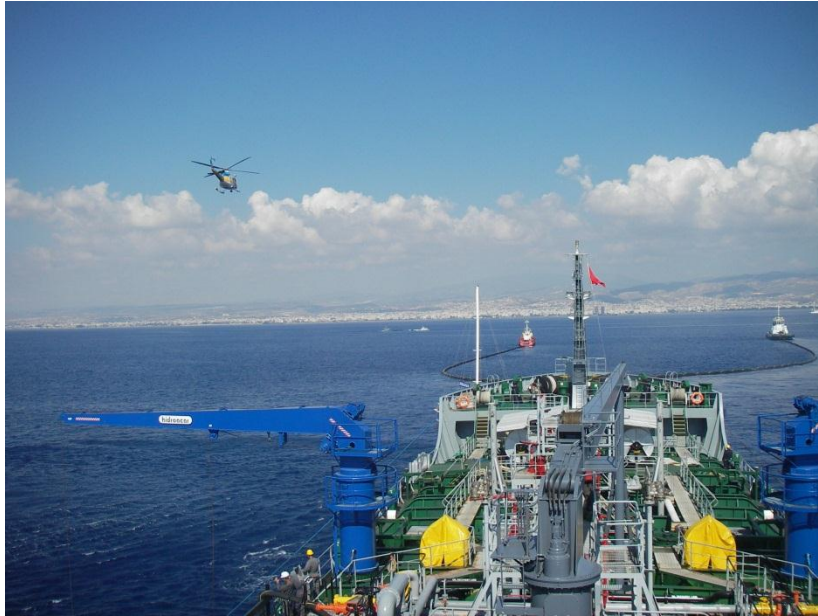
**Picture 15: Exercise NIRIIS 2011**

The exercise counted on the participation of the vessel *Alexandria*, contracted by EMSA from Petronav, two support vessels, small crafts, one helicopter and an "observer's boat" for the press and other observers. During the exercise, the on scene commander (OSC) coordinated the operations from the *Alexandria*. The exercise scenario simulated serious structural damage of a tanker en route from Suez to Cyprus carrying 20,000 tonnes of heavy fuel oil. According to the exercise program, the Petronav vessel was tasked to collect and recover the simulated oil spill with her on board oil recovery systems. This task was carried out in coordination with other participating units.

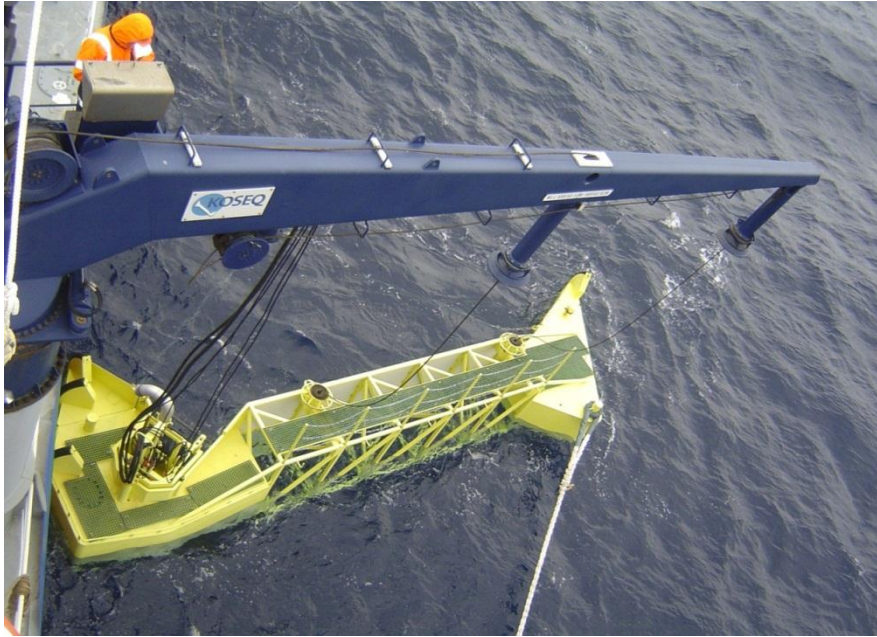
**Picture 16: Salina Bay with the starboard sweeping arm deployed**

The tugboat *Bonassola* was the lead vessel of the strike team, located near the *Sara*. The EMSA vessel *Salina Bay* was instructed to follow the *Bonassola* and deploy her sweeping arms. Due to adverse weather conditions only the tugboat *Bonassola* was able to deploy her flexible sweeping arms. The *Salina Bay* performance during the exercise was up to the expected standards, especially taking into account the adverse weather conditions.
