Critical deck Permeability for the Survivability of a Damaged ROPAX

Dimitris A. Spanos *

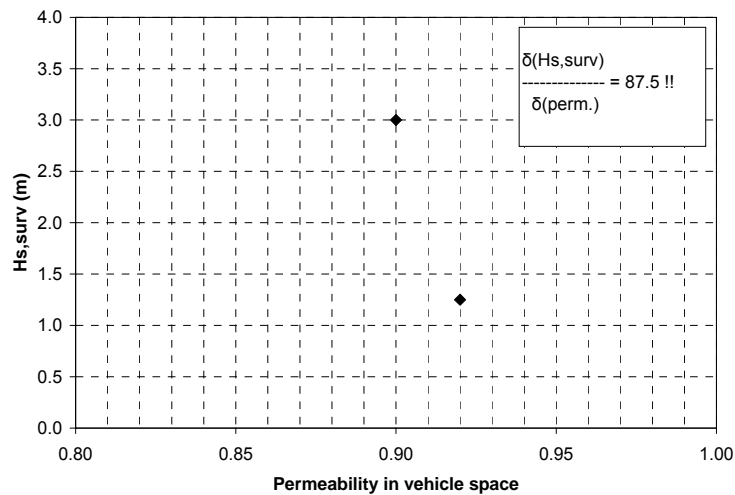
Two estimations carried out, assuming $\mu=0.92$ and $\mu=0.90$ for the permeability of the vehicle deck. Initially the case of 0.92 resulted a survive wave height $H_{s,surv}=1.25$ m. Then the value of 0.90 studied expecting to record a higher wave height (as illustrated above), which was indeed much higher $H_{s,surv}=3.00$ m, and shown in Figure 4.

Figure 4 The survive wave height for the damage ROPAX in variation of the permeability of the vehicle space.

Thereof, a small change in permeability by 0.02 resulted a large increase of the survive wave height. The corresponding trend equals 87.5, which practically indicates a jump of $H_{s,surv}$ at the region of the critical permeability 0.92.

The estimated survive height as presented in above Figure 4 has been based on the physical survive of the vessel, instead of a conventional one. While in a context of conventional survivability the survive height $H_{s,surv}=3.0$ m for $\mu=0.90$ would not be detected, but most likely some other height a bit higher from $H_{s,surv}=1.25$ m, which is the height for $\mu=0.92$.
