### SAFEMED III Seminar on EMSA's Oil Pollution Response Services

#### Role of EMSA – CleanSeaNet

Marc Journel/Siegfried Schmuck  
Unit C3 – Satellite based monitoring services

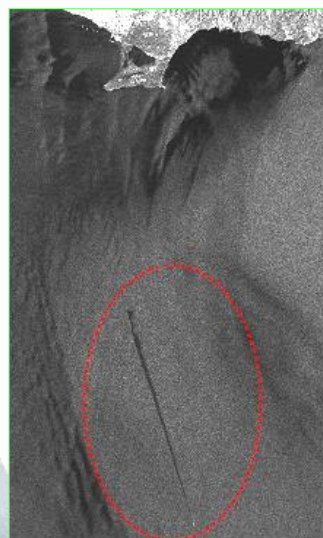
## Oil Slick Detection Principle using SAR

- Synthetic Aperture Radar (SAR) emits electromagnetic pulses
- Radar signal bounced back by sea ripples created by the wind
- SAR sensor measures the level of the backscattered signal i.e. Ocean's roughness
- **Oily films**
  - smooth the sea surface
  - reduce the backscattered signal
  - **appear as darker areas**

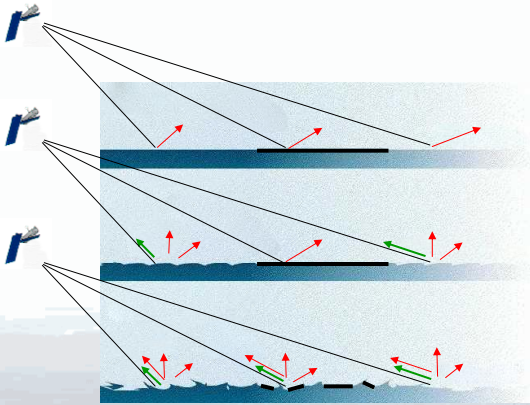
### Moderate winds favourable for oil slick detection

**Low wind:** Weak backscattered signal - Low contrast between oil slick and surrounding waters

**Moderate winds:** strong contrast between oil slick and surrounding waters

**High winds:** Useful signal lost in the ambient noise - Oil slicks often broken and dispersed into the water column

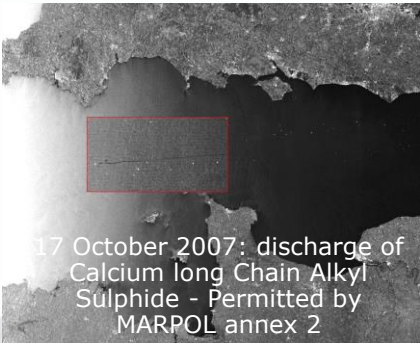
17 October 2007: discharge of Calcium long Chain Alkyl Sulphide - Permitted by MARPOL annex 2

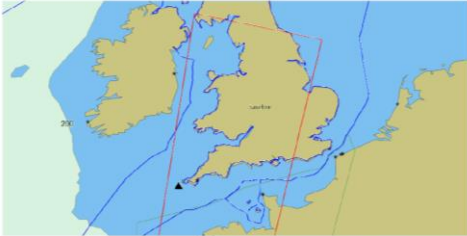
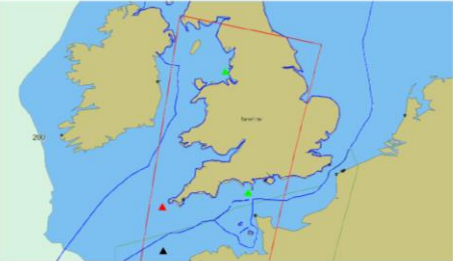
Possible Spill

Centre Position	
Latitude	Longitude
50° 00' 22" N	005° 59' 11" W

List of possible spills
