EMSA/OP/01/2016

Study investigating cost effective measures for reducing the risk from fires on ro-ro passenger ships (FIRESAFE)

European Maritime Safety Agency
SP Technical Research Institute of Sweden AB
Bureau Veritas
Stena Rederi AB

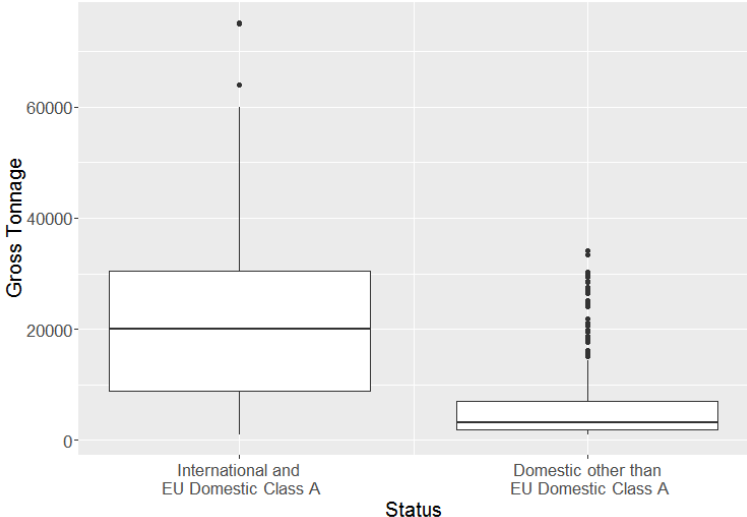
Figure 2.2-1: Gross Tonnage in the International and EU Domestic Class A fleet and Domestic other than EU Domestic Class A.

The boxplots show that the *International and Domestic Class A* fleet and the *Domestic other than EU Domestic Class A* fleet are two distinct fleets that cannot be studied together, due to their intrinsic differences, in terms of size and capacity, even if both fleets were SOLAS compliant.

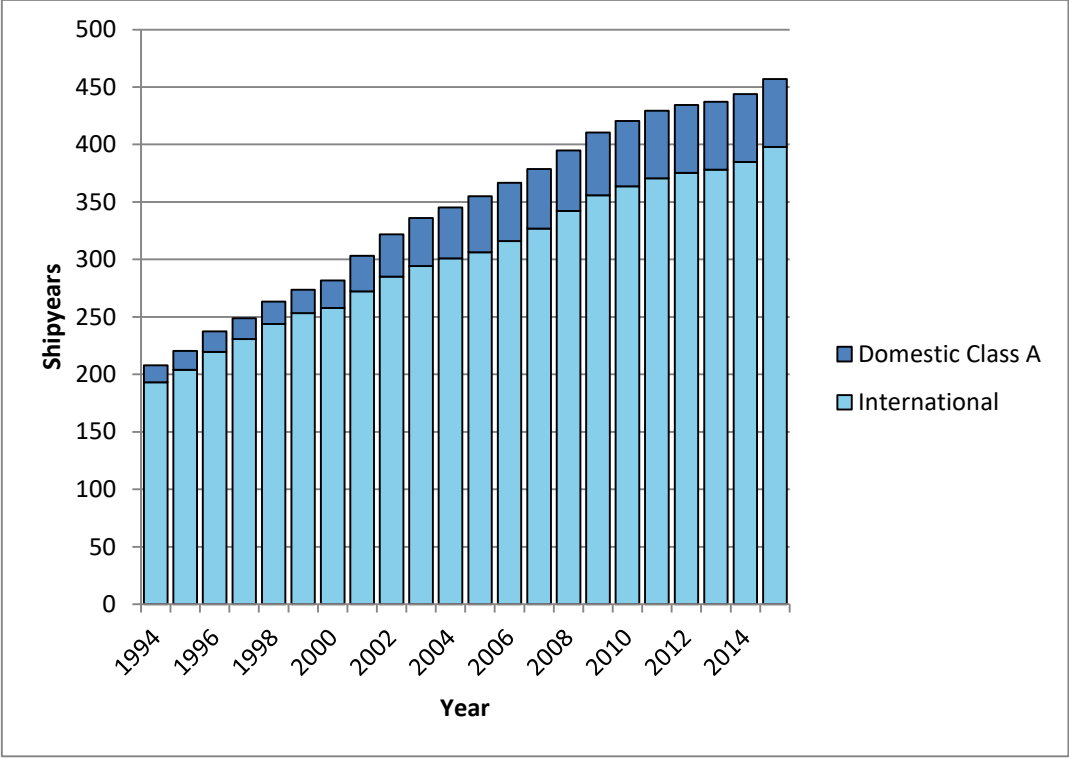
from about 210 shipyears in 1994 to 460 shipyears in 2015. The cause of this increase can be attributed to the filtering criteria selected for the study. The fleet under consideration consists of the ships compliant with the above-mentioned criteria. Each year, new ships enter the fleet (newbuildings compliant with the criteria), and contribute for additional shipyears, while almost no ships leave the fleet (since conversions are not considered and almost no scrapped or lost are observed). It seems a fair assumption to consider that the ships characteristics remain unchanged over time.

Figure 2.2-4: Number of shipyears per year for the FIRESAFE fleet between 1994 and 2015.

This led to a total of 7567 shipyears for the period 1994-2015, and 5530 shipyears for the period 2002-2015.

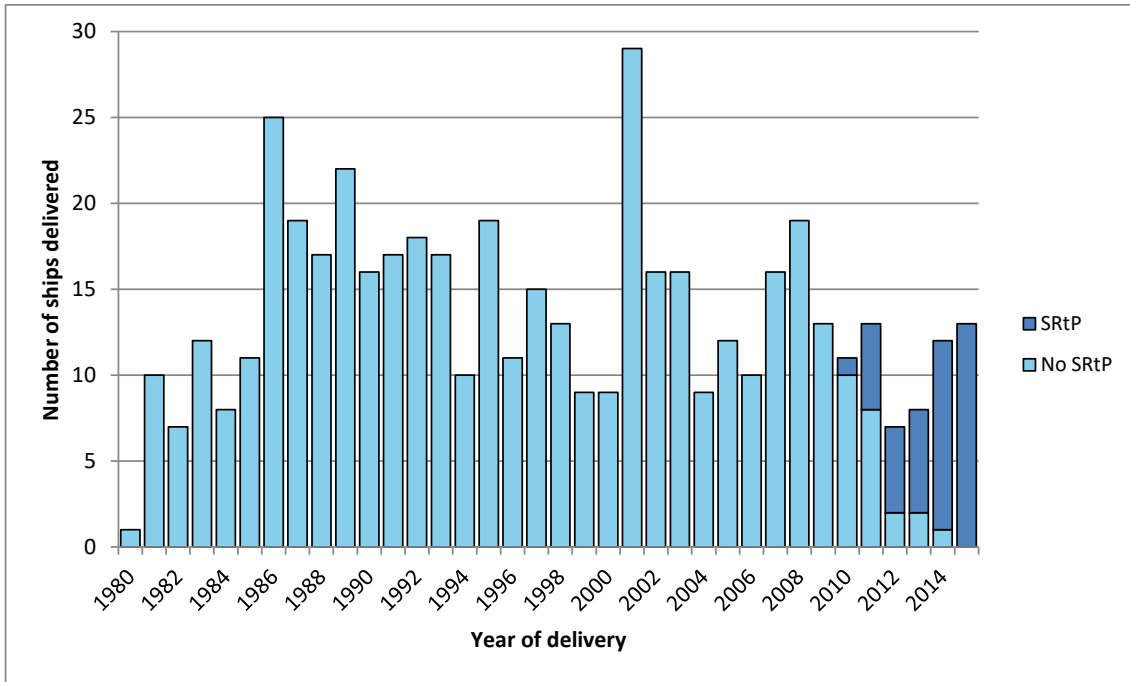
Figure 2.2-5 shows the number of ships delivered per year. Due to the filtering criteria (keel laying date), only one ship FIRESAFE-compliant has been delivered in 1980. No trend can be determined over the period.

Figure 2.2-5: Number of ships delivered according to delivery date⁶.

⁶ When keel laid date was not provided in the database – for 10 out of the 41 ships concerned, criterion has been applied to *built date*, as provided in MARINFO, therefore number of ships identified might be slightly over-estimated.

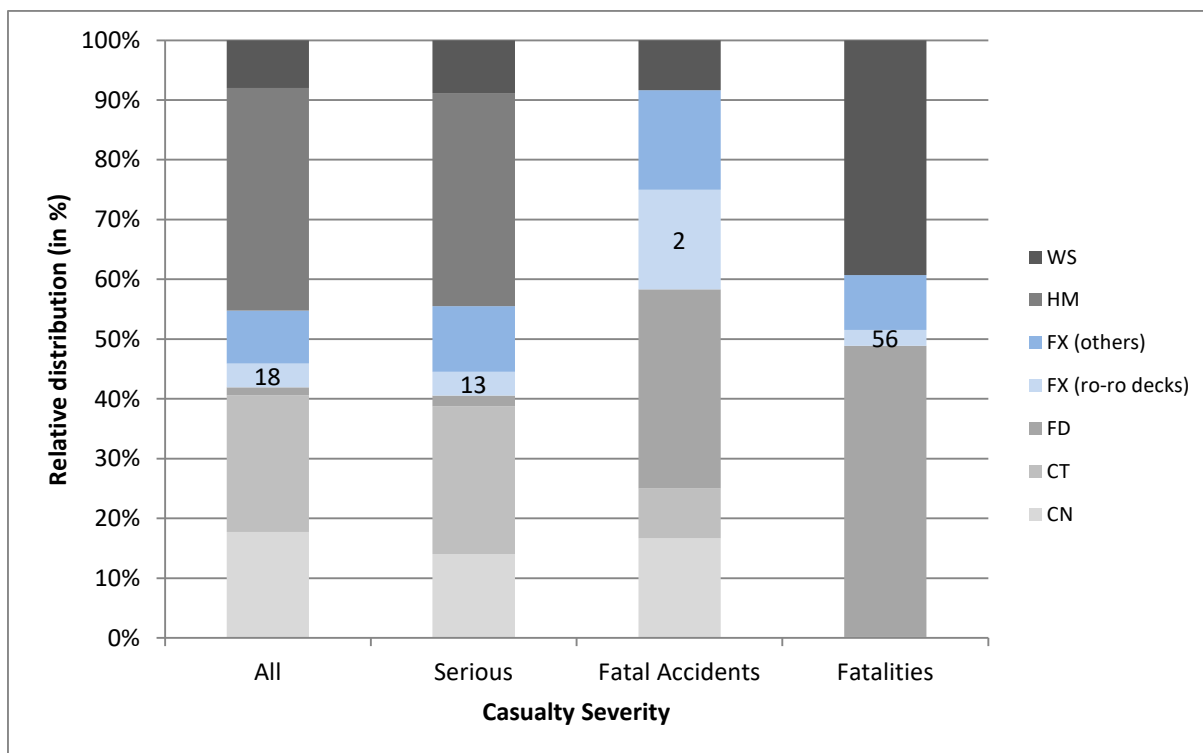
Figure 2.4-1: Relative distribution of casualty reports over the different accident categories on the FIRESAFE fleet between 2002 and 2015. Number of records for FX (ro-ro decks) provided by IHS. (WS: Wrecked/stranded, HM: Hull/machinery damage, FX: Fire/explosion, FD: Foundered, CT: Contact, CN: Collision)

Except for the Fire/Explosion accidents (and other accident types that had led to fires on ro-ro decks as identified during the data collection process), accident reports have not been reviewed, therefore the results presented in **Fel! Hittar inte referenskölla.2.4-1** might differ from previous FSA studies. The number of fatalities for the "Fires on ro-ro decks" fatal accidents corresponds to the ones reported in IHS. This number might vary in the following of the report as it depends on the source.¹⁵

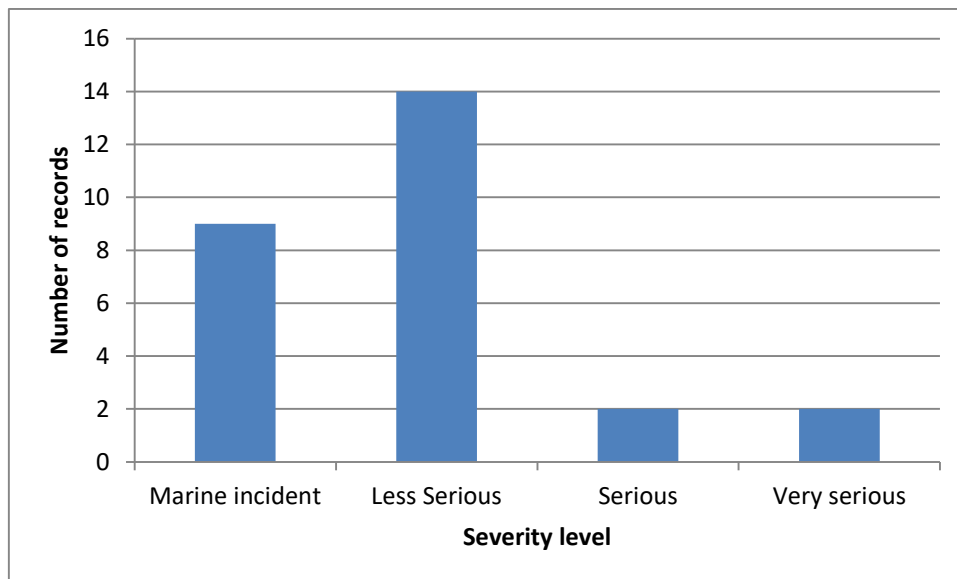
Therefore, statistics based on EMCIP database have been produced to give a picture that is considered to be closer to the reality, in terms of severity level ratios, than what is reported in **Fel! Hittar inte referenskölla**.. These results are shown in Figure 2.4-2.

Figure 2.4-2: Number of occurrences according to severity, based on EMCIP database.

85% of the 27 fires on ro-ro decks occurrences on FIRESAFE compliant ships recorded in EMCIP databases between June 2010 and June 2016 have been classified as *Marine incident* or *Less Serious Casualty*. Only 28% of the records were classified as *Non-Serious* in IHS.

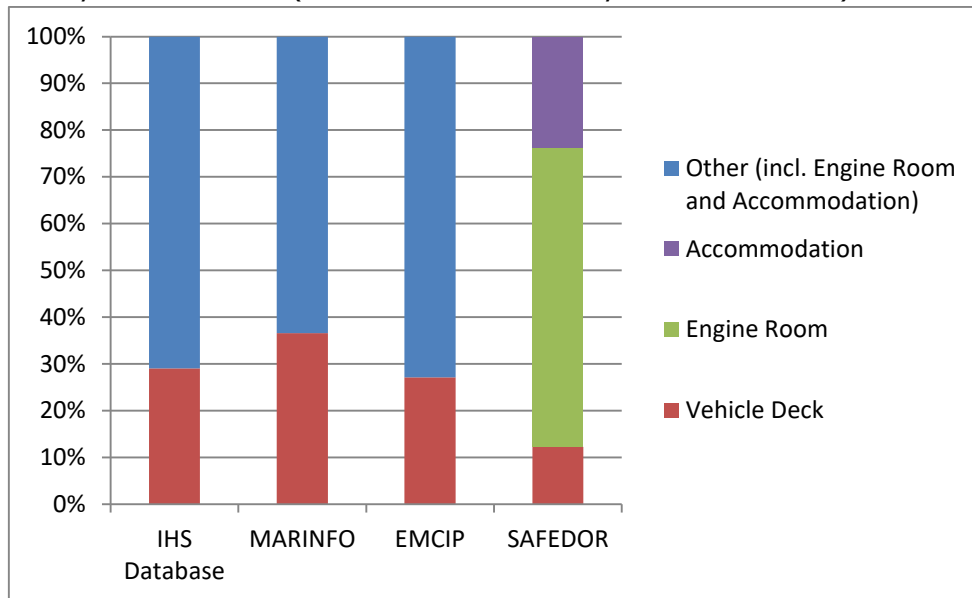
Statistics on IHS Casualty Database and MARINFO are based on accidents on FIRESAFE compliant ships during the period of study (2002 and 2015). EMCIP statistics has been computed from accident data on an undefined fleet of RoPax from June 2010 to June 2016. As for SAFEDOR, the ships considered are RoPax of 1,000 GRT and above and the period of study is 1994-2004 (no filter on the severity of the accidents).

Figure 2.4-3: Relative distribution of fire origin on RoPax ships in different accident data sources.

Due to the different periods and fleets considered, no conclusion should be drawn from Figure 2.4-3 on a potential increase in the proportion of fires on ro-ro decks or potential enhancement of fire safety in engine room and accommodation. However, it is worth noting the good degree of consistency between IHS Casualty Database, MARINFO and EMCIP, all around 30%, and the important difference with SAFEDOR (12%), the origin of this difference has not been ascertained. This proportion in SAFEDOR is close to what had been found in EMC MP08 (11%).

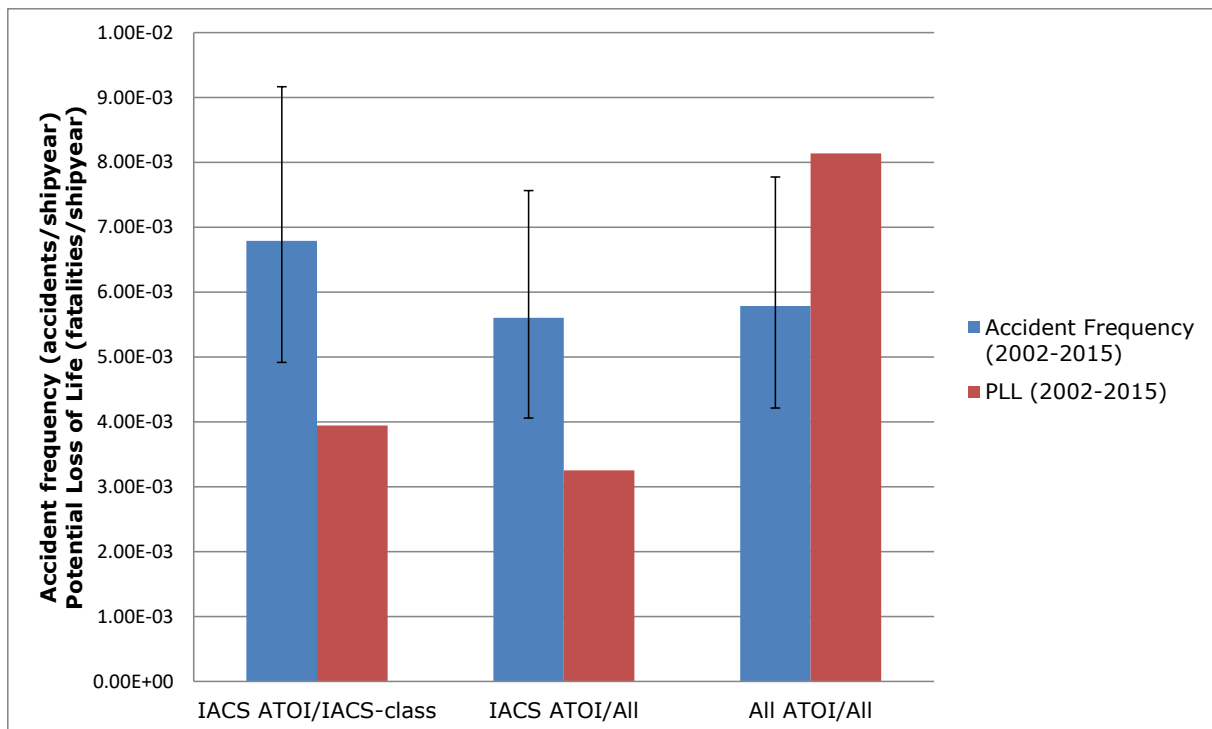
Figure 2.4-4: Impact of the IACS-class filtering criterion on the accident frequency and Potential Loss of Life.

While the consideration of the IACS parameter decreases the number of shipyears by about 20%, there was only one accident having occurred on a FIRESAFE-compliant ship which was not classed by an IACS society at the time of incident. This explains the increase in frequency between the *All* fleet and the *IACS-class* fleet. However, this unique accident was a fatal accident causing 27 fatalities, therefore the PLL of the *All* fleet significantly increases.

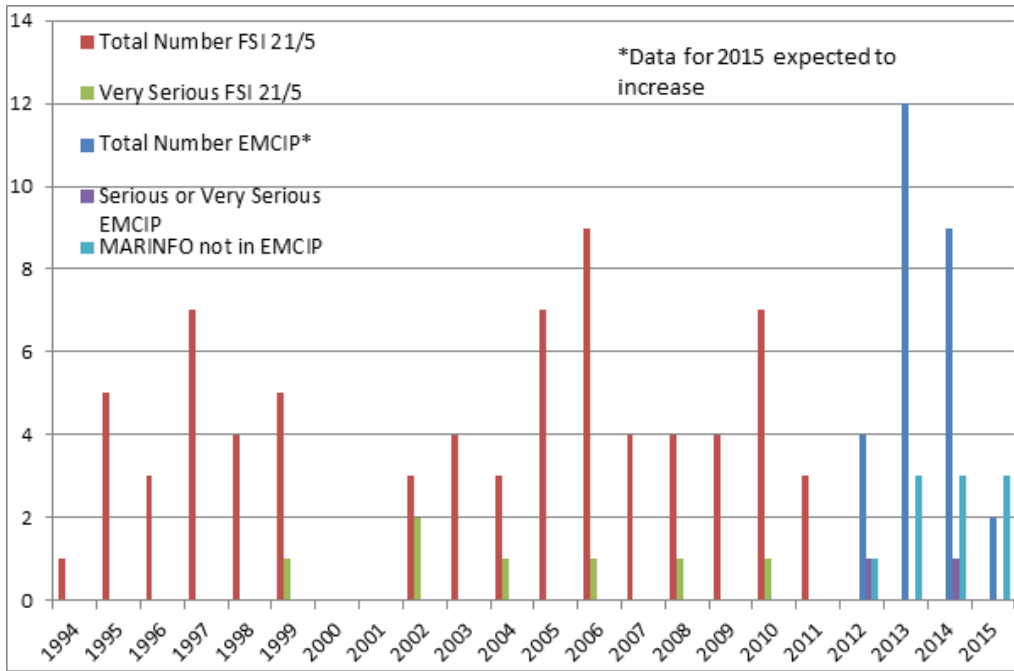
Figure 2.4-6: Fires on ro-ro decks 1994-2015 (from MSC 97/19/3 - Fire safety of ro-ro passenger ships). (IMO, 2016c)

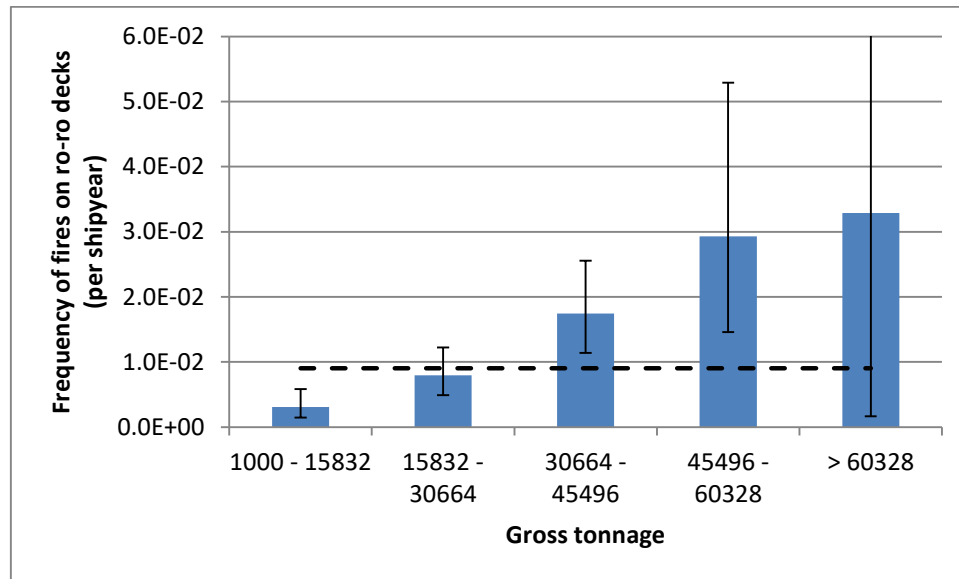
The impact of the ship size on the accident frequency on the FIRESAFE fleet between 2002 and 2015 has been investigated. There seems to be an increasing trend for larger ships, as indicated in Figure 2.4-10. However, it must be noted that the number of shipyears for the size category (GT>60328) is very low (about 30 shipyears over the full period) to provide an accurate estimation of the accident frequency for that period, as clearly shown by the large confidence interval.

Figure 2.4-10: Frequency of fires on ro-ro decks per size (GT) with 90 % confidence interval between 2002 and 2015 and average for all categories.

The confidence interval for the GT>60328 size segment has been cut short to maintain the readability of the figure, the upper bound being at 1.56E-01 fires on ro-ro decks per shipyear.

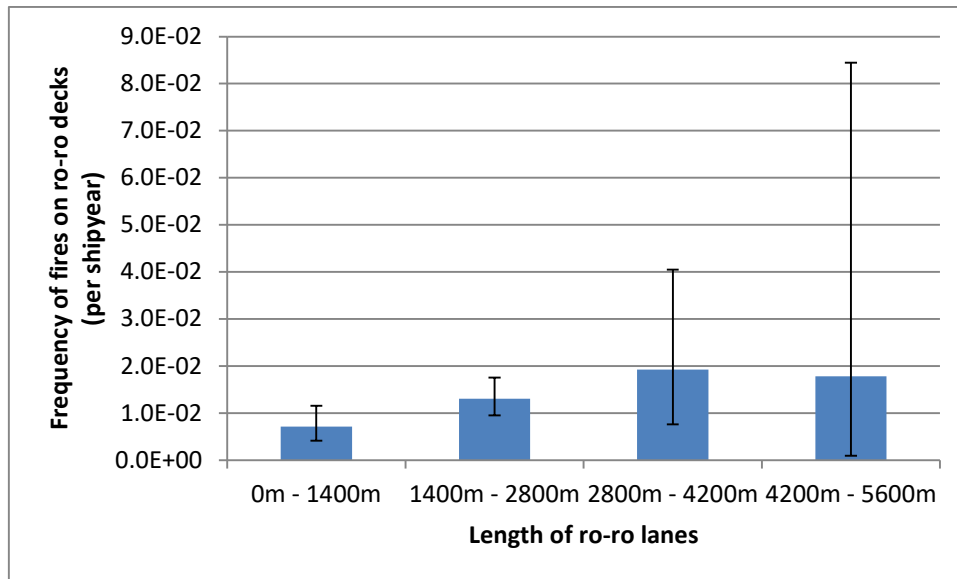
The number of lane meters (or length of ro-ro lanes) is available in IHS World Fleet database. However, this information was provided only for 368 ships out of the 490 ships of the FIRESAFE fleet. The frequency of fires on ro-ro decks for the fleet for which this information was available is reported in Figure 2.4-11 for different size categories.

Figure 2.4-11: Frequency of fires on ro-ro decks per length of ro-ro length category between 2002 and 2015 with 90% confidence interval (note that the fleet considered is not the entire FIRESAFE fleet at risk due to lack of data on lane meters).

As for the gross tonnage, there seems to be an increasing trend for ships with high number of lane meters. However, due to the large confidence intervals, which indicate that this trend could be explained only by stochastic variations, no conclusion will be drawn from that figure.

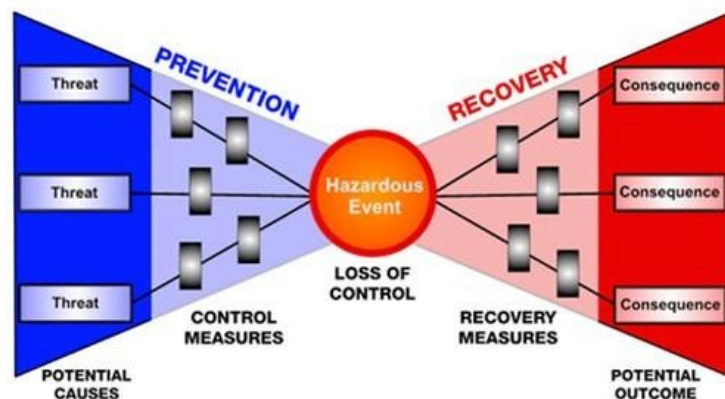
The concept used for the current Fire HazId was developed based on a well-known model in risk management called the Bow Tie model. It is a barrier risk model developed to assist the identification and management of hazards. The Bow Tie model is illustrated in Figure 2.5-1.

Figure 2.5-1. Illustration of the Bow Tie model, a barrier risk model for identification and management of hazards.

The Bow Tie model consists of different elements that build up the risk picture. The risk picture revolves around a hazardous top event. The top event is something with potential to cause harm unless it is controlled, in this case a ro-ro space fire. Focus is turned to one side at a time beginning with the threats on the left-hand side. These are potential causes for the top event which are explored through different escalation factors and control measures. Thereafter potential outcomes are investigated together with escalation factors and different recovery measures. The different control measures are barriers populated on either side of the model that are described by Table 2.5-1:

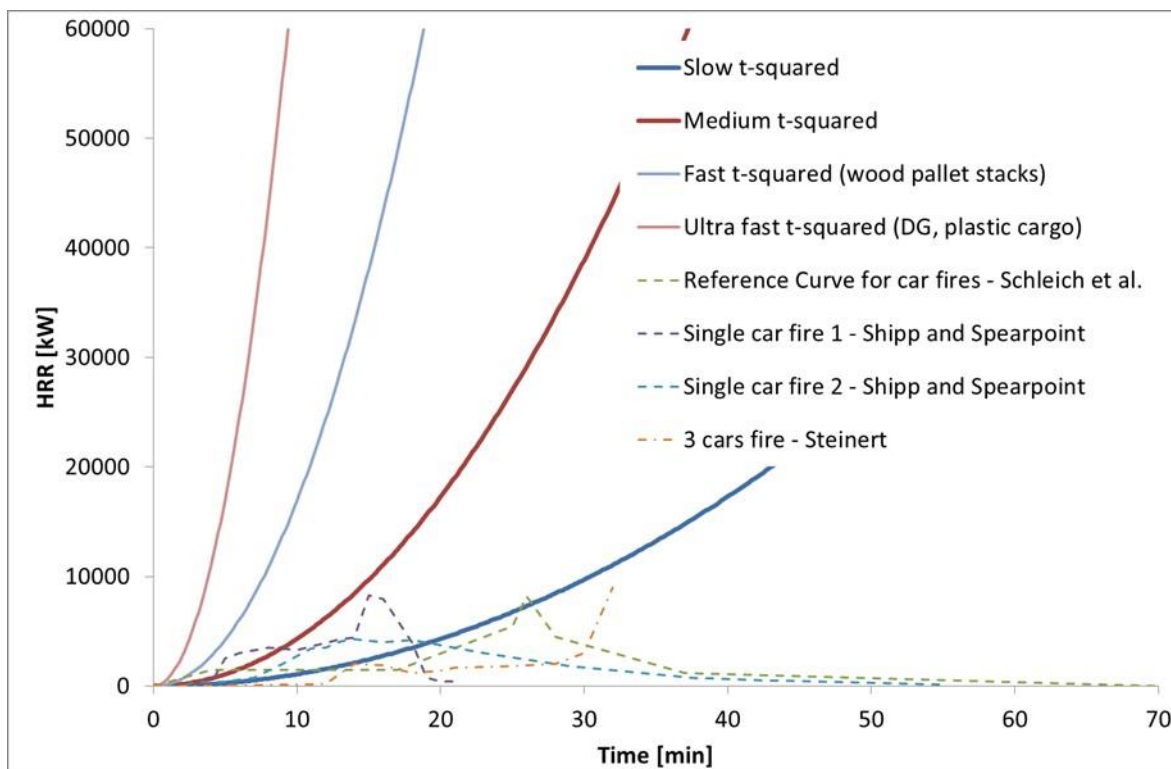
The fire growth in car fires has been studied in a number of research projects. Some of these studies were consolidated by Yuguang Li [Li Y,2004] and it was shown that the fire growth in parked cars varies between 0.003 kW/s^2 (denominated "slow" fire growth) and 0.012 kW/s^2 ("medium" fire growth). A number of relevant fire scenarios to support this are presented in Figure 2.7-1.

Figure 2.7-1 – Slow, medium, fast and ultrafast t-squared fires compared to a number of actual car fire tests and a reference car fire curve

Based on these experiences from car fires a medium fire growth is considered to be the expected fire growth rate for ro-ro deck fires, in most car fire scenarios this can be considered conservative. However, it should be noted that on a ro-ro space there is potential for fires with a more rapid fire growth e.g. in case of a large fuel spill, dangerous goods or other kinds of combustible cargo.

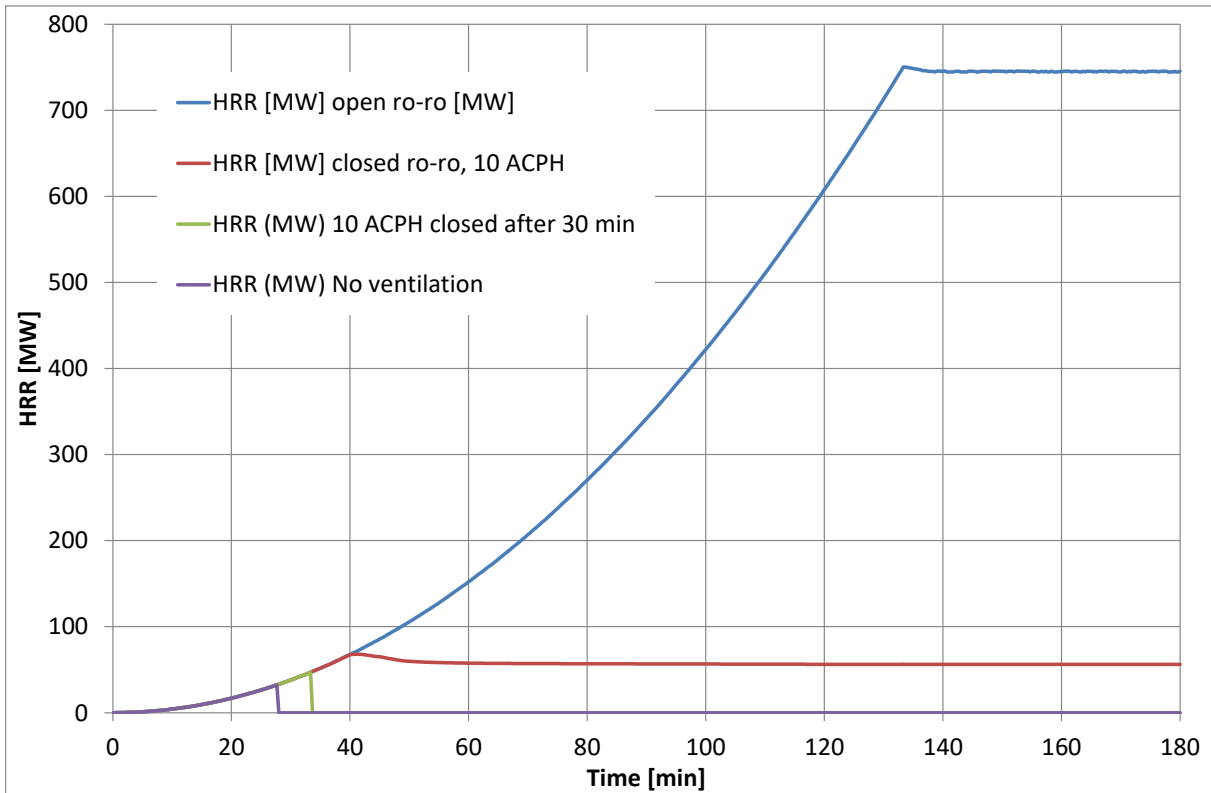
All simulations were performed assuming a medium fire growth rate and the fire was always allowed to grow until ventilation control was reached. The resulting heat release rate data is presented in Figure 2.7-2 .

Figure 2.7-2 - Heat release rates as a function of time for varying levels of ventilation

It is not obvious that a ro-ro deck fire will continue to grow until ventilation control is reached. However, Figure 2.7-32 clearly shows that the natural ventilation available on the open ro-ro deck will not be a limiting factor for the fire development before it reaches catastrophic dimensions that seriously threatens the entire ship is reached. A more detailed plot of the first 60 minutes of the same results is shown in Figure 2.7-3.

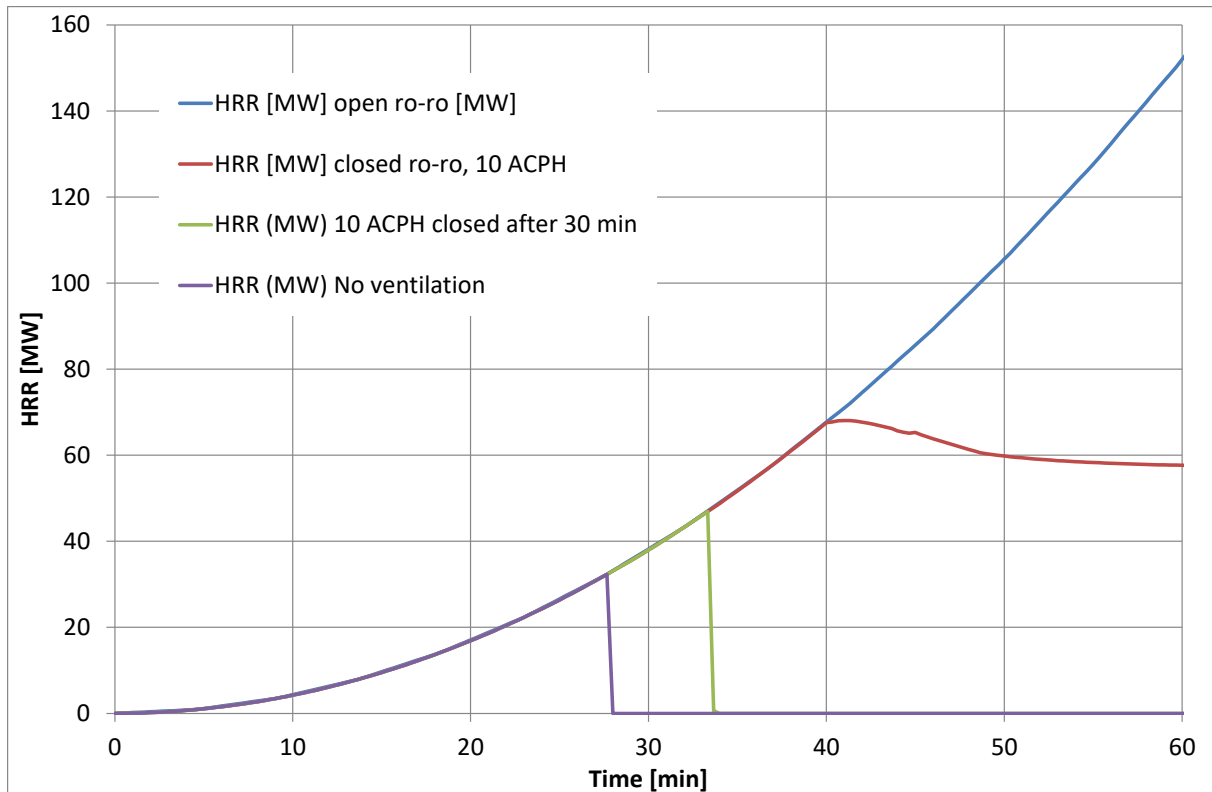
Figure 2.7-3 - Heat release rates as a function of time during the initial 60 minutes for varying levels of ventilation

It can be seen that if the mechanical ventilation, for any reason, is not turned off there will be a continuing ventilation controlled fire at about 60 MW. Further, if the ventilation fans and dampers are closed after 30 minutes the fire will reach about 45 MW before it self-extinguishes due to oxygen starvation just a few minutes after the ventilation is closed. If the ventilation is closed immediately after ignition the fire grows to about 30 – 35 MW before it self-extinguishes.

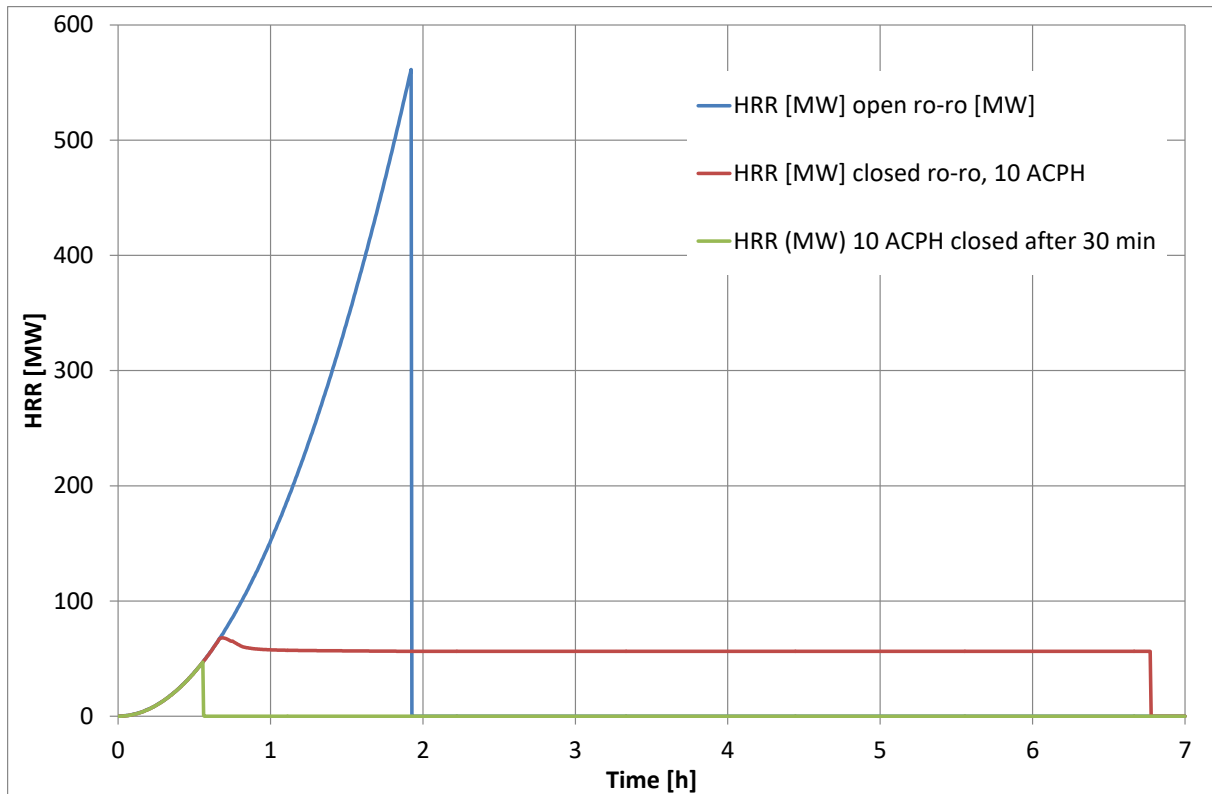
If a fire at ventilation control is not extinguished by manual means or by fixed firefighting systems, the fire will continue until the available fuel is consumed. If we consider the same ro-ro decks as above, there are sufficient lanes for about 200 cars. Each car (incl. fuel) has a fire load of about 5-8 GJ/car [Li Y,2004] hence, a total fire load of about 1 300 GJ can be expected if the deck is fully loaded with cars. Based on this, the duration of an uncontrolled car fire can be calculated for the different ventilation scenarios, see Figure 2.7-34.

Figure 2.7-4 - Duration of uncontrolled car fire at different ventilation rates (assuming all fires grow until ventilation control).

It can be seen that the scenario where the ventilation is completely closed after 30 minutes the fire self-extinguishes after about quickly thereafter and reaches a maximum heat release rate of about 45 MW. The other two scenarios where the fire is not extinguished with active firefighting means and the ventilation is not closed results in long lasting fires (2 - 7 hours) with a high-energy release rate. Such fires are not likely contained in the space of origin and it is likely that abandonment of the ship is required at such conditions.

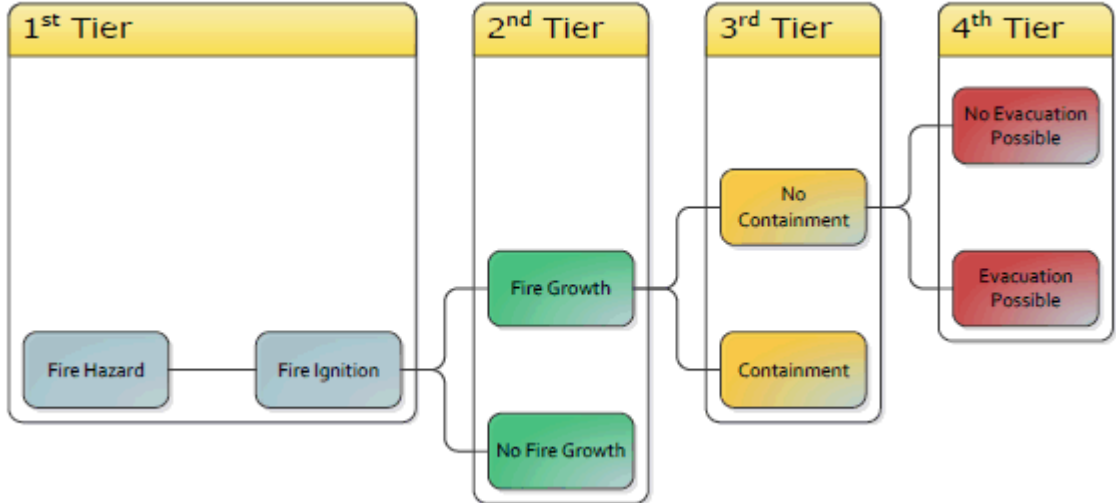
Based on the information that has been provided by EMSA stemming from the work of the GoE regarding the structure of the risk model, as well as the hazard identification (see Section Fire hazards/risks) and the fire scenarios identified (see Section Development of fire scenarios) in the previous step, a suitable risk model has been developed. Figure 2.8-1 provides the chain of event as provided by EMSA, which is composed of 4 tiers and is applicable to any spaces.

Figure 2.8-1: Fire risk model (extracted from document: 1st Correspondence of the Group of Experts on fire on ro-ro decks, EMSA, 2015).

This chain of event allows the identification of pivotal events which affect the outcome of different fire on ro-ro deck scenarios.

It should be noted that the fire risk model, as provided by EMSA, does not explicitly mention fire extinguishing. This is included within the 2nd tier along with fire detection.

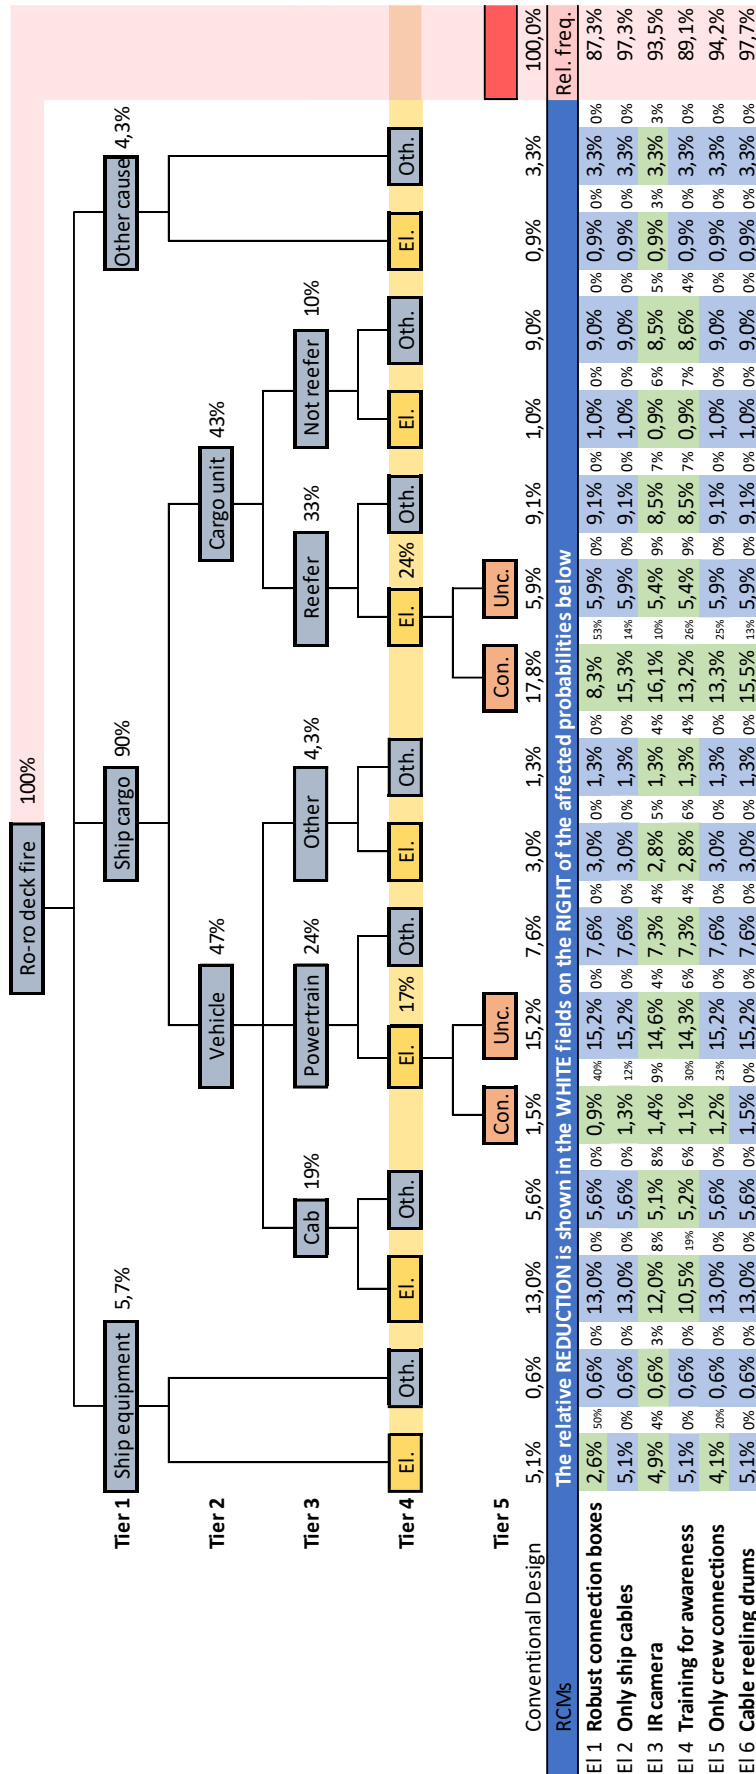
Figure 3.4-2. Fault tree risk model for electrical fire as ignition source with estimated effects of RCOs.

The list with the RCOs, affected nodes, important factors to consider, and the average values of the estimations are presented in Figure 3.4-1. The averaged estimated effects of the RCOs were linked to the risk model for electrical ignition sources on ro-ro deck, as illustrated in Figure 3.4-2. The concluding effects on the probability and frequency of fire and fire with electrical ignition source are presented, respectively, in Table 3.4-1.

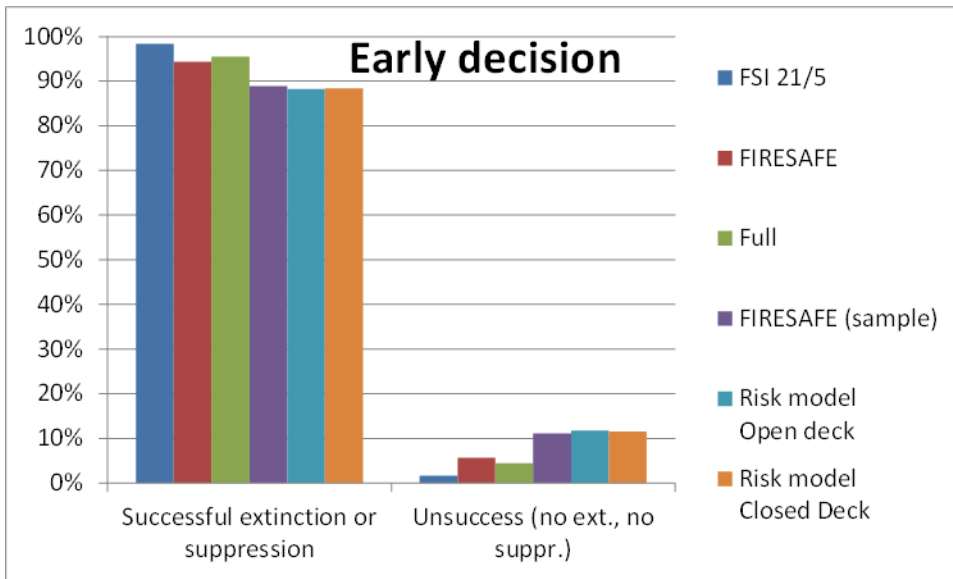
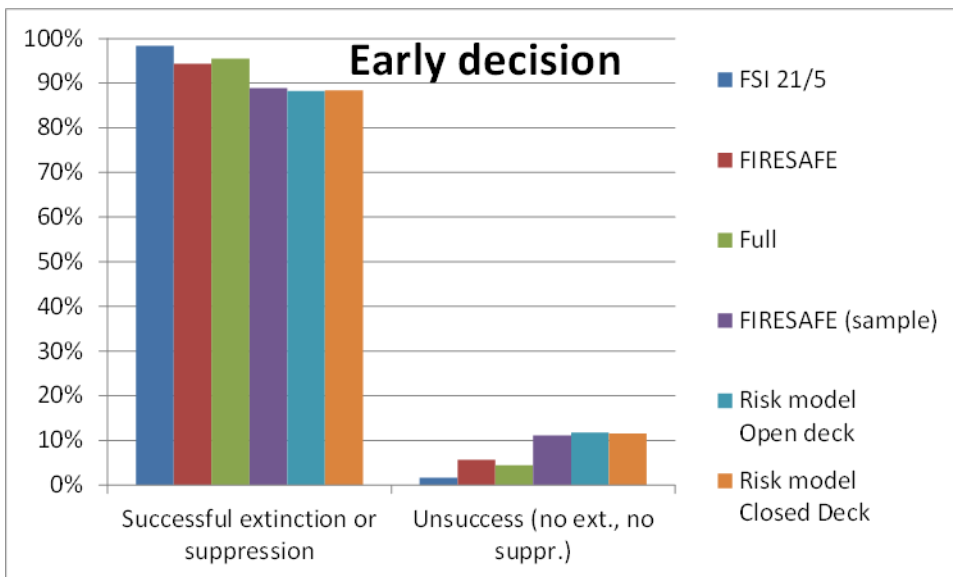
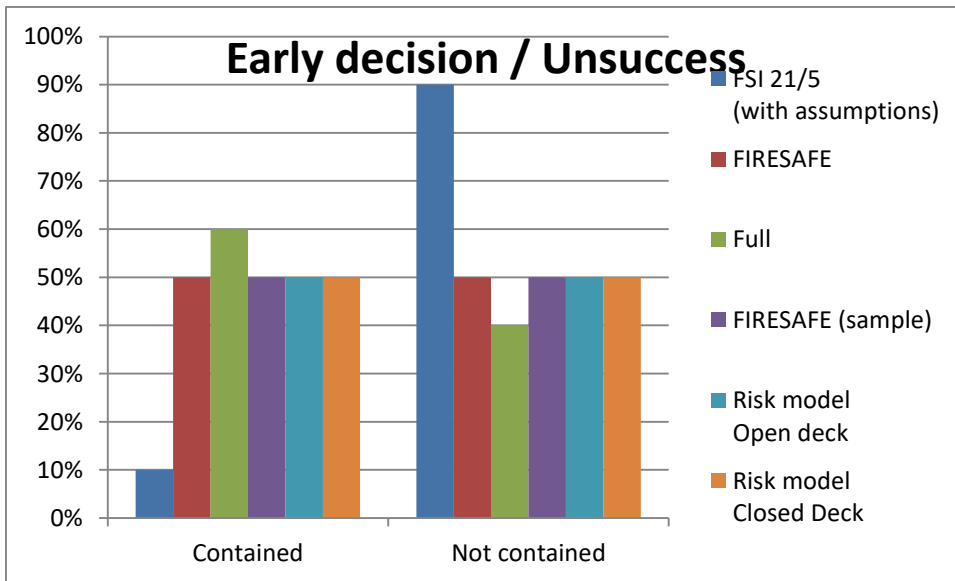
Figure 4.1-4 Comparison of datasets

Figure 4.1-5 Comparison of datasets

Figure 4.1-6 Comparison of datasets

Figure 4.1-7 Comparison of datasets

Figure 4.1-8 Comparison of datasets

The comparison is presented in the figures below. Difference in favour of Early Decision, Successful suppression or extinguishment, and containment in the FSI 21/5, All data, and FIRESAFE datasets come from the fact that these datasets include much more Marine incidents and Less Serious Accidents than in the FIRESAFE sample. Nonetheless, some trends can be detected.
