Risk acceptance criteria and risk based damage stability. Second interim report.

European Maritime Safety Agency

Report No.: PP092663/2, Rev. 1

Task and objective: This report includes a review of HAZIDs for passenger ships previously carried out, an updated collision risk model including uncertainty and sensitivity analysis and the presentation of 5 sample ships that will be used in the further studies.

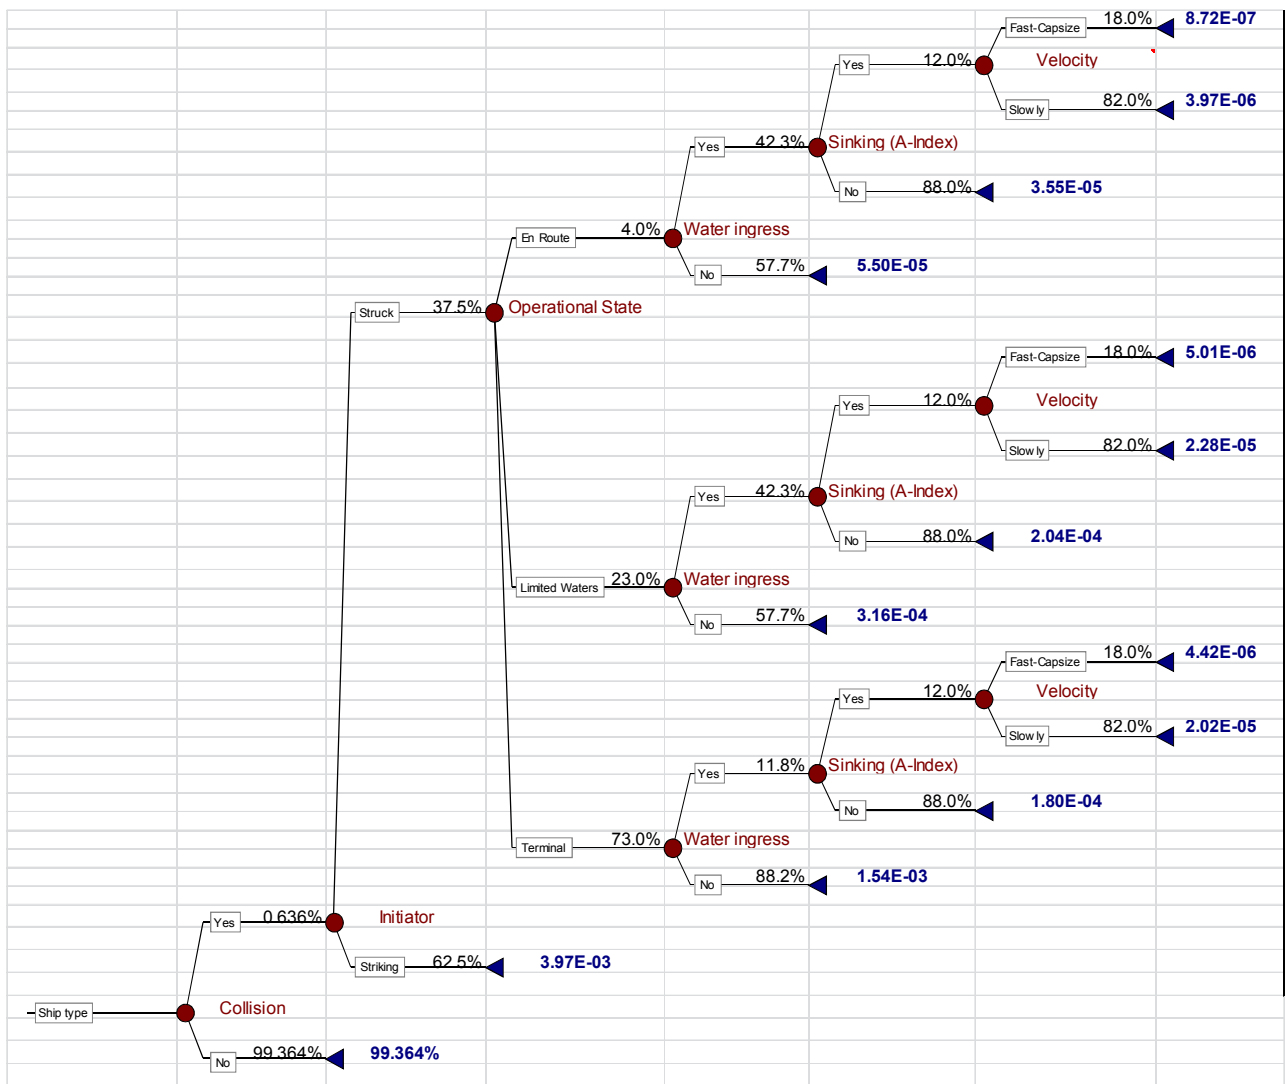
Figure 7-1 Collision risk model for ship type cruise of Task 1c.

The risk model used in GOALDS and Task 1c of this project is shown in Figure 7-1. As shown both scenarios for collision "en route" and "limited waters" consider the same dependent probabilities and also consequences assigned to these scenarios. Therefore, both branches of the event tree are merged. Probability of flooding of accidents in "terminal" areas is and will be lower than for other areas and therefore this branch is kept in the risk model. In this context "terminal" area is the berth and the entrance ways to ports used for manoeuvring.

In the collision risk model dependent probabilities for events “initiator”; “operational state” and “water ingress” (Figure 7-1) are estimated by means of casualty reports. In total 74 casualty reports for Cruise and RoPax are available for 1994 to 2012 after the review plus 1 accident from the time before. Typically, casualty reports do not contain all information needed to quantify the above mentioned dependent probabilities, e.g. for “initiator” 65 reports contain relevant information (1990 to 2012) only, where the reports are unequally distributed over both ship categories with smaller numbers for Cruise. In order to reduce uncertainty in the dependent probabilities for the three events it is suggested to merge the information for both ship categories.

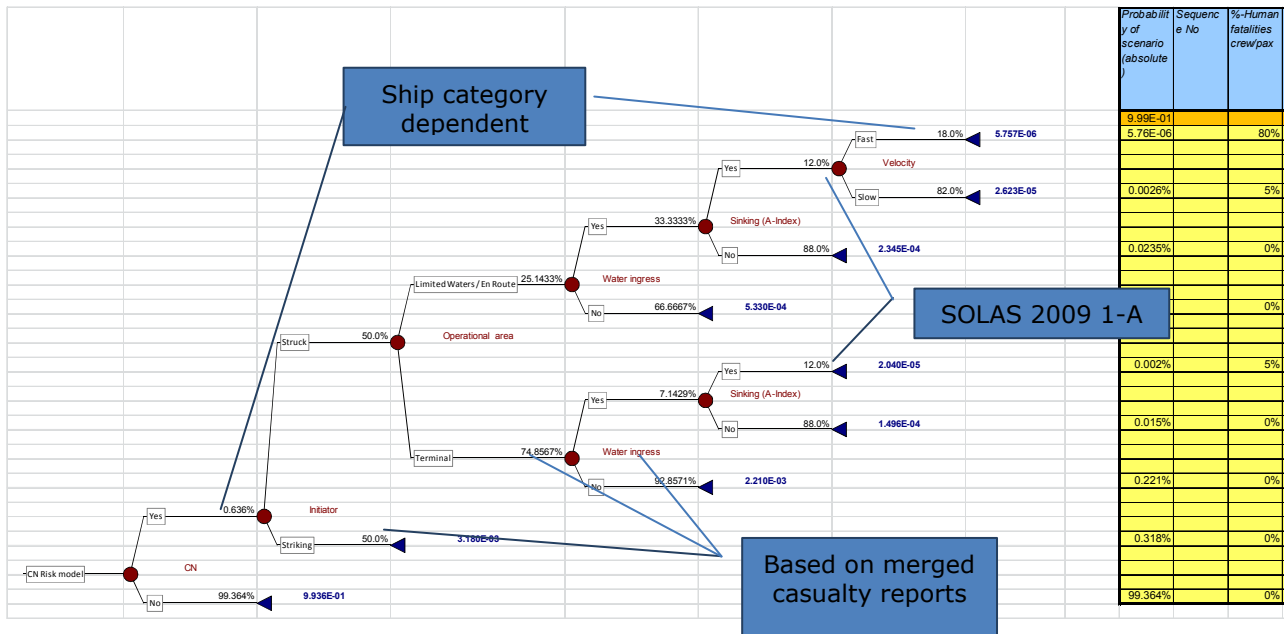
Figure 7-5: CN risk model for cruise ship (draft).

The updated risk model for Cruise is shown in Figure 7-5 highlighting also which parts of the collision risk model that are ship category dependent.

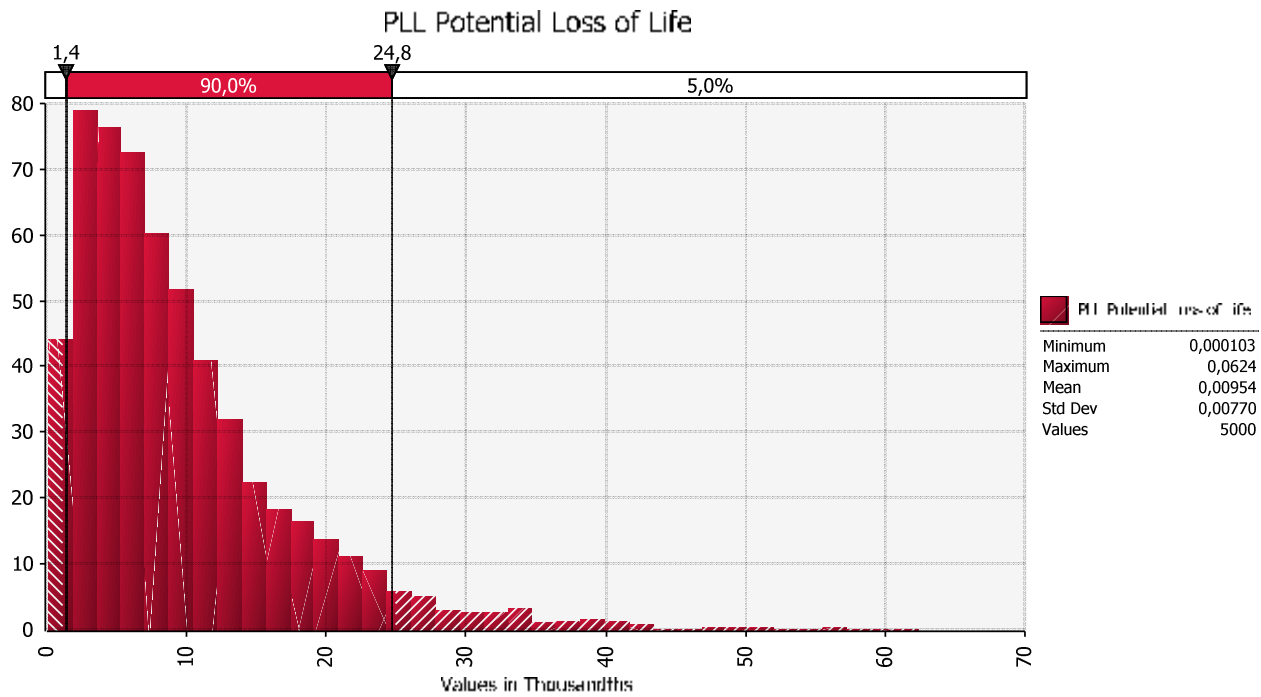
Figure 7-15 PLL distribution for small cruise ship with maximum capacity of 400 persons and 90% occupancy.

Using this risk model, the PLL is calculated (Monte Carlo Simulation) in terms of a distribution as shown in the following for the three cruise ship size categories small (Figure 7-15), medium (Figure 7-16) and large (Figure 7-17). The figures also show the characteristic values like mean, standard deviation and 90% confidence interval. For example for the medium cruise ship the mean PLL is 5.6E-02 per ship year, which is higher than the value calculated using the static values (mean values for the nodes in the event tree), namely 4.4E-02. As shown the 90% confidence interval is large stretching from 8.2E-03 per ship year to 1.5E-01 per ship year.

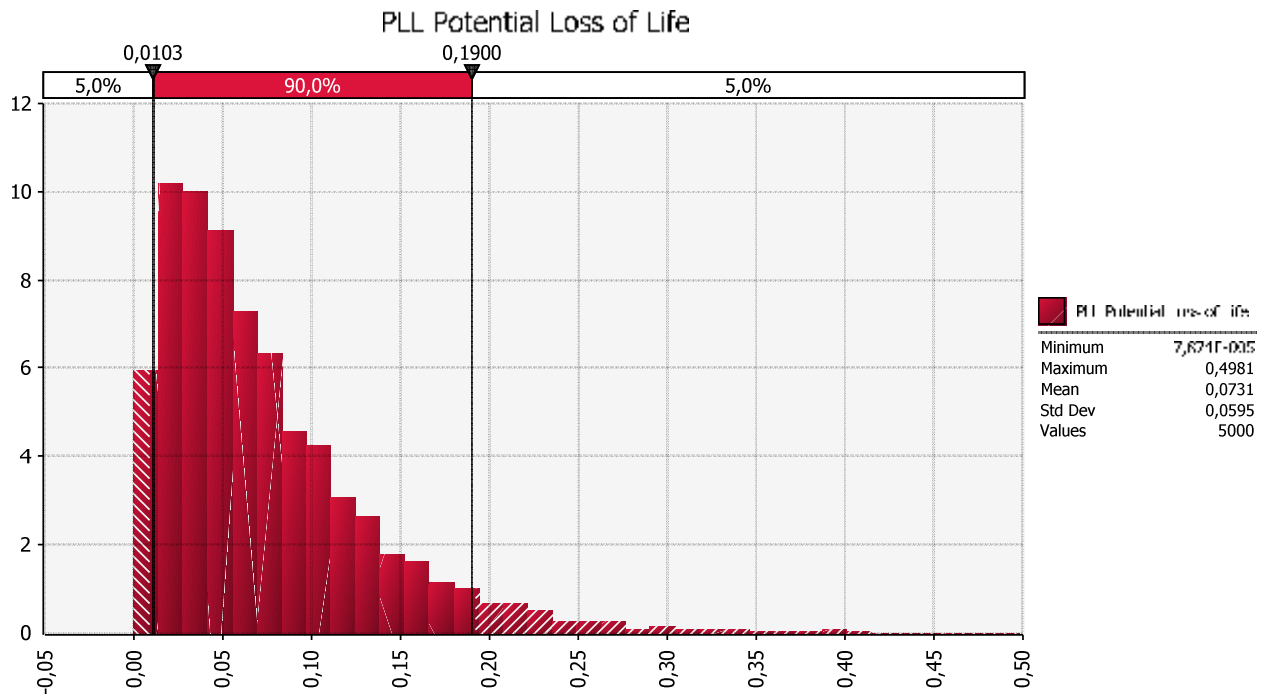
Figure 7-17 PLL distribution for large cruise ship with maximum capacity of 6,730 persons and 90% occupancy.

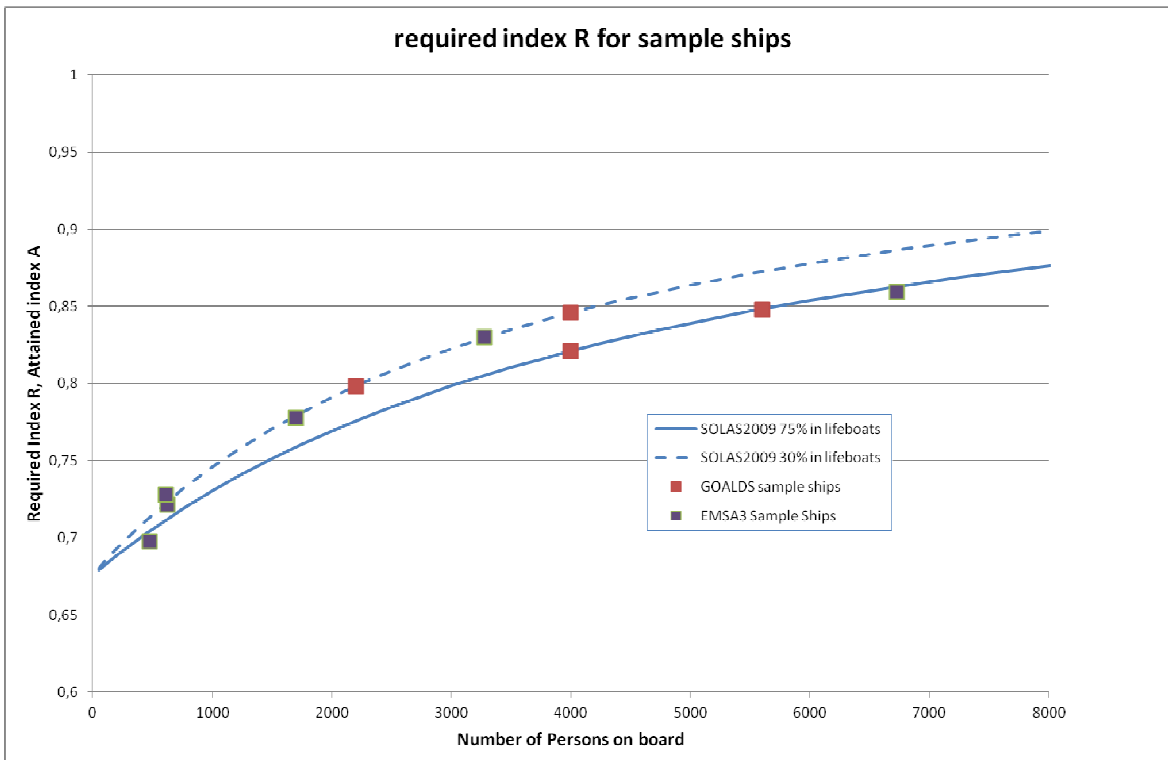
Figure 8-2 Required index for passenger ships

Also with regard to the covered range of required subdivision index the sample of ships to be investigated closes the gaps left by the GOALDS study.

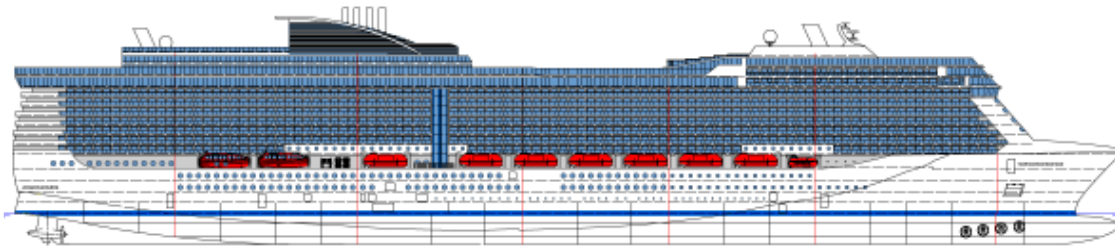
Figure 8-3 Profile – Large Cruise vessel

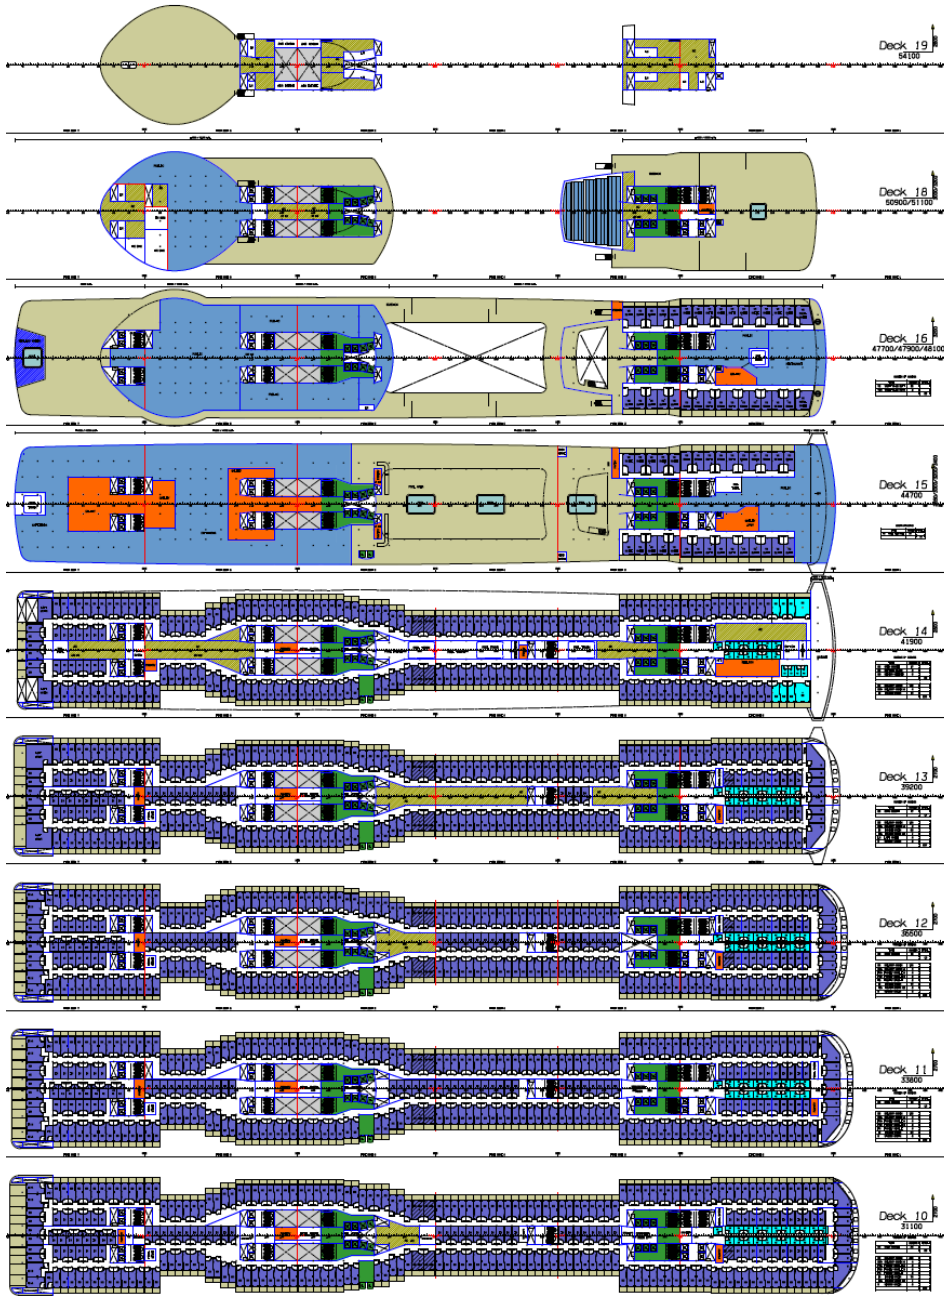
Figure 8-4 Deck 10 – 19 – Large Cruise Vessel

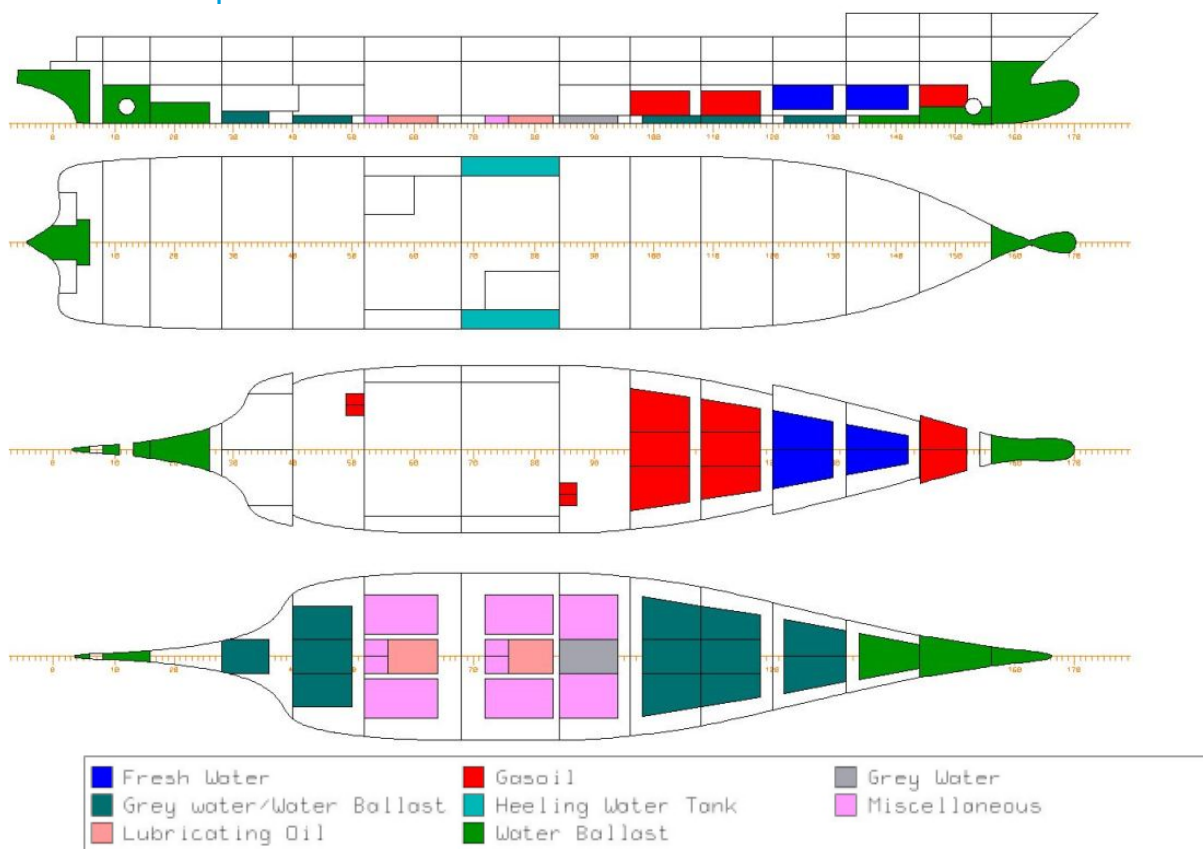
Figure 8-15 Tankplan – Small Cruise Vessel

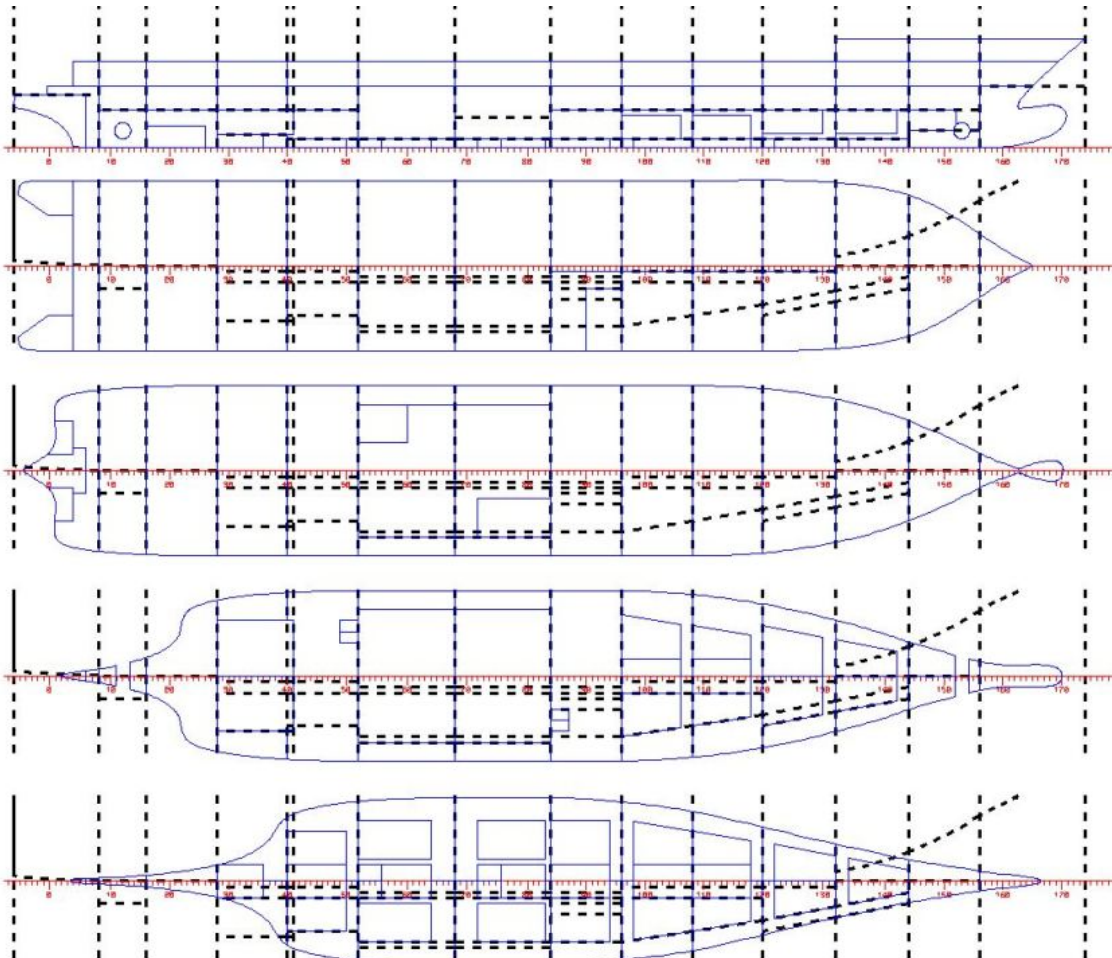
Figure 8-16 Subdivision used for calculations – Small Cruise Vessel

Following subdivision is used for damage calculations:

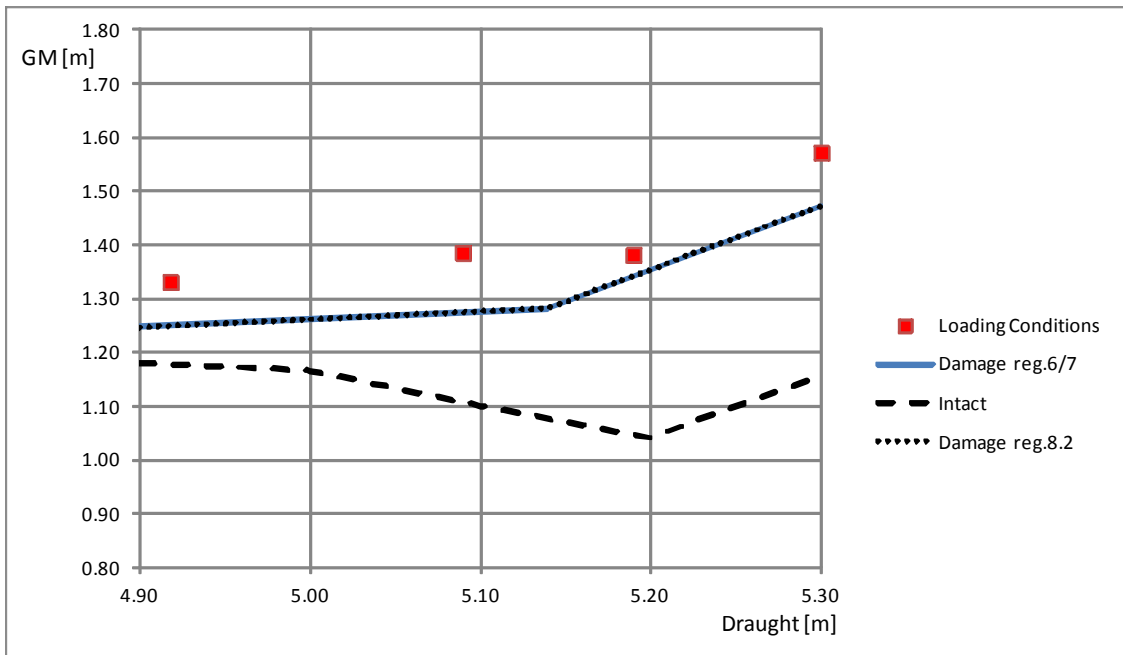
Figure 8-18 GM Limiting curve – Small Cruise Vessel

The following diagram, Figure 8-18 shows the summary of the GM requirements together with the actual loading conditions.

There are various limits shown which all need to be complied with, in particular there is the limit of the intact stability criteria as defined by the IS code 2008, and 2 limits for compliance with the damage stability requirements.

Based on this data the reg.8.2-3 is more stringent as with same value of GM for the initial conditions the reg.7 has some margin.

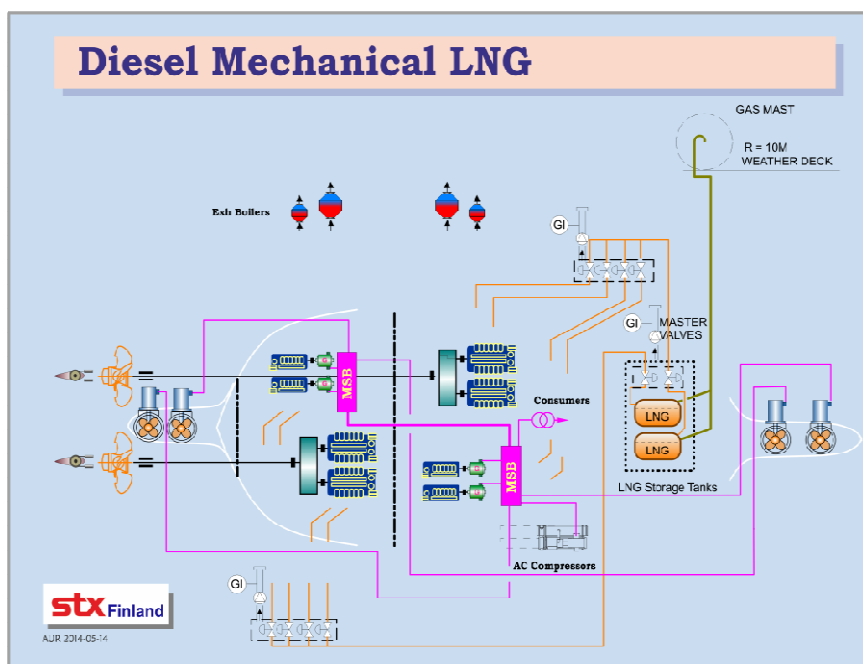
Figure 8-21 Machinery lay out

The ship has diesel mechanical propulsion. Each CP-propeller is driven by two medium-speed dual fuel engines via a reduction gearbox. The engines and reduction gear box for each shaft line are located different watertight compartments. Four auxiliary dual fuel engines each driving a generator for to supply power for the ships network. These auxiliary engines are also divided into two different watertight compartments.

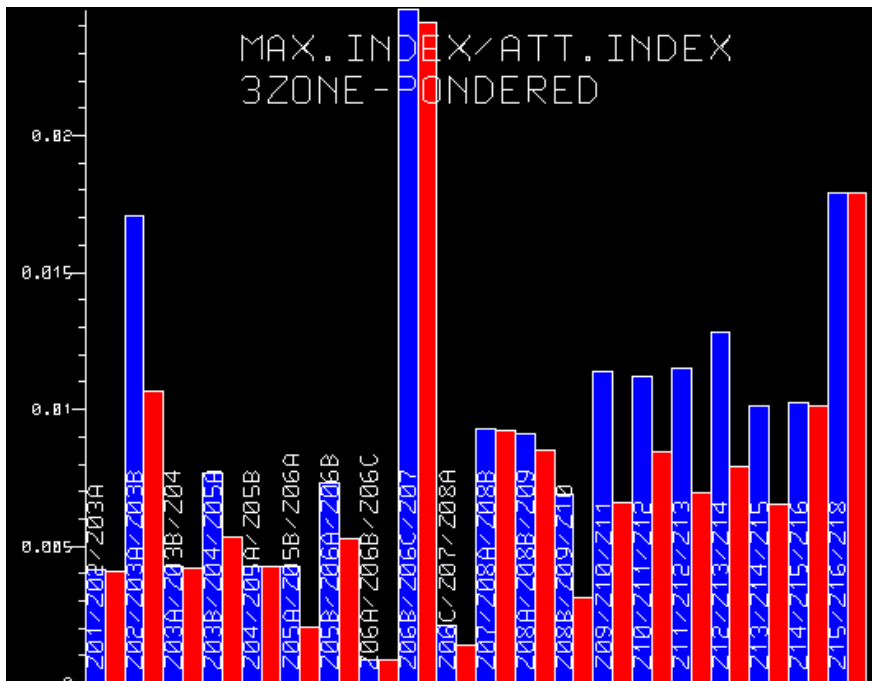
Figure 8-31 3-Zone damages max index vs attained index

This figure below (Figure 8-31) shows that there is some loss of attained index in the fore part for 3 zone damages.

Margin on the index = 0.074 This margin is reduced to 0.062 with the new agreement from SLF55 concerning the regulation 7-2.3 of SOLAS II.1
