European Maritime Safety Agency

**Double Hull Tankers:
High Level Panel of Experts
REPORT**

3rd June 2005

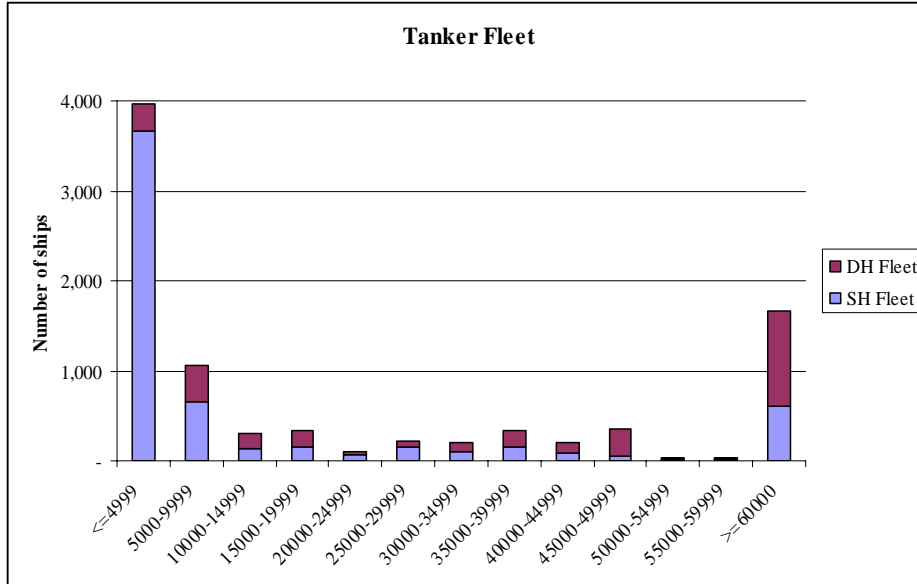
Current breakdown of the single and double hull world tanker fleet by numbers and Deadweight (DWT):

Source: CESA based on Lloyd's Register/Fairplay

At the end of 2004, some 65% by tonnage and 56% by number of existing tankers above 5,000 dwt, were double hulled.¹

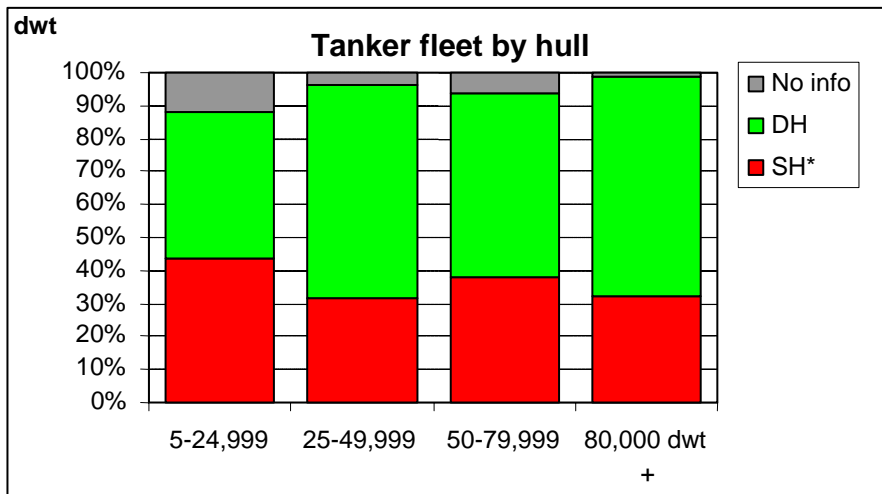
Source: INTERTANKO

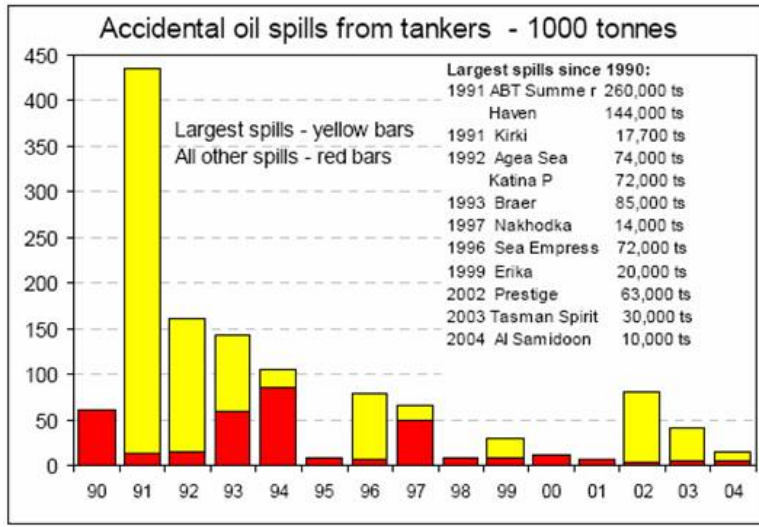
Oil spills:

Source: INTERTANKO

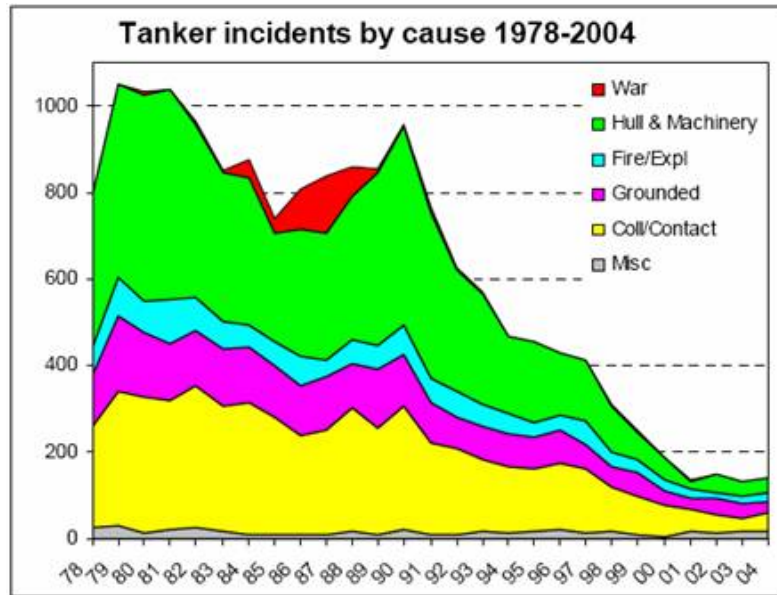
Source: INTERTANKO

Whilst it is recognised that for low energy collisions and minor groundings, the double hulled tanker is much less likely to spill oil than a single hulled tanker, for some of the incidents that are recorded above a double hulled tanker may fare no better than its single skinned predecessor.

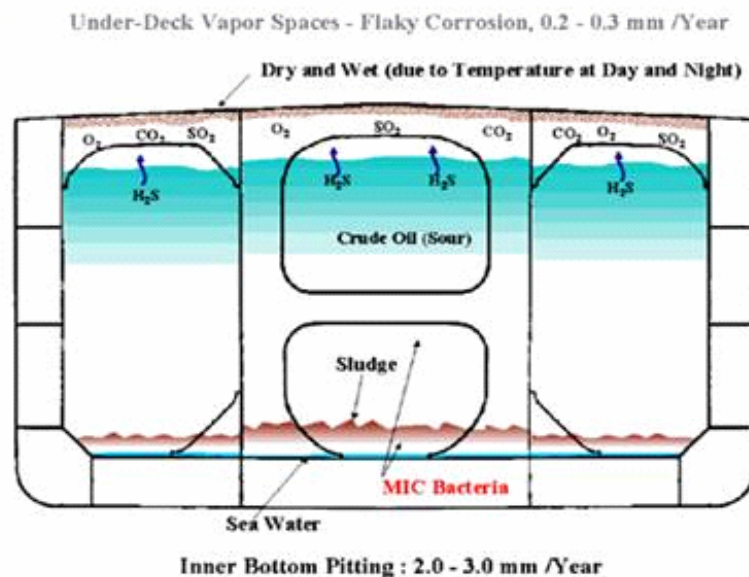
Deck & Inner Bottom Corrosion

Source: INTERTANKO

"Individual tankers usually exhibit a unique, but controllable corrosion pattern. However, recent experiences of OCIMF members have indicated problems in new single and double hull tonnage from excessive pitting corrosion of up to 2.0 mm per year in the un-coated bottom plating in cargo tanks due, inter alia, to microbial induced corrosion processes. In addition accelerated general corrosion up to and exceeding 0.24mm per year has been found in vapour spaces. This type of wastage and the increased rate of corrosion, which is much greater than that which would be normally expected, give cause for serious concern."

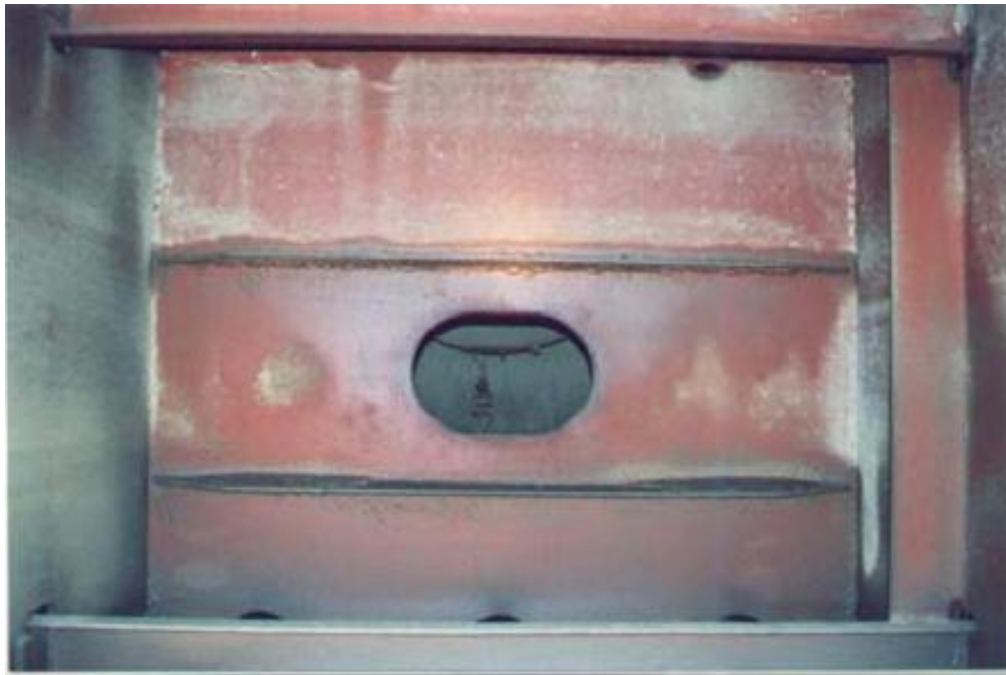
Correct paint application, ballast tank condition after 13 years (a bulk carrier double bottom tank is shown in this example)

The following photos show the ballast tanks of two ships of the same age (13 years). During construction, both ships were coated with an epoxy system, the application of the ballast tank coating for the ship in the first photo was correctly done, whilst that for the ship shown in the second photo was clearly poor. The photos show the importance of using correct application procedures (surface preparation and paint system application) and of coating selection.

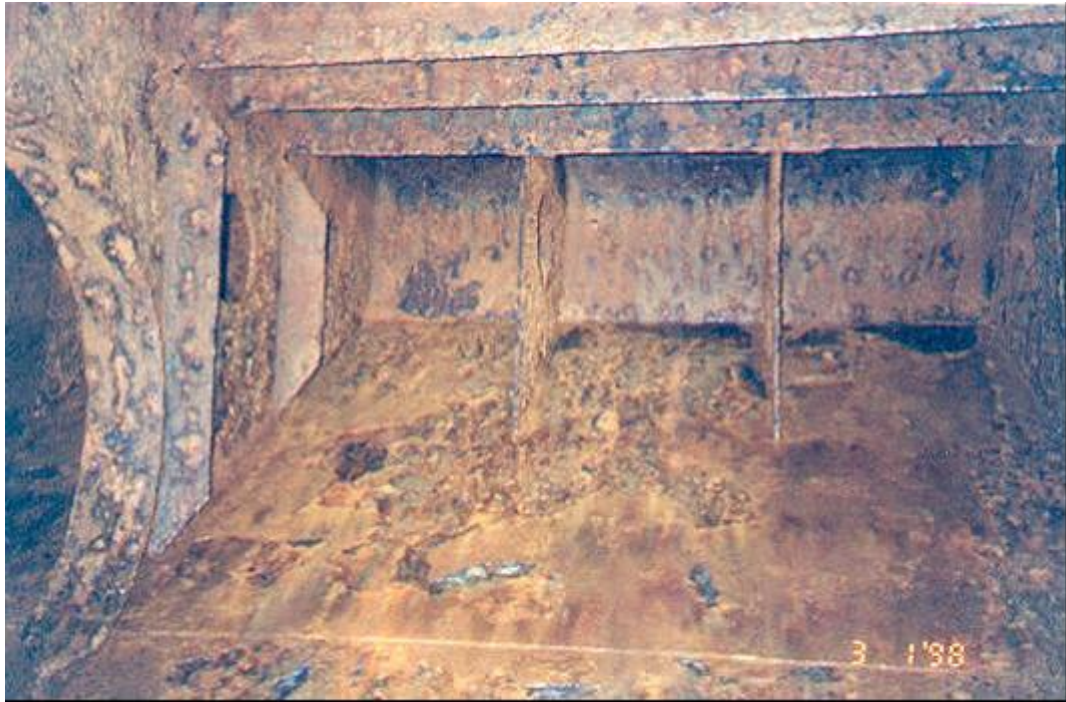
Poor paint application, ballast tank condition after 13 years (a bulk carrier top side tank is shown in this example)

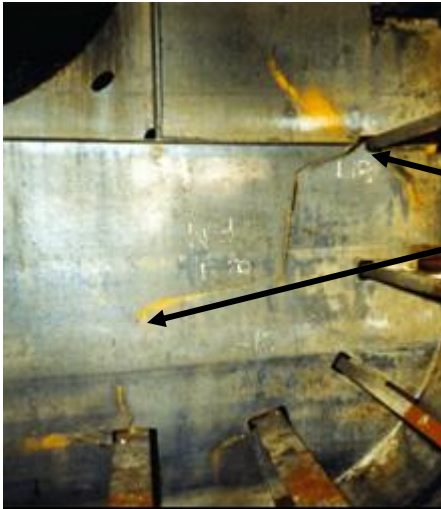
Photo showing a fatigue crack in the transverse web plating of a wing water ballast tank in a single hull tanker

Fatigue cracks, which may occur on all vessel types, are associated with cyclical stress and can be linked to 'optimised' ship structures, poor design details, corrosion, stress concentration, incorrect use of high tensile steel and a vessel's trading patterns/area of operation. Fatigue cracks are generally found on older vessels although they have been found on vessels within five years of delivery.

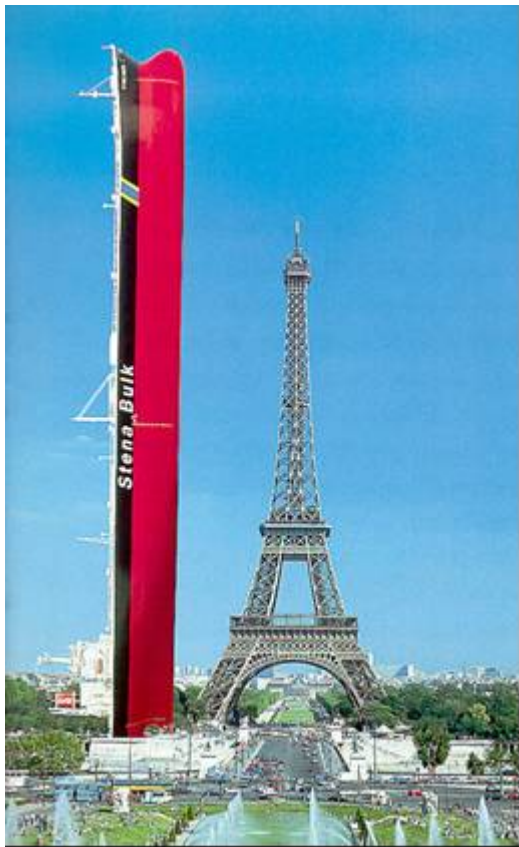
Large tankers have many internal spaces containing complex structure

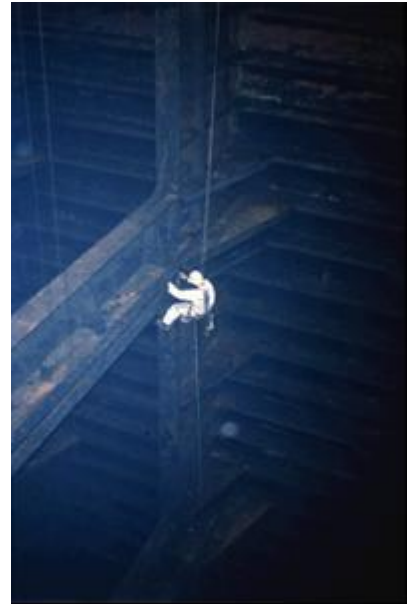
They are difficult to survey:

- Internal tank spaces are generally dark, wet, slippery and dirty with no ready means of access to much of the tank structure

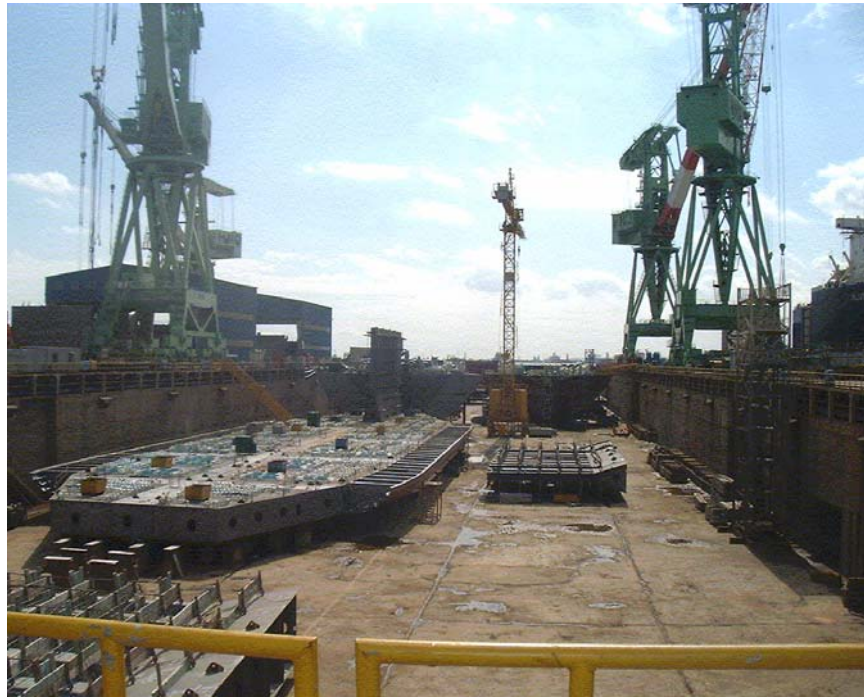
Double hull tanker in the building dock:

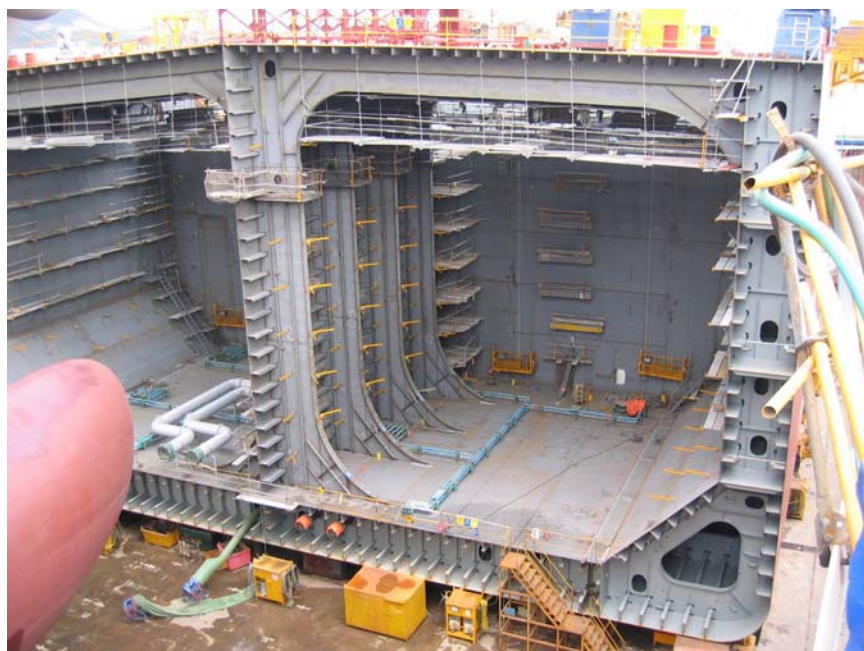
The ballast tanks have been coated during the block stage (grey), the cargo tanks have not yet been coated (structure still in prefabrication primer):

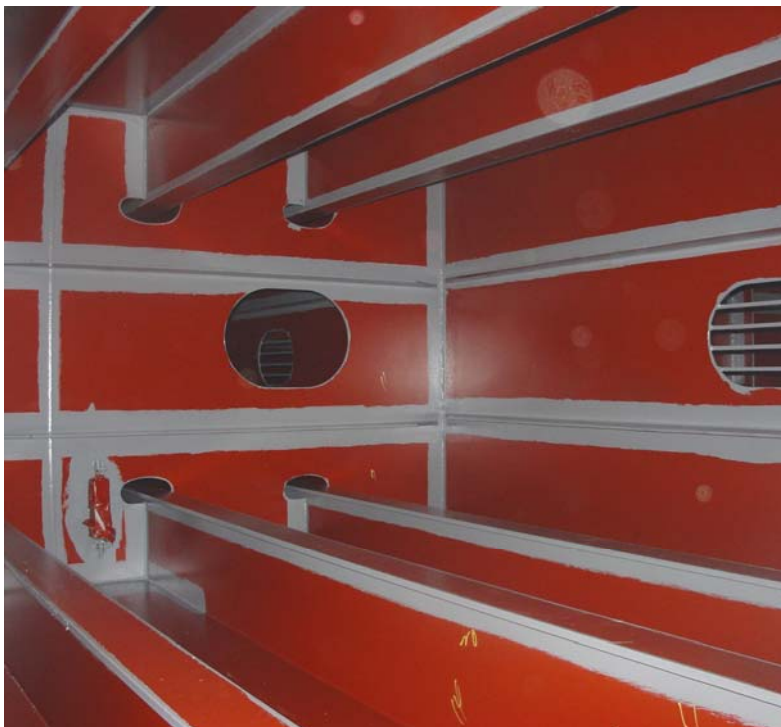
Manual stripe coating of vulnerable areas and locations that are difficult to spray after first coat and prior to application of the final coat (to ensure adequate film thickness):

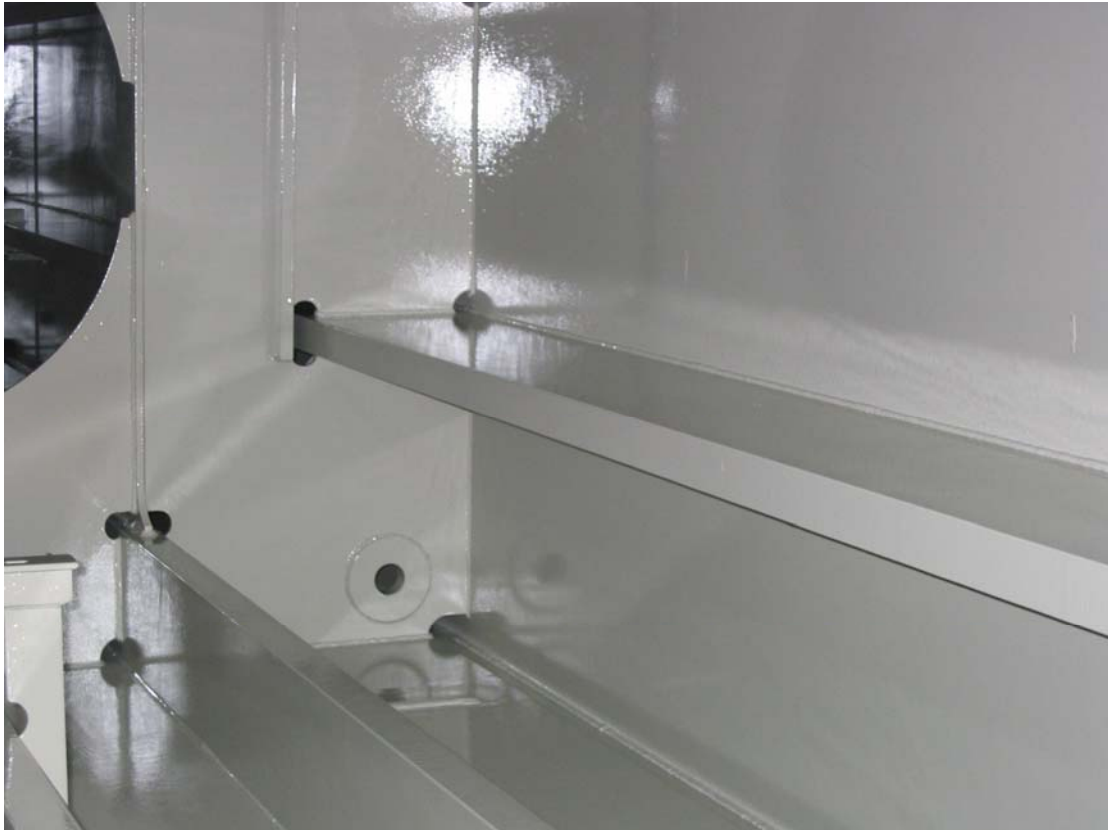
Internal structure in a double bottom tank after coating:

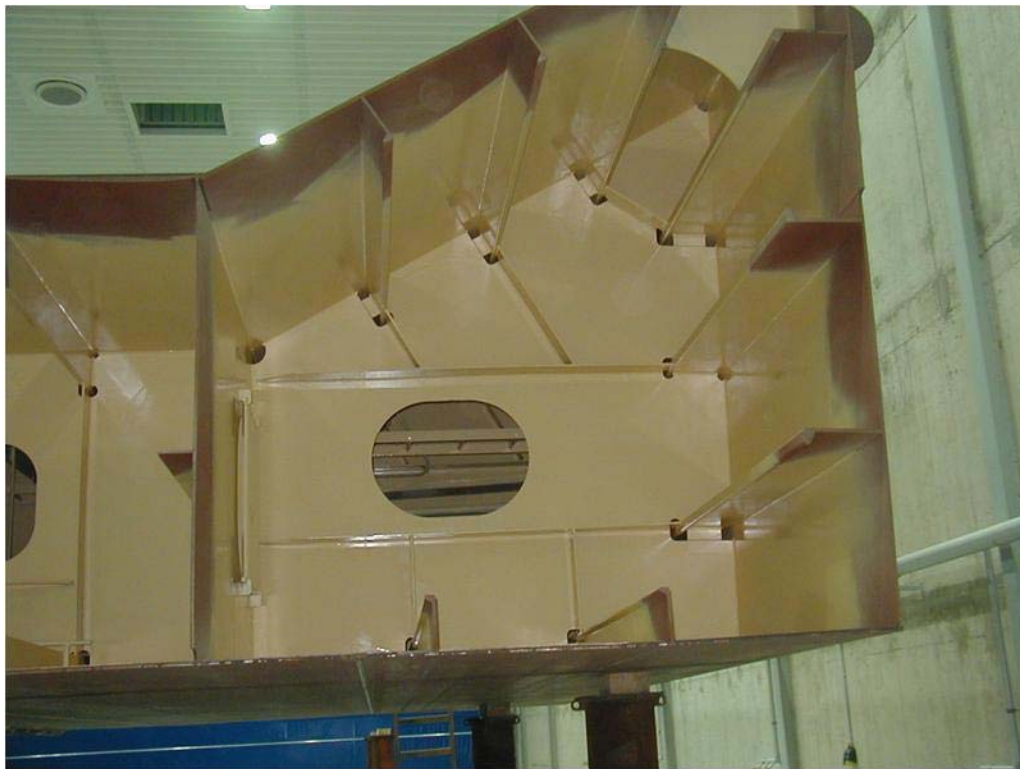
Side tank block after coating:

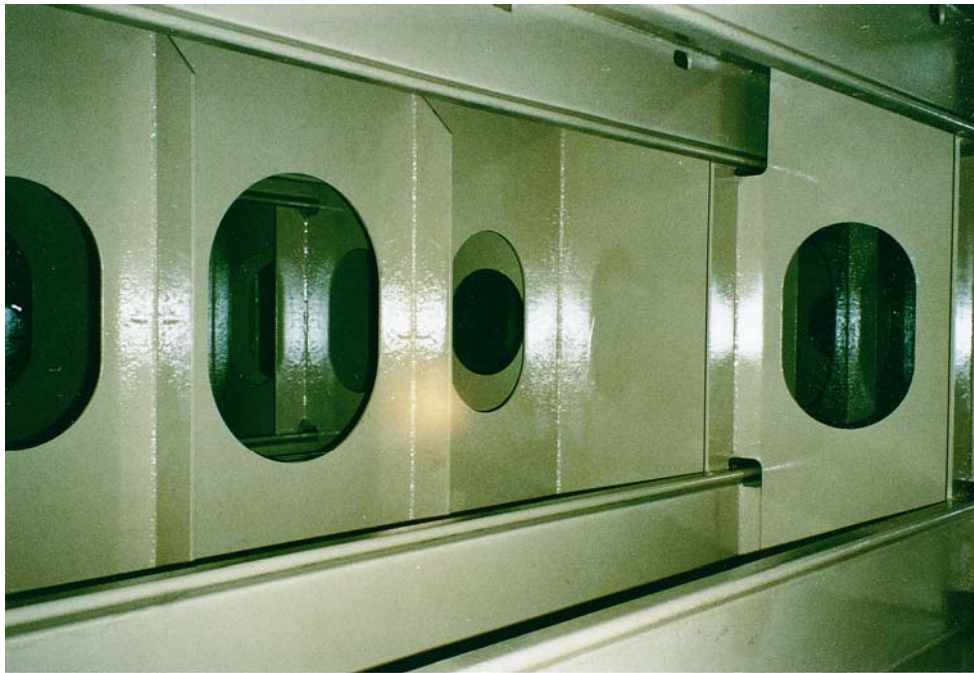
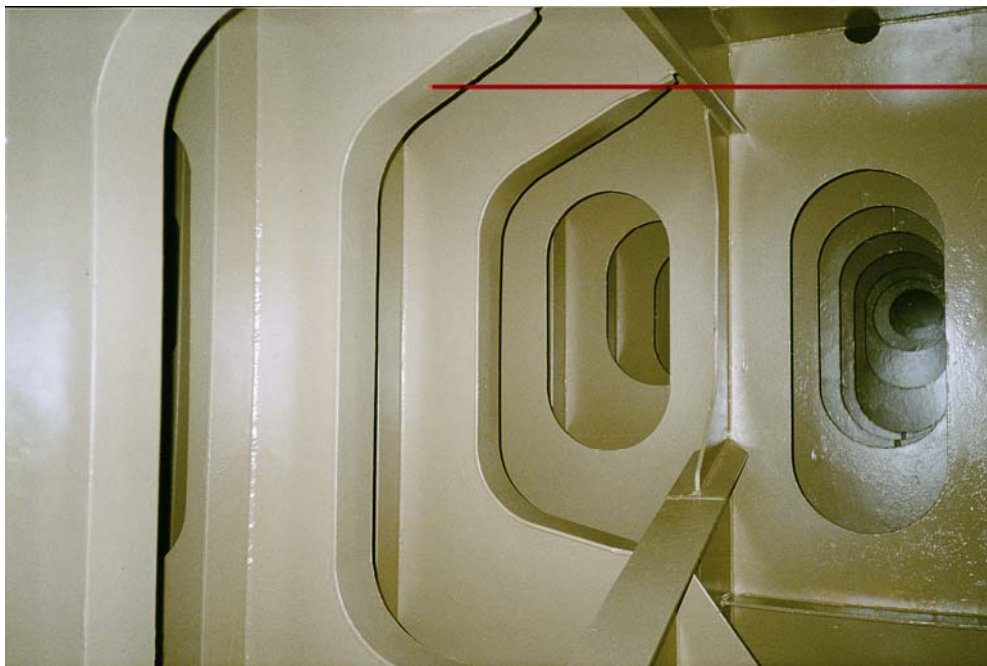
Views inside a newly coated double bottom water ballast tank:

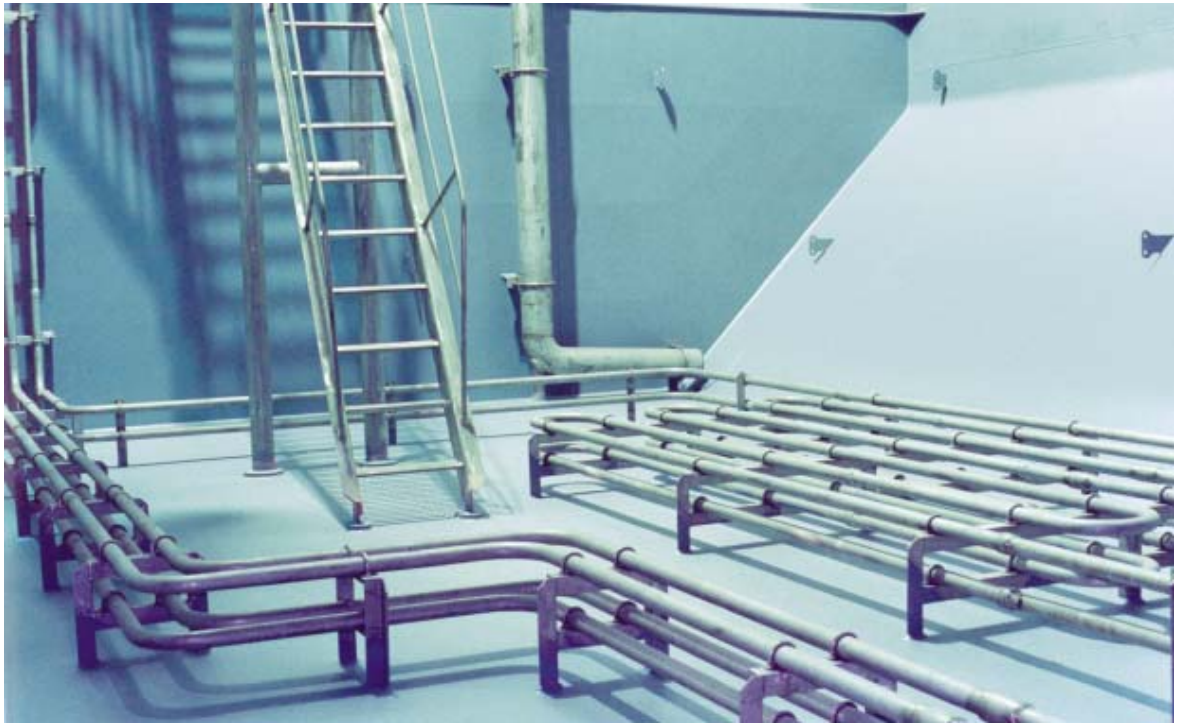
A newly coated cargo tank after completion of outfitting:

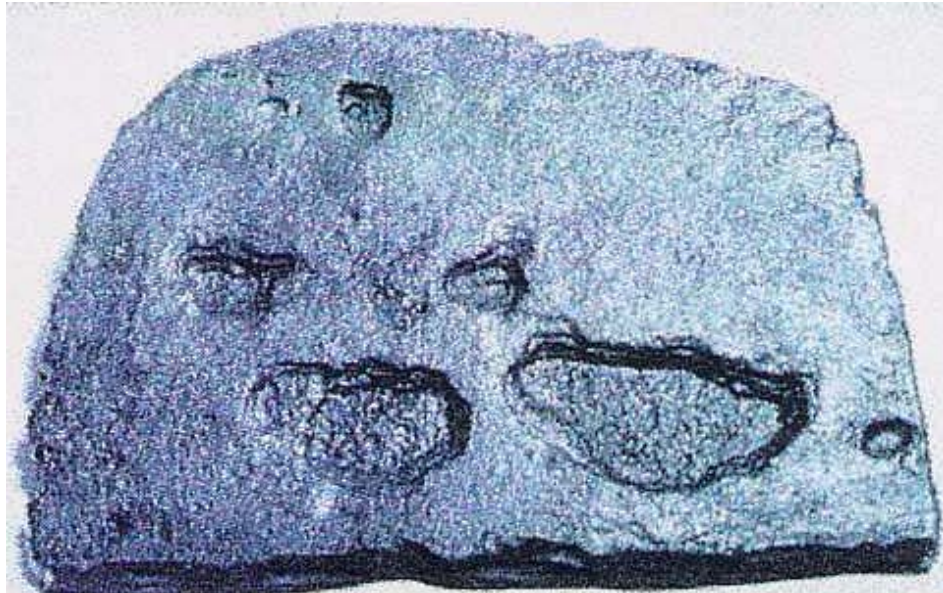
Steel plating taken from the inner bottom of a cargo oil tank in a double hull oil tanker showing pitting corrosion brought about by microbial attack:

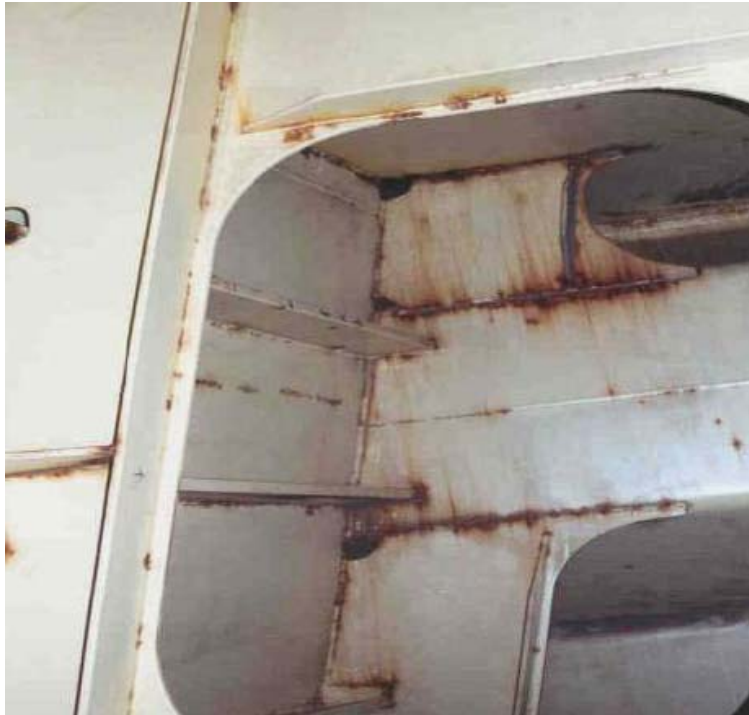
Premature coating breakdown: after 3 years of service:

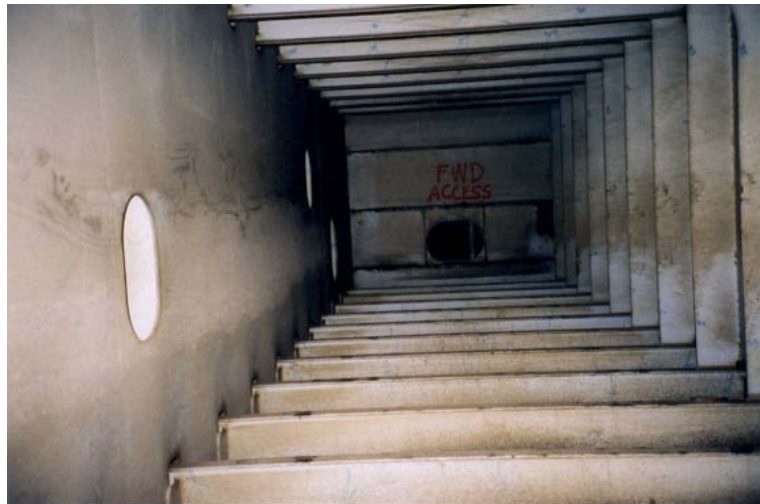
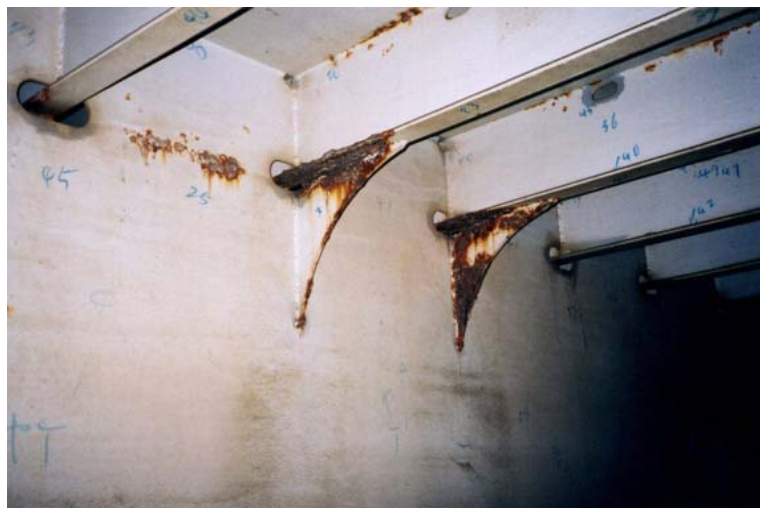
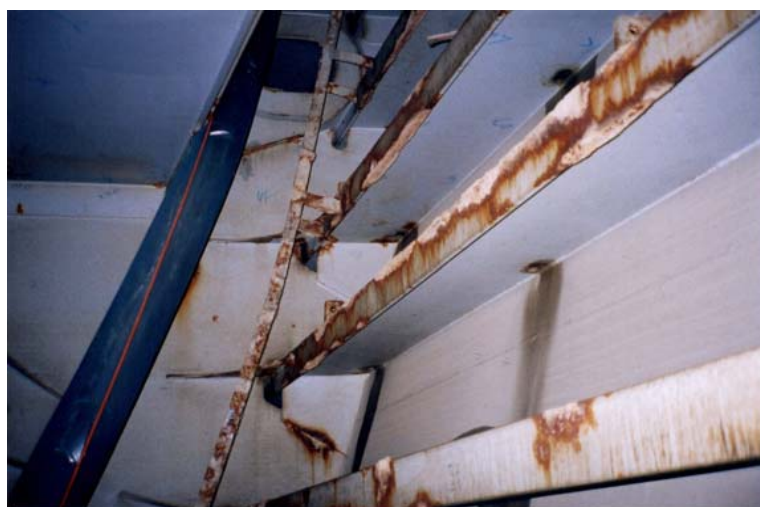
Ballast tank coatings in a double hull oil tanker after 10 years of service. The coatings have performed satisfactorily although they now need to be maintained to enable continued protection of the tank structure:

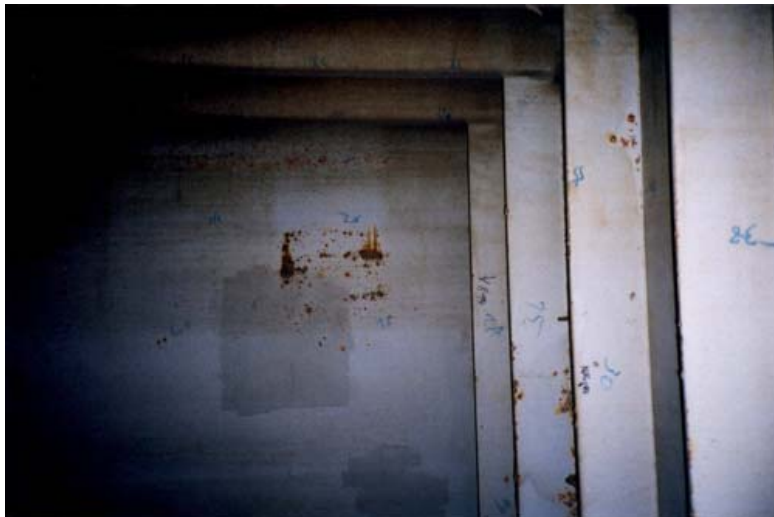
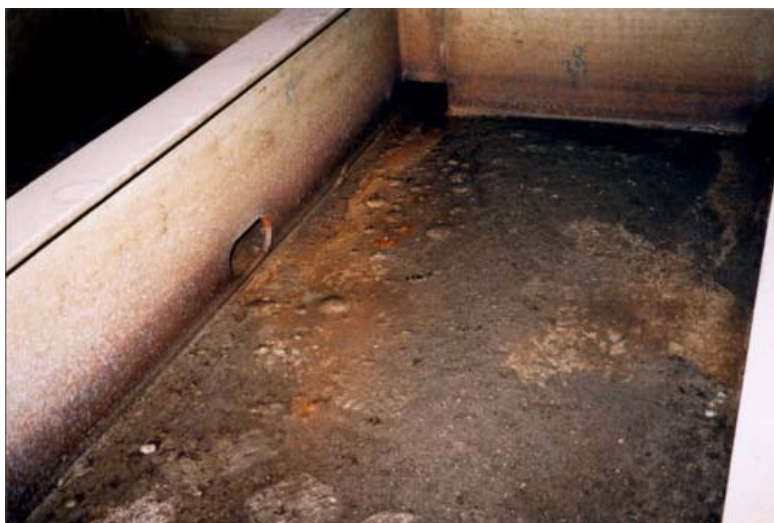
Ballast tank coatings continued:

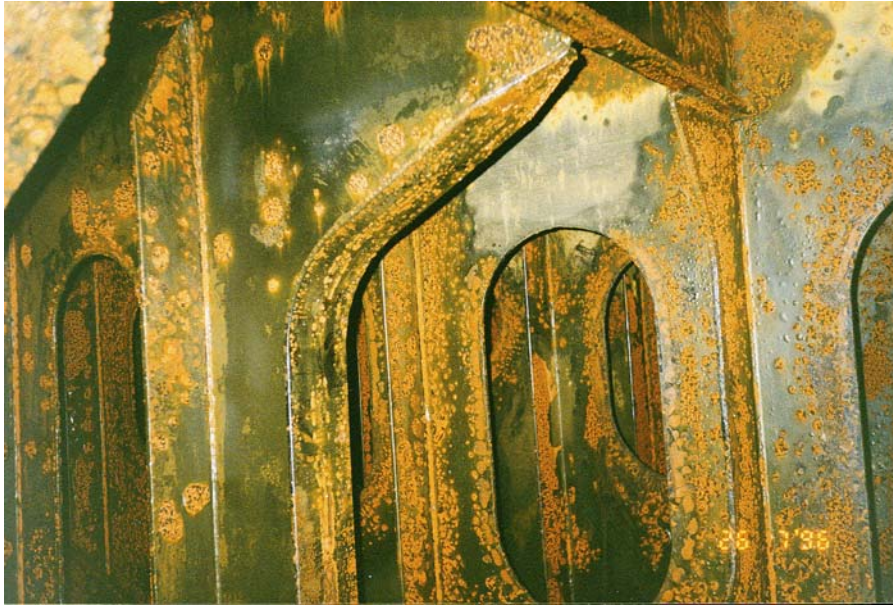
General coating breakdown without loss of structure:

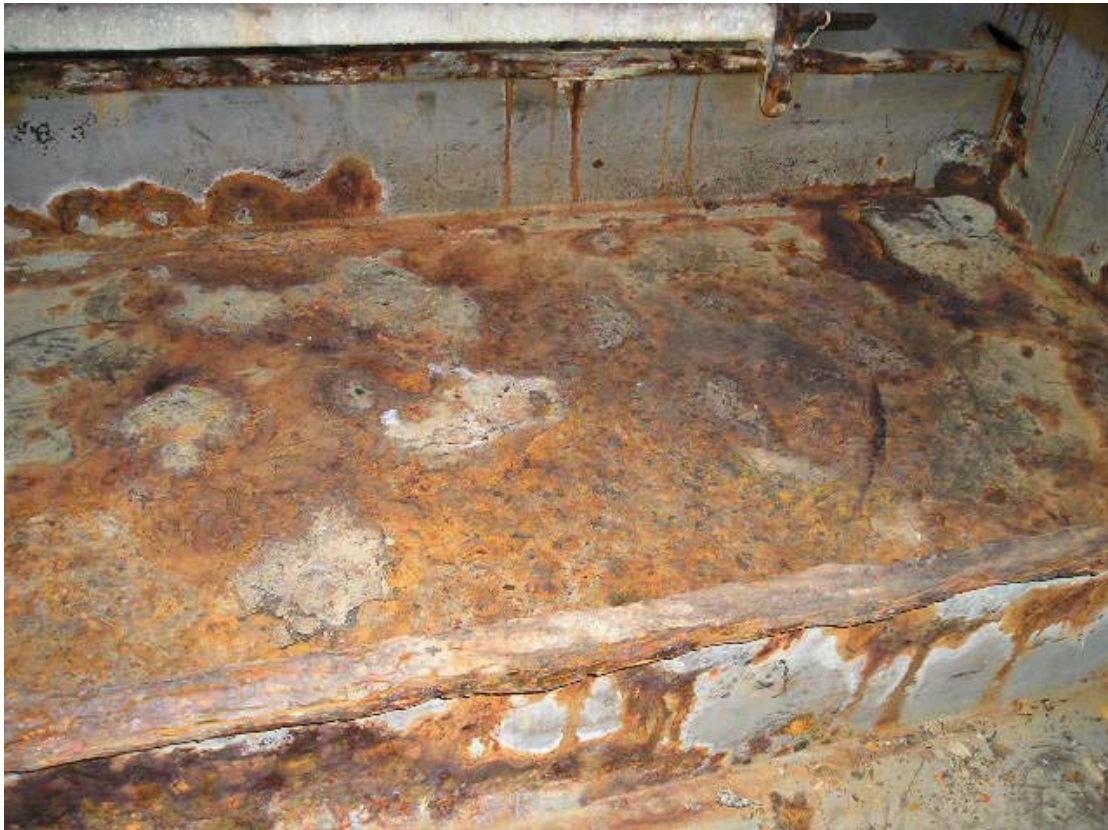
Structural loss due to corrosion:

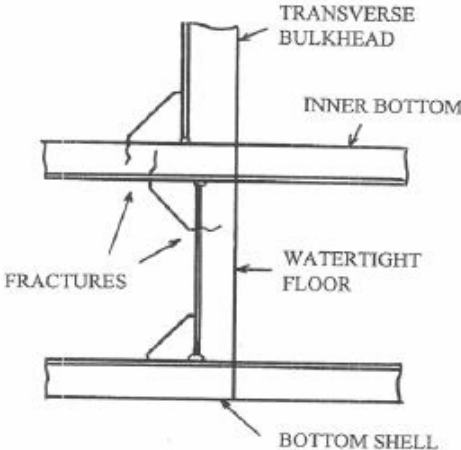
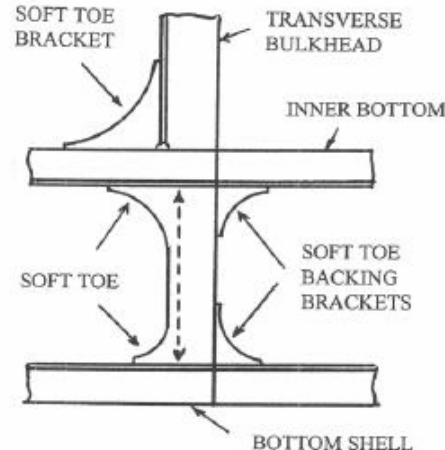
An example from the catalogue of structural details showing typical fatigue damage and a recommended means of repair:

LOCATION : BOTTOM BALLAST TANK		GROUP NO 4
EXAMPLE : CONNECTION OF LONGITUDINALS TO NO 1 WATERTIGHT FLOORS		
TYPICAL DAMAGE	PROPOSED REPAIR

<p>FACTORS CONTRIBUTING TO DAMAGE</p> <ol style="list-style-type: none"> 1. Asymmetrical connection of bracket in association with a backing bracket which is too small. 2. Relative deflection between adjacent floor and transverse bulkhead. 3. Inadequate shape of the brackets. 4. High stresses in the inner bottom longitudinal and the floor stiffener. 		
FIGURE 20	TANKER STRUCTURE CO-OPERATIVE FORUM SUBJECT: CATALOGUE OF STRUCTURAL DETAILS	FIGURE 20
