SAFETY ANALYSIS OF EMCIP DATA

ANALYSIS OF MARINE CASUALTIES AND INCIDENTS INVOLVING CONTAINER VESSELS

V1.0

September 2020

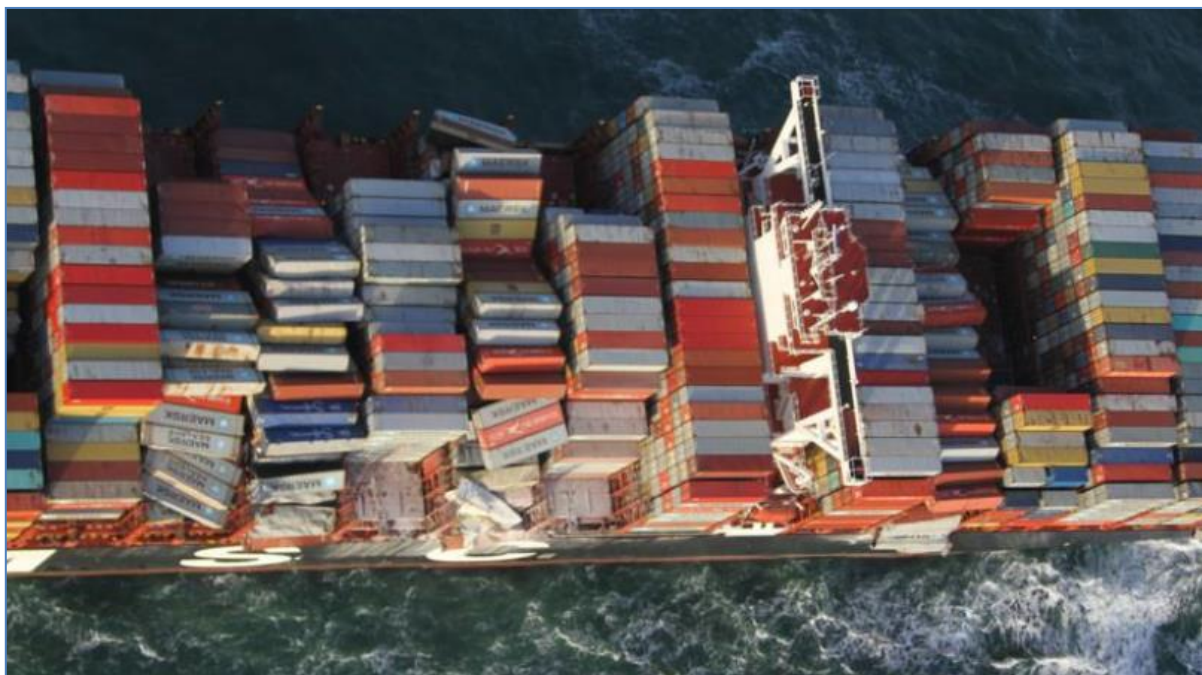
Figure 1 - Top view *MSC Zoe* following the loss overboard of containers (Source: BSU / Netherlands Coastguard)

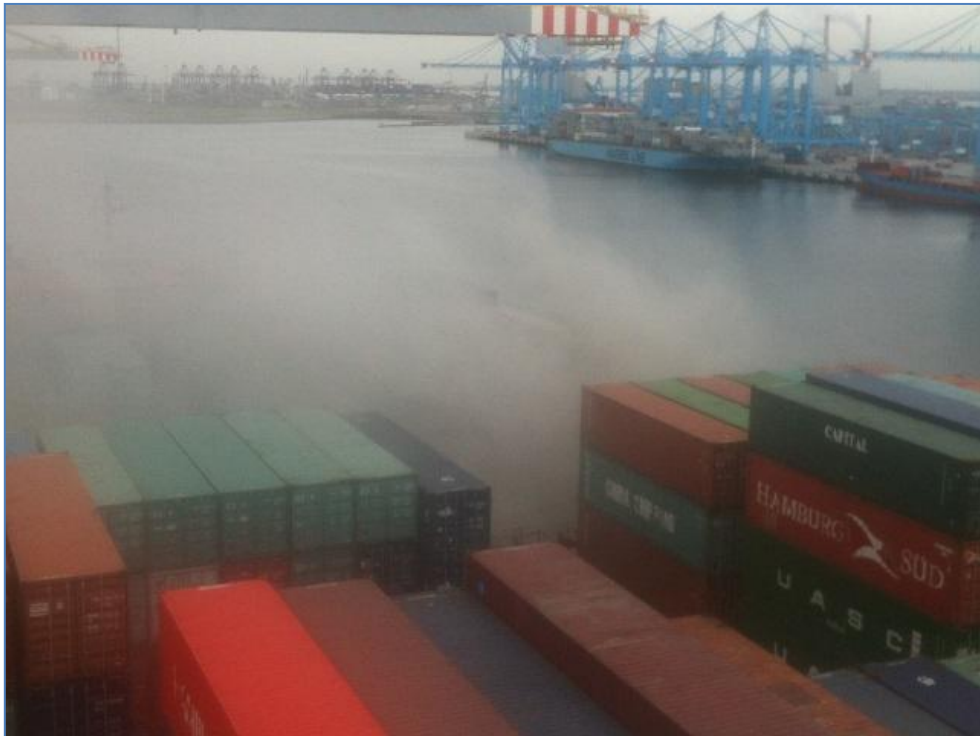
Figure 2 – Smoke from cargo hold nr.2 of *MV Barzan* on 07/09/2015 (MSIU)

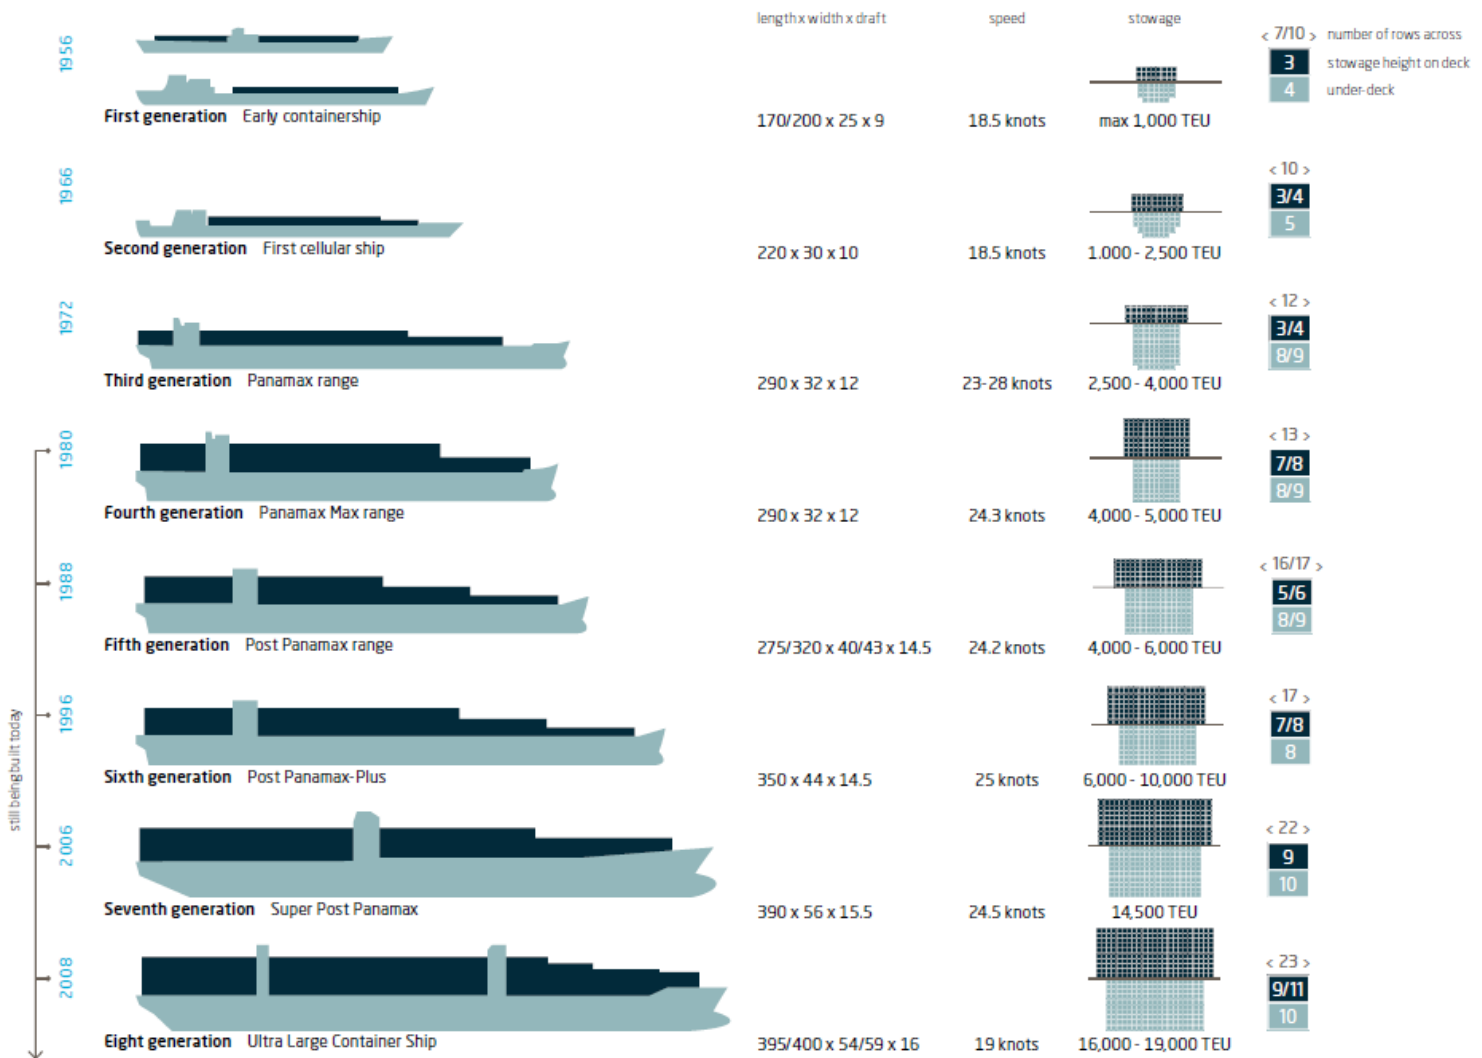
Figure 7 - Containership generations (source: Gard Guidance on Freight Containers, 2016)

<p>Development Generations</p>	<p>Container vessel have been through various development phases, which are classified as generations:</p> <ol style="list-style-type: none"> 1. First Generation (1956) – Early container vessels 2. Second Generation (1966) - First cellular vessels 3. Third Generation (1972) – Panamax Range vessels 4. Fourth Generation (1980) – Panamax Max vessels 5. Fifth Generation (1988) – Post Panamax vessels 6. Sixth Generation (1996) - Post Panamax Plus vessels 7. Seventh Generation (2006) – Super Post Panamax vessels 8. Eighth Generation (2008) – Ultra Large Container vessels
<p>Handling Modes</p>	<ul style="list-style-type: none"> • Container Roll-on Roll-off (Ro-Ro) ships can carry a combination of containers and vehicles. The containers are stored on the deck while the vehicles are rolled inside the hull on to tween decks that can be adjusted to different heights to accommodate all kind of vehicles. • Container Load-on Load-off (Lo-Lo) which carry other cargo in combination with containers. are ships are provided with cranes to lift the cargo. For cargo that cannot be fitted inside a container, or doesn't come in a container, it can be lifted, placed and secured on the deck or hold.

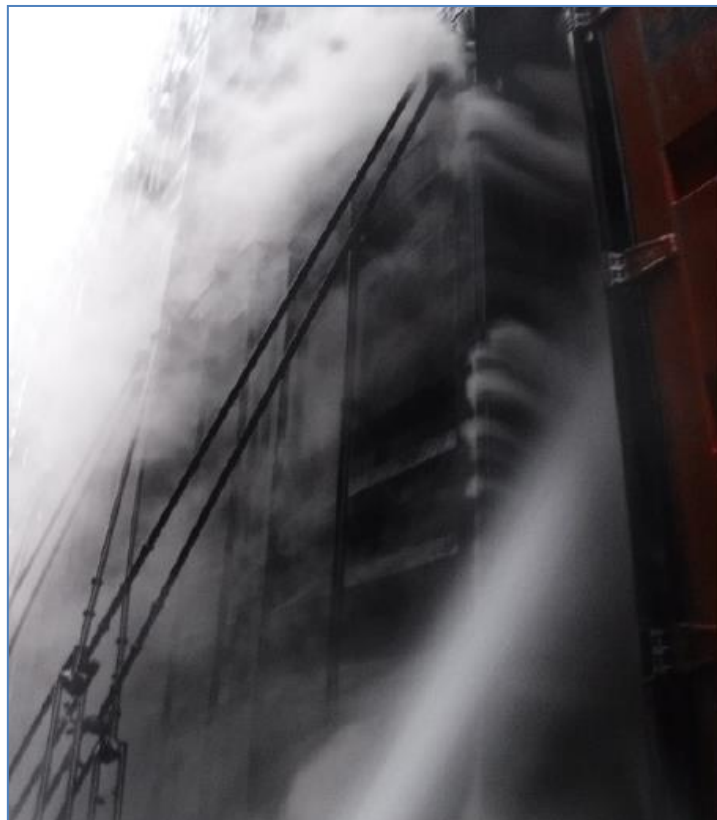
Figure 8 - Firefighting at bay 12, row 3 - *Yantian Express* (Source: BSU)

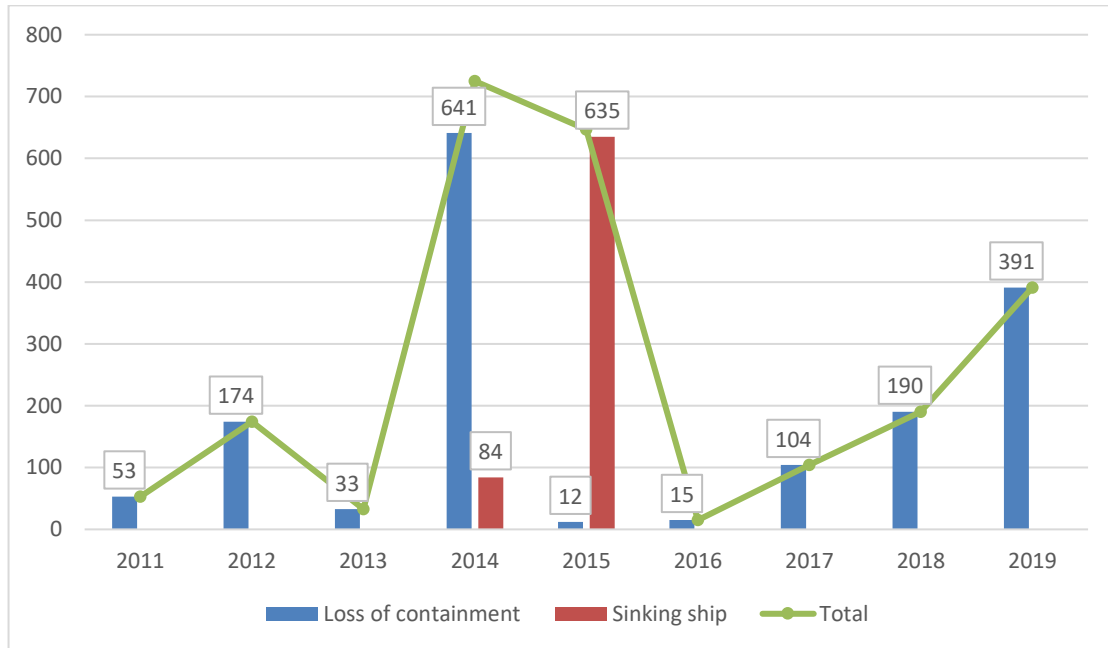
Figure 13 - Containers lost overboard

The number of containers lost overboard was also analysed in this study and these numbers are categorised by the loss of containment due to weather conditions or caused by other events (collision, grounding, listing and foundering).

AIBs reported 58 occurrences concerning containers lost overboard, totalling 2,332 of over the period, with an average of 284 containers lost per year (measured from 2012 to 2019). Peaks have been recorded in 2014 and 2015, the latter mainly related to the sinking of “*El Faro*”. Between 2016 and 2019, the number of containers lost has recorded an increasing trend, with figures in 2019 that appear significantly above the average.

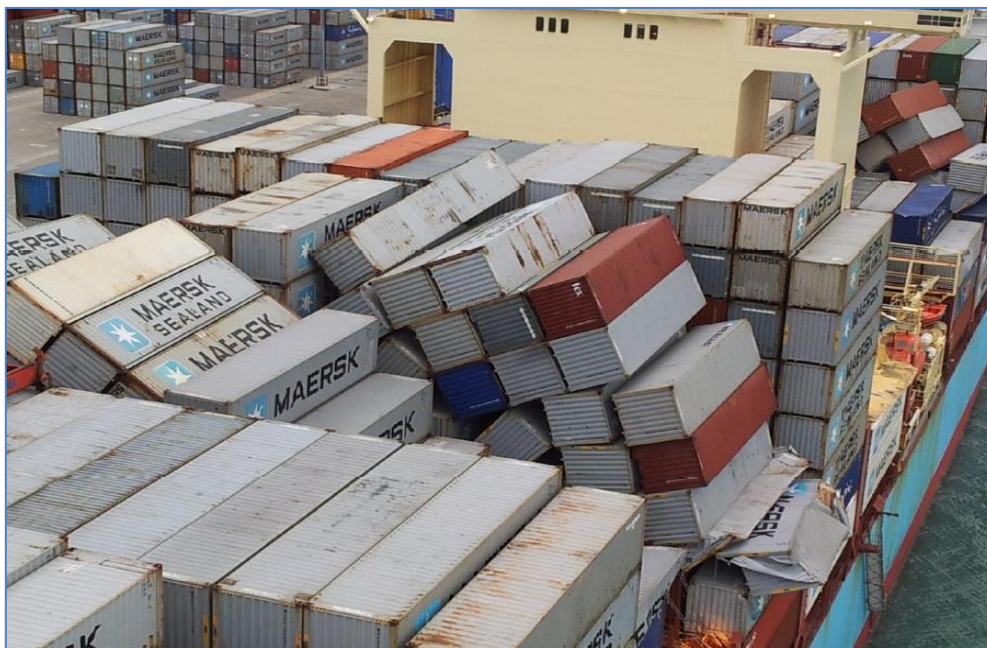
Figure 23 - *Svendborg Mærsk*, aft deck at arrival (Source: DMAIB / MÆRSK)

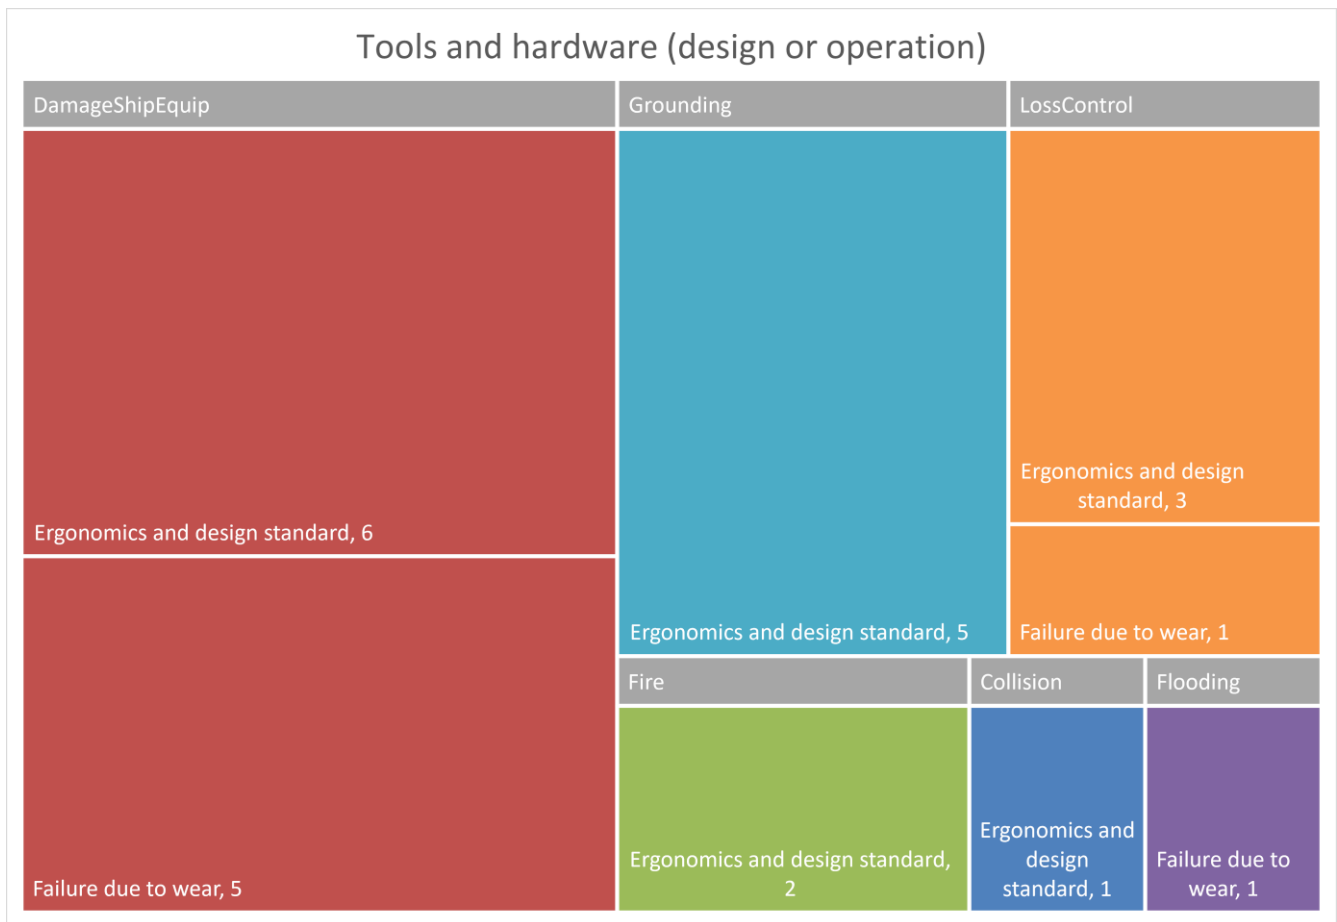
Figure 26: CF distribution for SI: Tools and hardware (design/operation)

- a. **Ergonomics and design standards**, including issues with the ship or equipment design that harmed the safe and effective operations.
 CF grouped in this area concern the safety standards used for designing hardware (devices, mechanisms or even deck layouts). Examples include the inadequate illumination and layout of the deck where mooring operations were ongoing, contributed to a fatality, or indicators of the engine performances that reported misleading information or led to not properly visible data.
 Other reported issues concern the design of the rescue boat arrangement and their sub-optimal performance when exposed to the natural environment.

- b. **Failure due to wear and tear:** material fatigue is a common factor for failure of mechanisms and appliances, especially when in the context of the sea environment and the vessels’ operations. Excessive stress on mooring ropes or the high load on the hydraulic motor of the windlass are examples that contributed to the breakdown of this equipment.

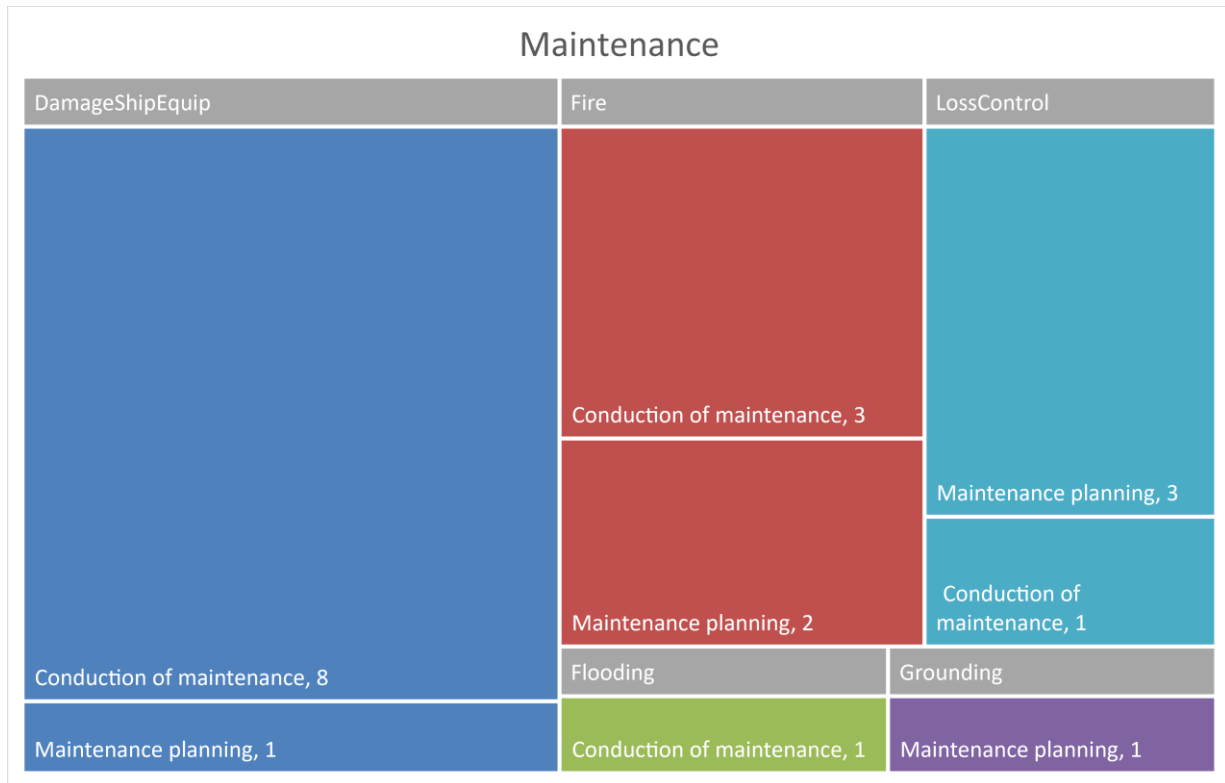
Figure 28: CF distribution for SI "Maintenance"

Maintenance is a critical domain for containership safety, given the complexity of shipborne systems and equipment as well as the fast-paced operations that are common on this type of vessels. This safety issue was found in 18 investigations and mainly concerned the SMS of the companies. Twenty CF have been recorded in EMCIP, mainly linked to “damage to ship or equipment” (9 CFs) and “fire/explosion” (5 CF).

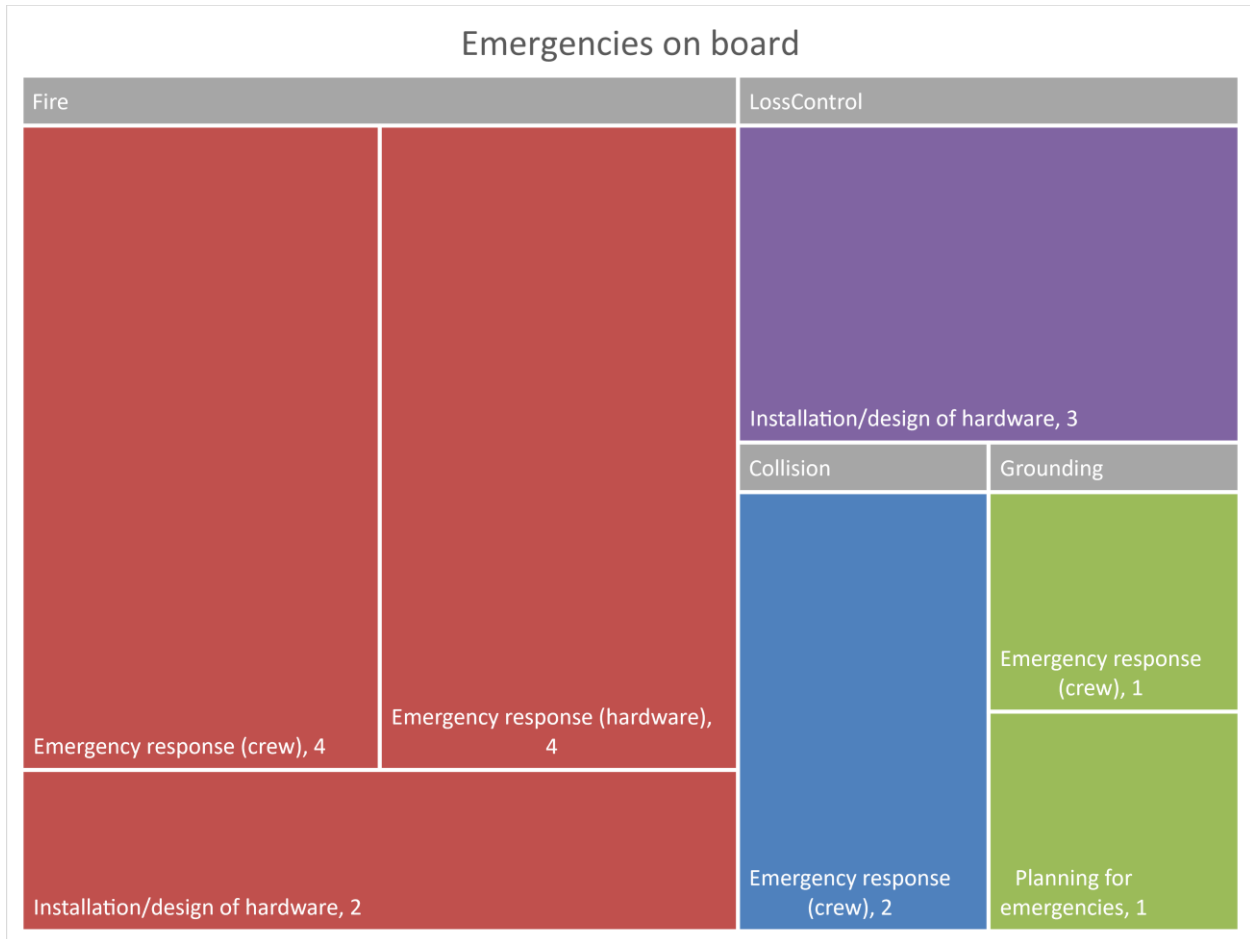
Figure 29 - CF distribution for SI “Emergencies on board”

Issues concerning the processes or actions made during an emergency status, as well as equipment or safety mechanisms that are used during an emergency, have been reported in 10 investigations comprising 17 CF.

The most prominent SA is “Fire/explosion” (10 CF).

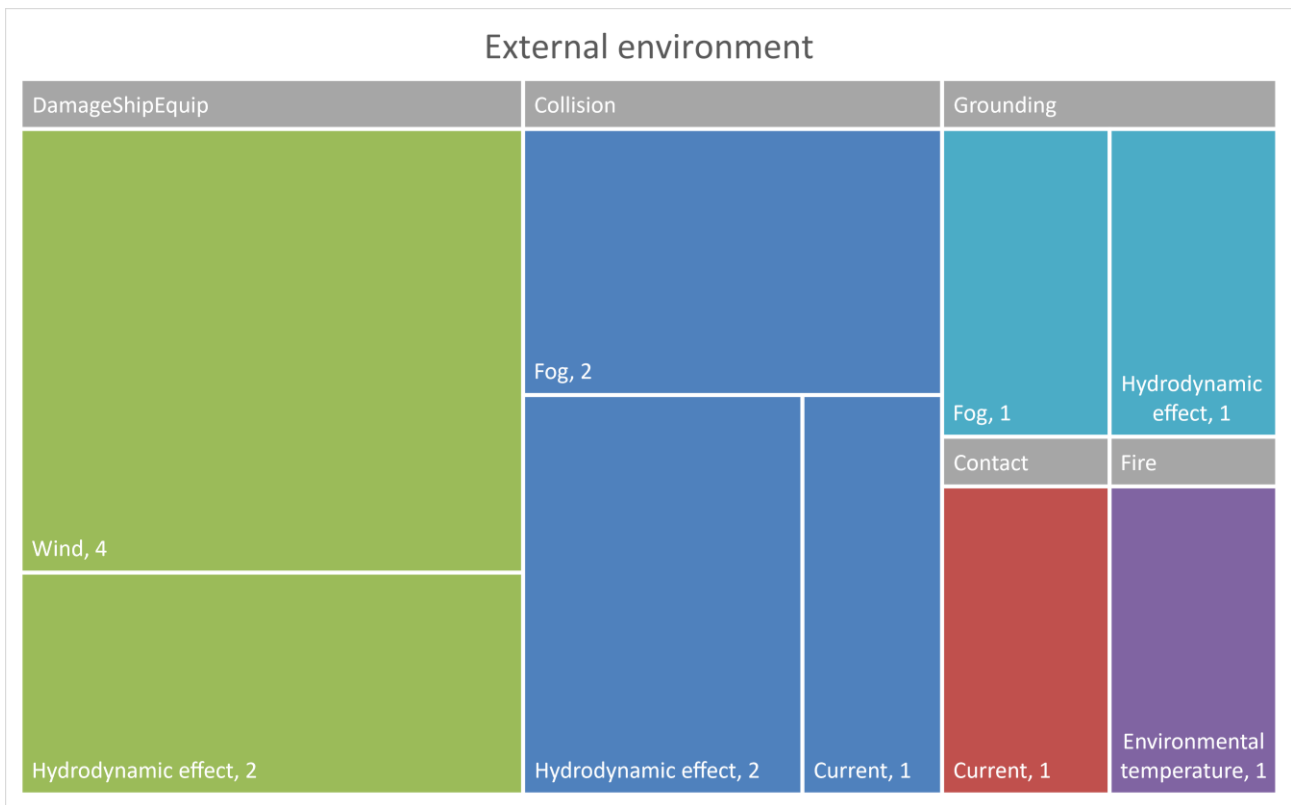
Figure 30 - CF distribution for SI "External environment"

The external environment has been reported as a CF in 12 investigations, making a total of 17 CF, mainly concerning damage to ship or equipment and collisions.

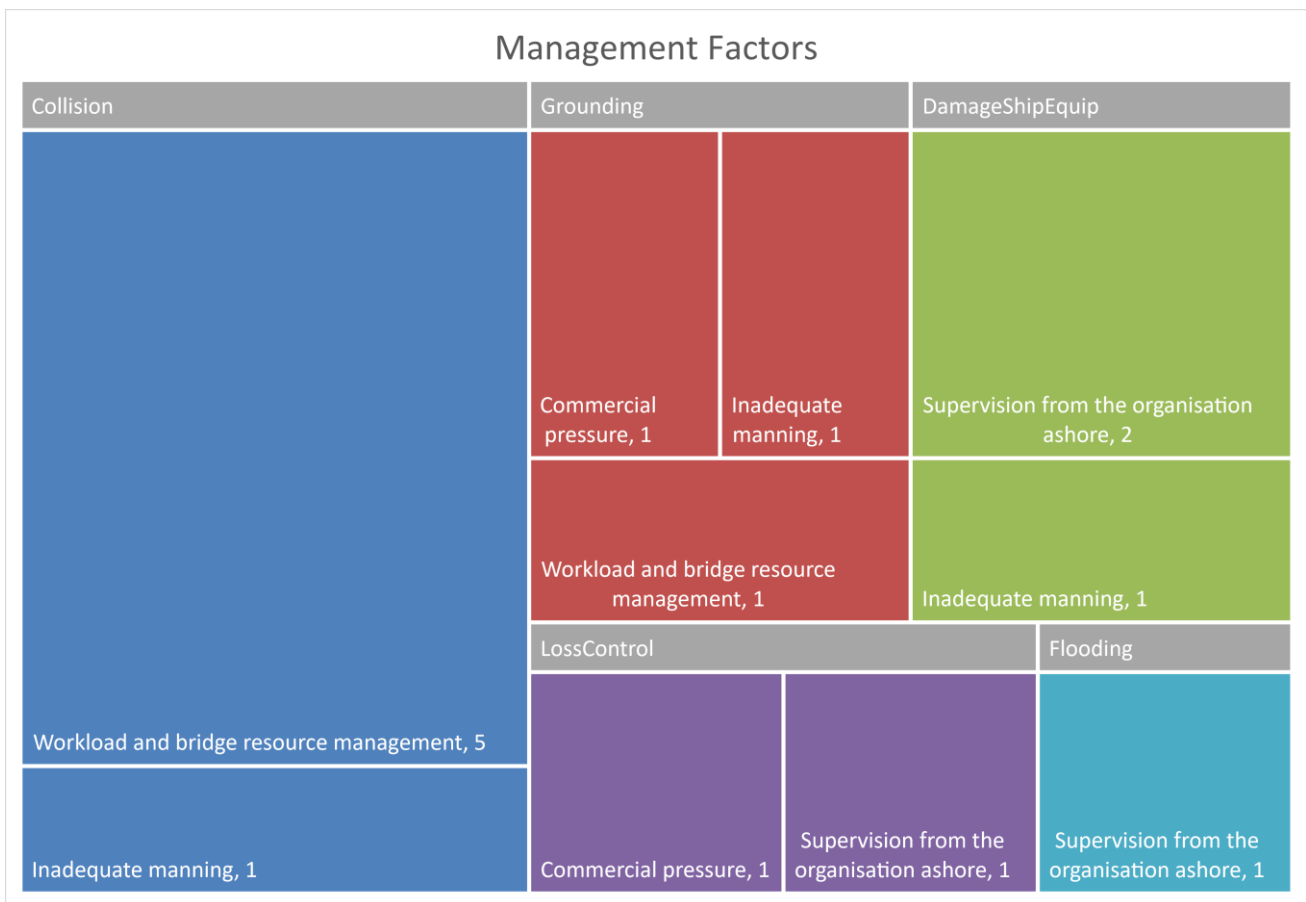
Figure 32 - CF distribution for SI “Management Factors”

Management plays a pivotal role for ship safety, regardless of the type of vessels. Fifteen CF concerning companies’ policies on certain matters and the shipborne management of the crew have been reported in 14 investigations, mainly related to collisions (6 CFs).

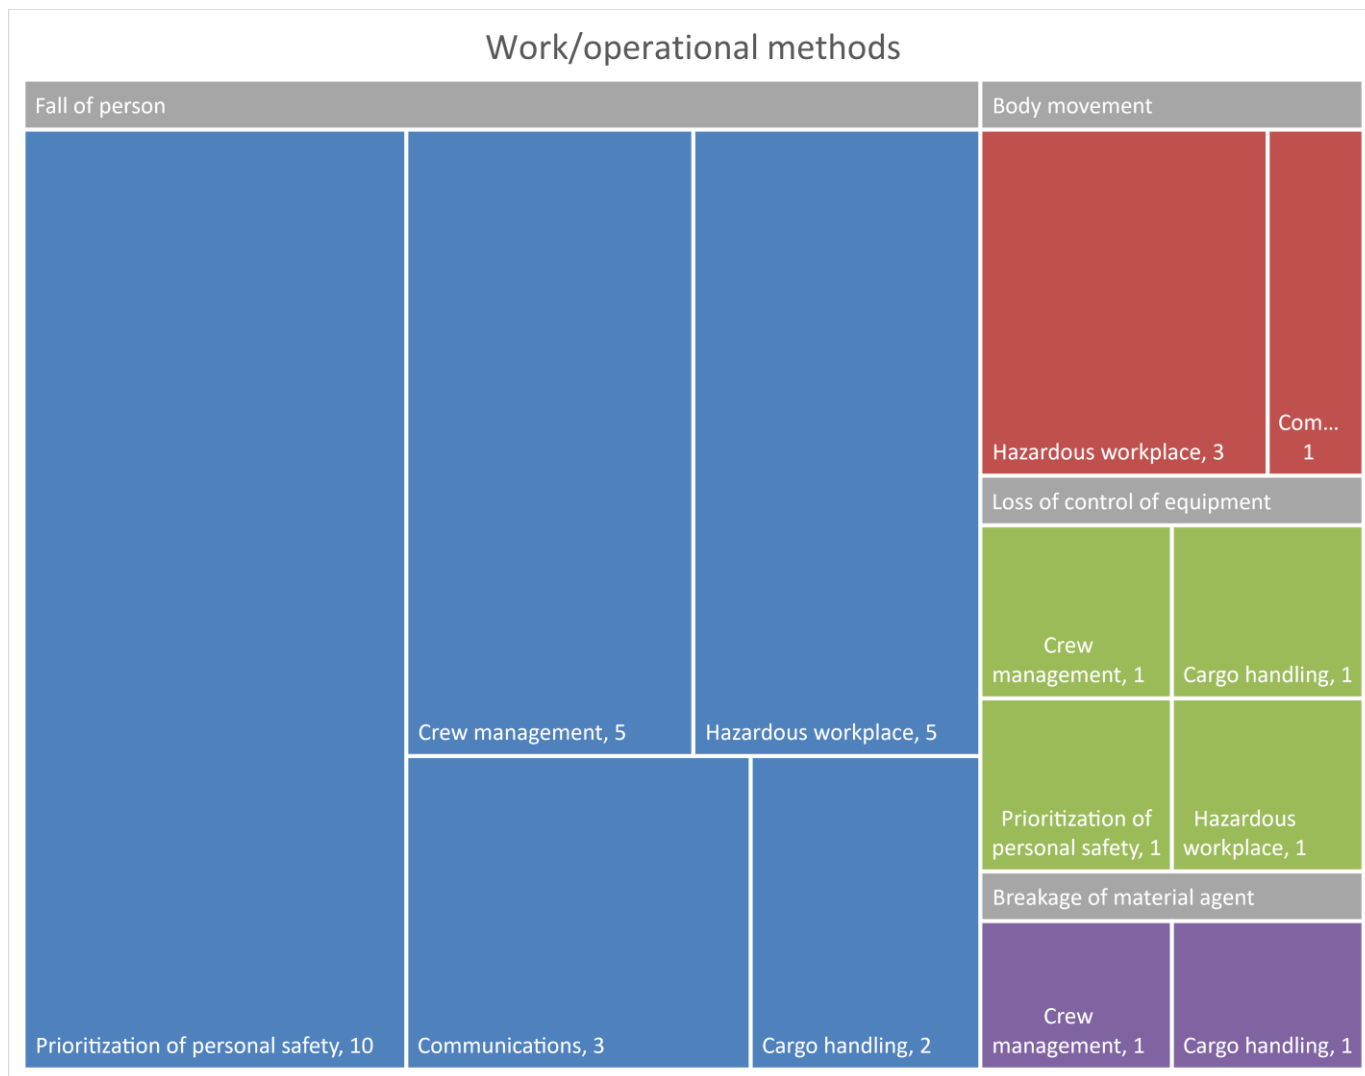
Figure 35 - CF distribution for SI “Work/operational methods”

“Work and operations methods” is the most frequently reported SI for occurrences with person(s) as it was found in 22 safety investigations with a total of 34 CFs, mostly referred to slipping/stumbling/falling (25 CFs).

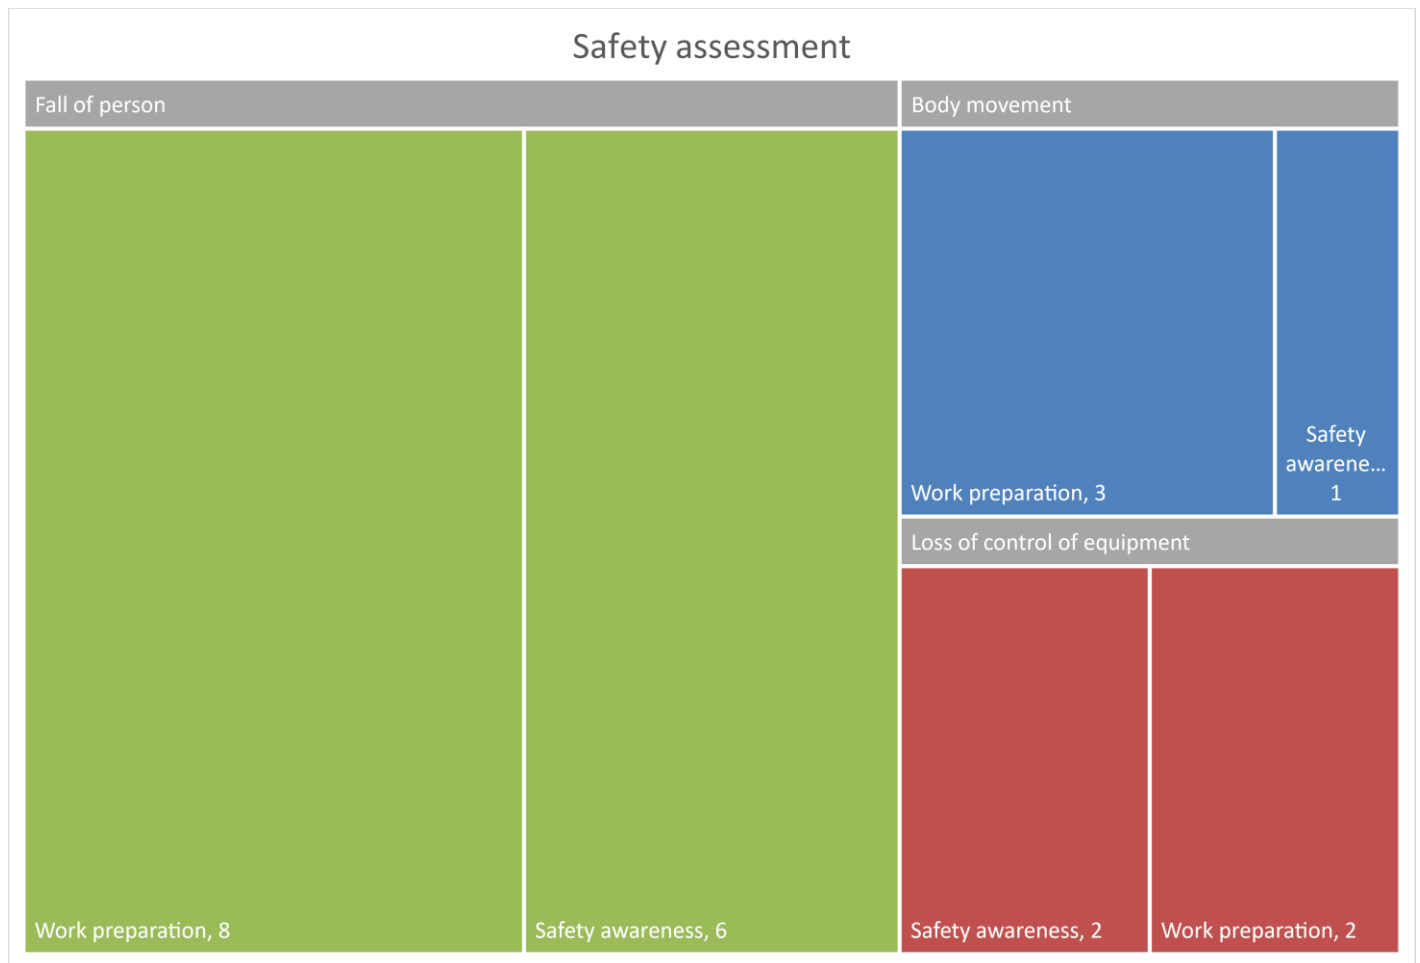
Figure 37 - AoC distribution for SI “Safety assessment”

“Safety assessment” is a recurrent SI that was identified in 22 CFs reported in 17 safety investigations.

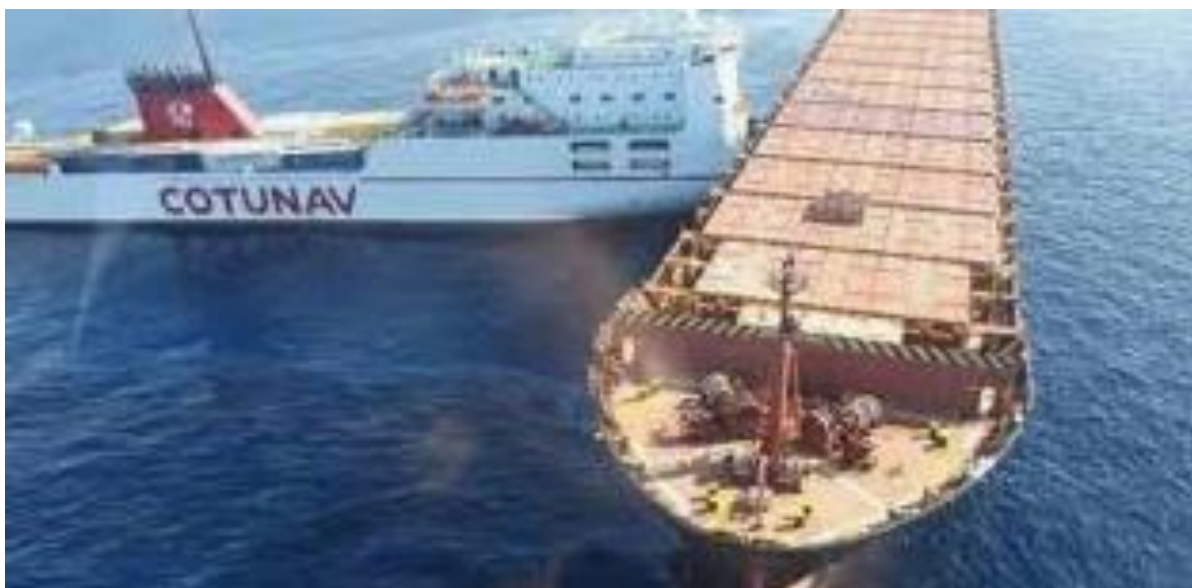
Figure 38 - Collision CSL Virginia - Ulysse on 7 October 2018, off cap Corse (Source: BEA Mer / Prefecture maritime de la Méditerranée)

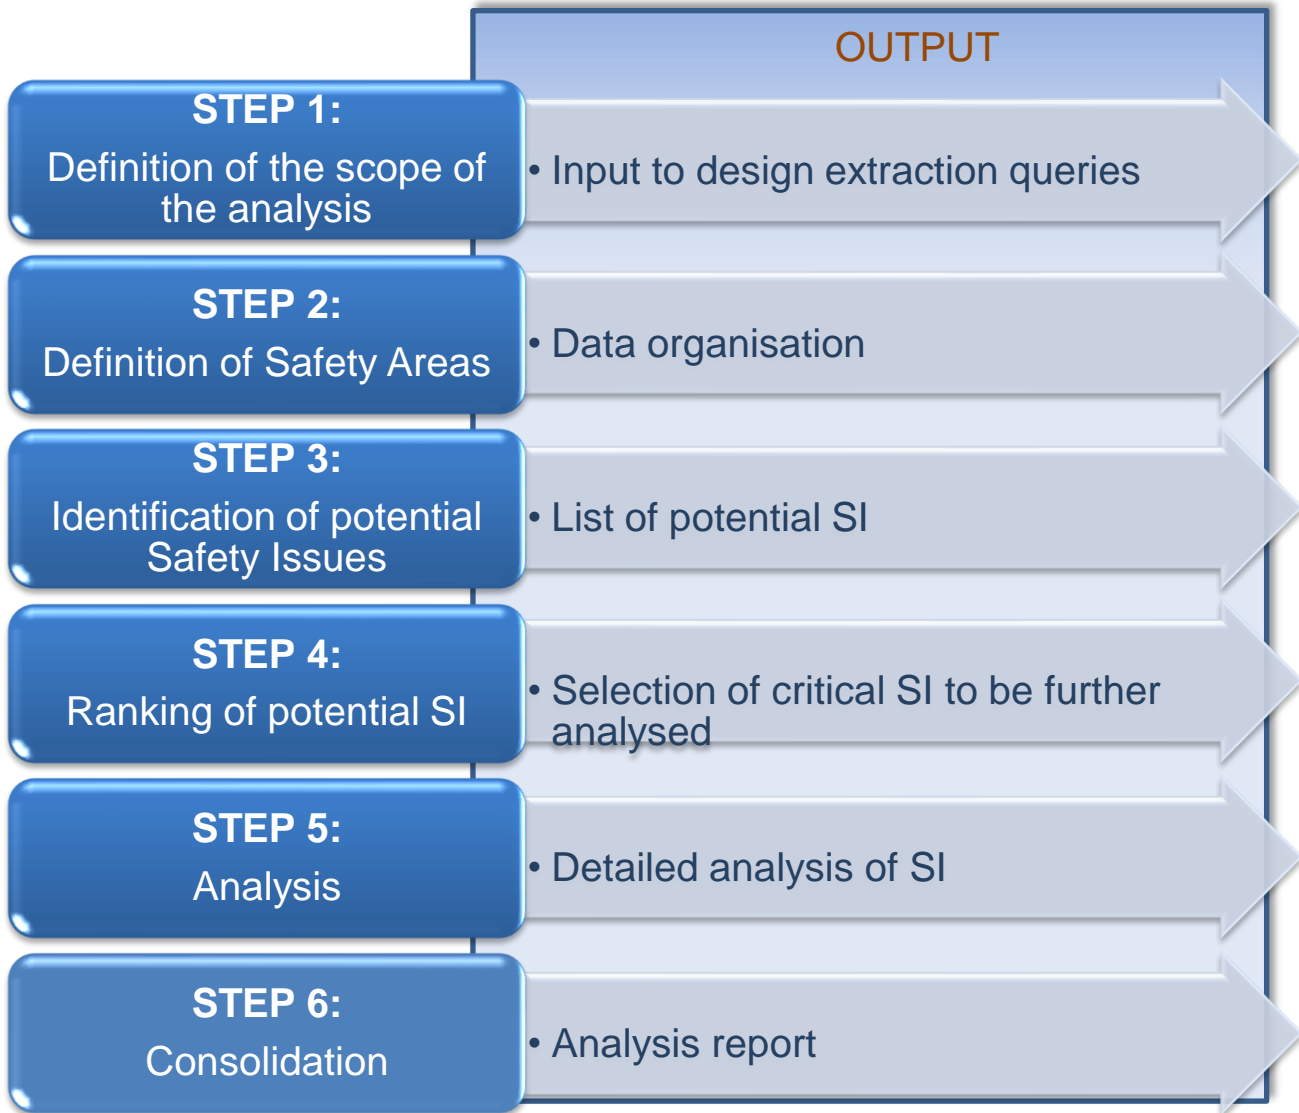
The EMSA methodology for analysis EMCIP data comprises the following 6 high-level steps¹⁹:
