HSVA Report No. 1669

**Research for the Parameters of the Damage Stability Rules
including the Calculation of Water on Deck
of Ro-Ro Passenger Vessels,
for the amendment of the Directives
2003/25/EC and 98/18/EC**

Final Report Part I

European Maritime Safety Agency (EMSA)

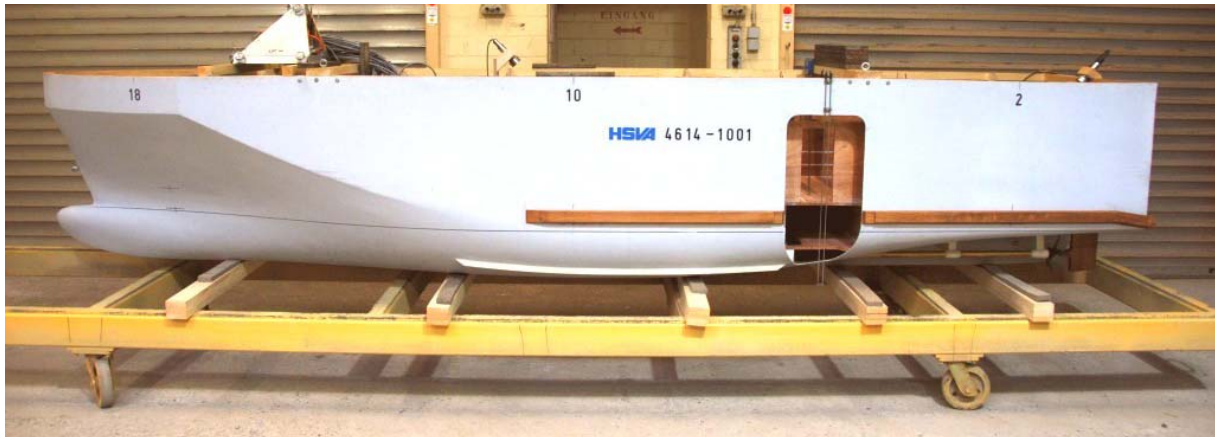
Fig. 25 The model HSVA No. 4614 of the ship EMSA1 with the opening of the Damage Case 1.

This chapter gives a short review of the model tests carried out with the HSVA model No. 4614 of the ship design EMSA1. The model and the damage opening of the Damage Case 1 are illustrated in Figures 25 and 26. The tests are reported in detail separately in the HSVA Report No. S590a/09 "Damage Stability Tests with the Model of an 80 m RoPax Vessel" by Ludwig (2009a).

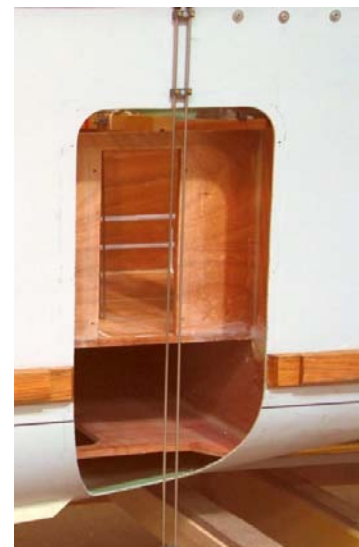
Fig. 26 The damage opening of the Damage Case 1.

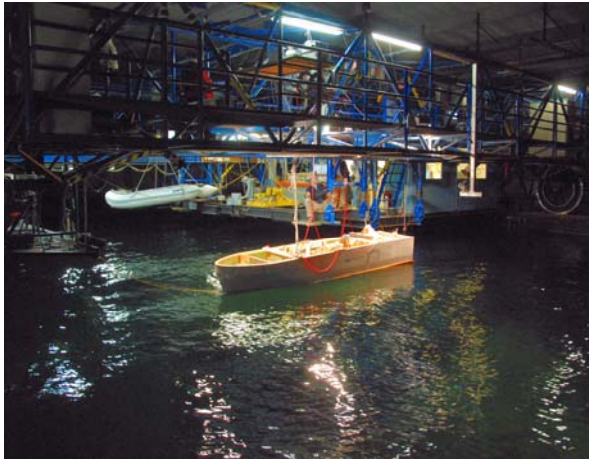
Fig. 27 Model and the towing carriage.

The tests were carried out in the HSVA's large towing tank on 23-24 of February 2009. The scale of the model was chosen to be 16. Thus a 5 m long model was used in the 18 m wide test basin, leaving sufficient space in front of the bow and behind the stern of the vessel in beam seas. The 300 m long test basin provided a sufficiently long measurement period practically free of wave reflection. The irregular beam seas were generated with the JONSWAP- spectrum. Figures 27-30 illustrate the tests with the model of the EMSA 1.

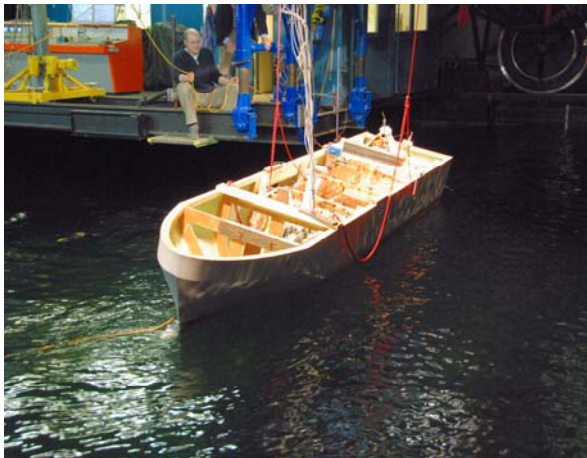
Fig. 29 The model was kept in beam seas with occasional control by two lines connected to the bow and stern of the model, if necessary.

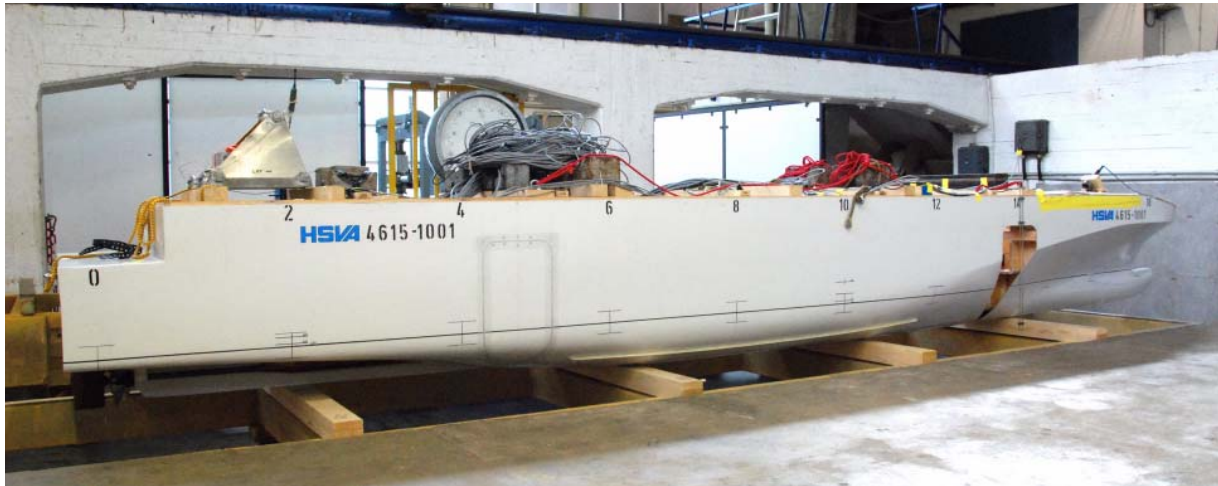
Fig. 49 The model HSVA No. 4615 of the ship EMSA2/EMSA2MOD with the opening of the Damage Case 4 at the ship side. The closed opening for the Damage Case 1 can also be seen between the stations 4 and 6.

This chapter gives a short review of the model tests carried out with the HSVA model No. 4615 of the ship design EMSA2. The model and the damage opening of the Damage Case 4 are illustrated in Figures 49 and 50. The tests are reported in detail separately in the HSVA Report No. S590b/09 "Damage Stability Tests with the Model of a 200 m RoPax Vessel" by Ludwig (2009b).

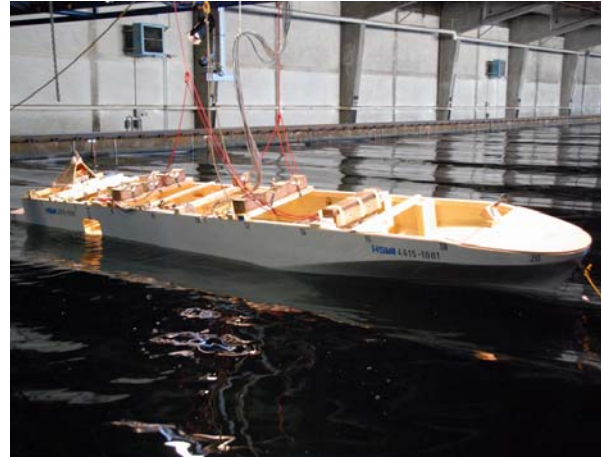
Fig. 52 The list increases gradually.

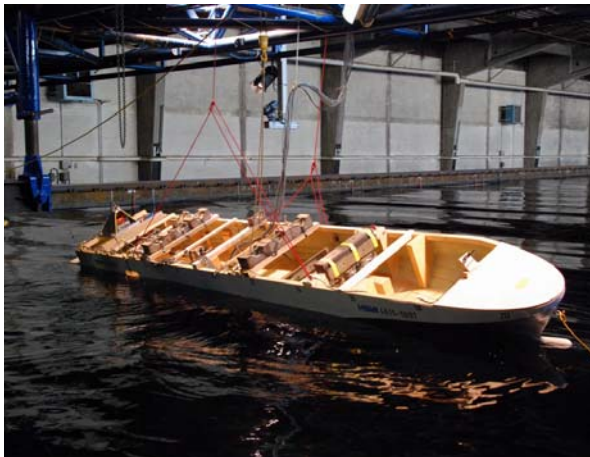
Fig. 53 The list exceeds 20°.

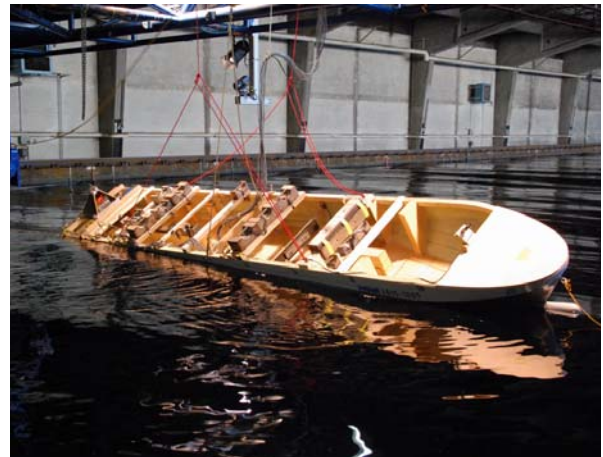
Fig. 54 The list grows further and a full capsizing of the model is avoided only with the help of the red "preventer" lines.

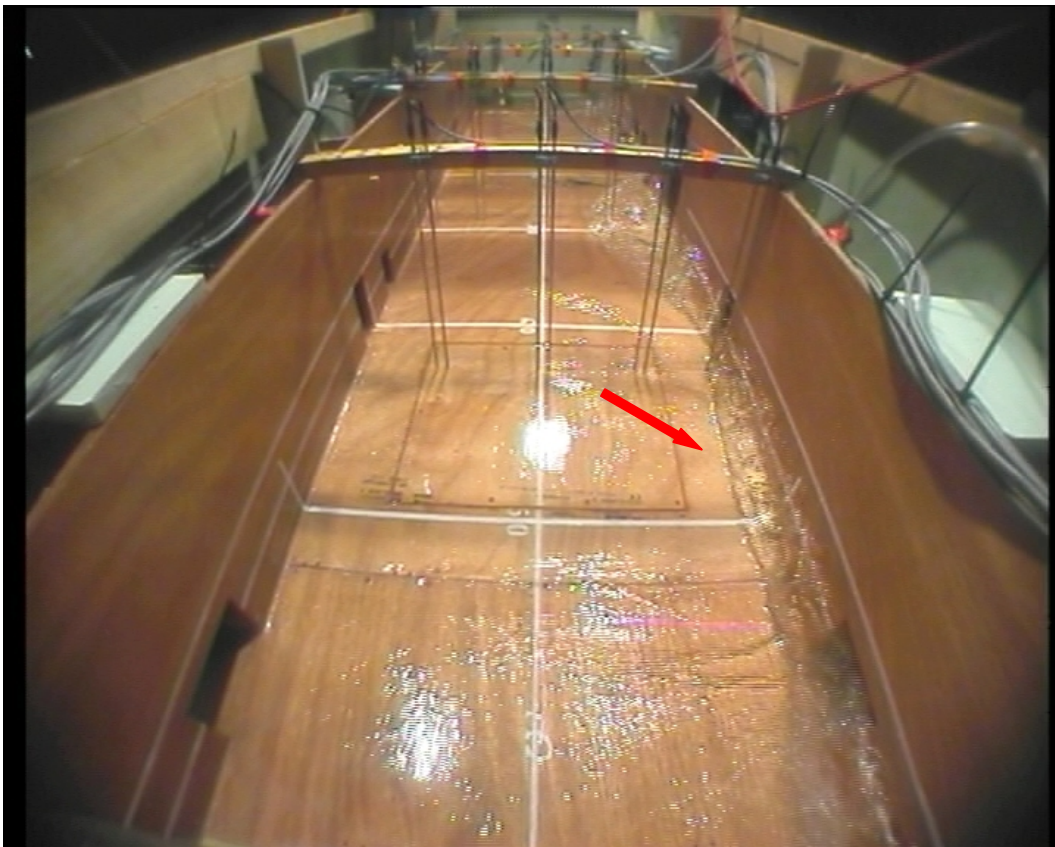
Fig. 63 Water sloshes against the damaged side wall. The water elevation at the wall exceeds the first white line at 1 m height.

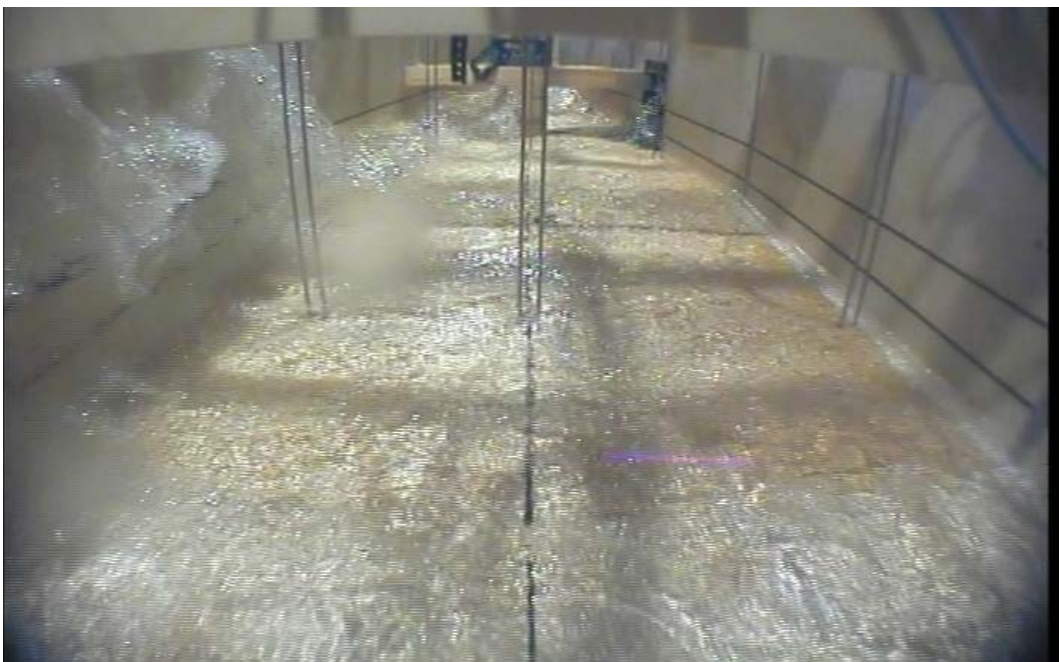
Fig. 72 One of the selected frames from a video recording of the measurement no. 35. The frame shows water sloshing over 6 m high against the port side wall.

Figures 71 and 72 are individual frames from the video recording of the vehicle deck during measurement no. 35 with the significant wave height H_s of 4.3 m. The ship motions together with the large amount of water on the vehicle deck of the ship EMSA2MOD in Damage Case 4 led to rather impressive wave formations on the vehicle deck. Such wave impacts can be expected to be able to move cars. Whether hard objects, cars or other cargo accelerated by sloshing waves, can damage the side walls when *impacting against* them, was not studied here. The issue, however, may be worth some consideration, specially in cases like EMSA2MOD having a large amount of water on the vehicle deck.
