EMSA/OP/10/2013

Risk Acceptance Criteria and Risk Based Damage Stability, Final Report, part 2: Formal Safety Assessment

European Maritime Safety Agency

Report No.: 2015-0166

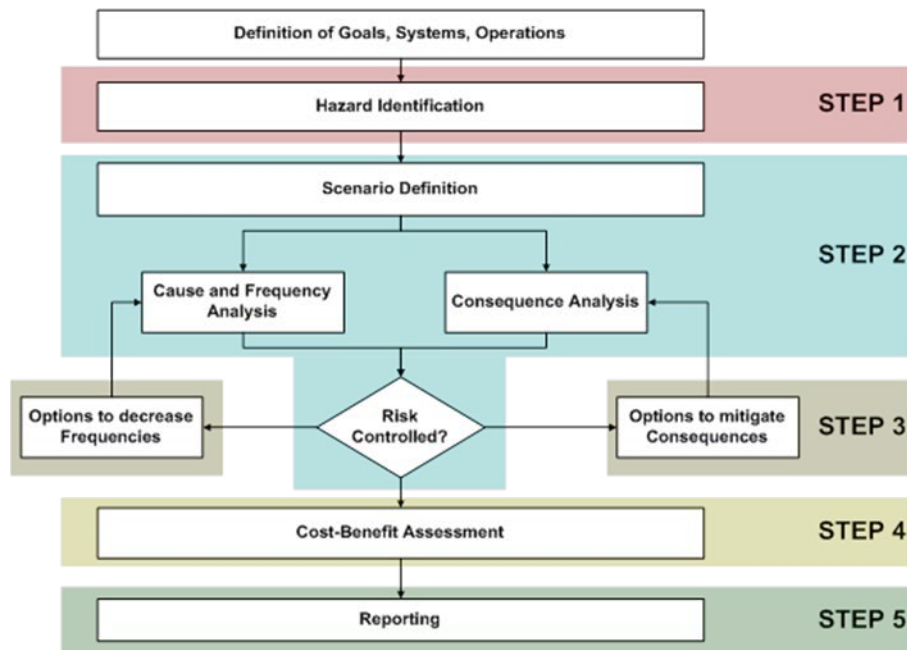
Fig. 8-1 Flow chart of FSA process

This risk analysis of passenger ships, i.e. cruise ships, passenger ships, RoPax and RoPaxRail, aiming on the development of updated damage stability requirements for these ship types if justified by cost-benefit assessment is based on the process outlined in the Formal Safety Assessment (FSA) guidelines (MSC 83/INF.2, 2007; MSC-MEPC.2/Circ.12, 2013) 1. The main steps of this process are shown in Fig. 8-1.

In the risk analysis (step 2 of FSA process, Fig. 8-1) the risk of passenger ship operation is quantified with respect to persons on board, i.e. crew and passenger. The risk of person on board is calculated in terms of potential loss of life (PLL) as well as other values. Risk is also evaluated by means of societal risk (F-N diagram) as well as characteristic values used in other industries, e.g. fatalities per billion passenger km.

The aim of step 3 of the FSA process (Fig. 8-1) is the identification of measure reducing the risk. The focus of this investigation is damage stability of passenger ships and hence only risk control options that mitigate the consequences of water ingress after collision, contact or grounding accidents are investigated.

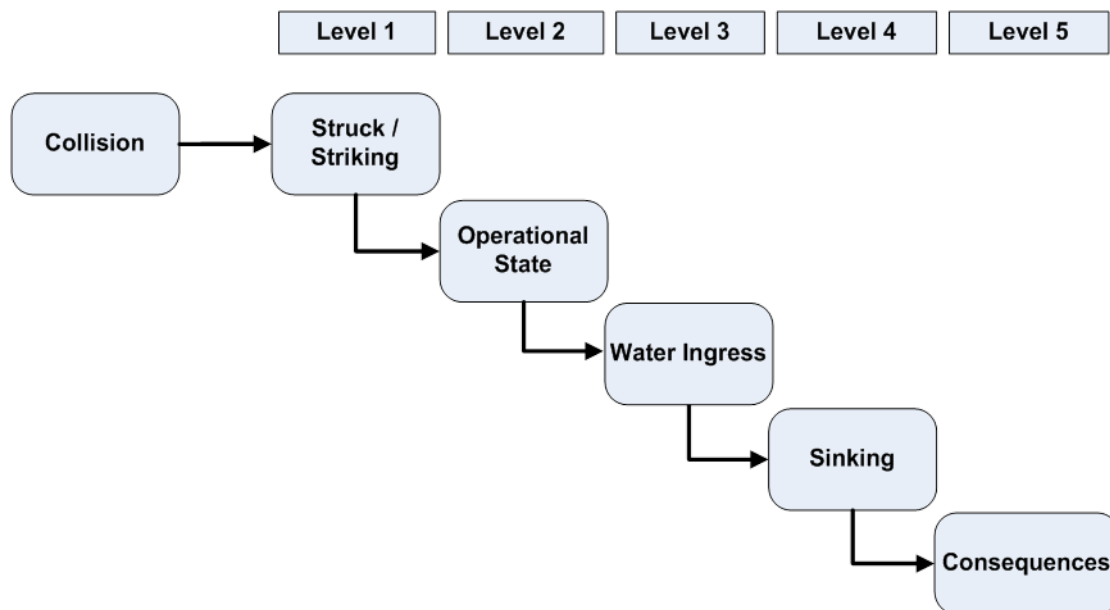
The high-level event sequence for collision is shown in Fig. 10-1. This event sequence was developed for both ship categories Cruise and RoPax in the GOALDS project 4 and is used also for this investigation because it is regarded to adequately describe the development of collision accidents. The consequences of collision accidents highly depend on whether the ship is striking or struck. Typically, for striking ship damages to hull occurred but they are limited to the bow area. Even if water ingress occurs, the damage stability is not reduced. The situation is different for ships struck. When a ship is struck it may lose its stability and sink. All measures to limit the consequences for person on board strongly depend on the area of accident, i.e. the operational area. When accident occurs close to the shore the reaction time for SAR is low compared to accident far from shore line. Hence, fatality rates for accidents close to shore should be lower. The following two nodes of the event sequence focus on the prerequisites for sinking, i.e. water ingress and loss of stability.

Fig. 10-1 High-level event sequence for collision of Cruise and RoPax (based on GOALDS)

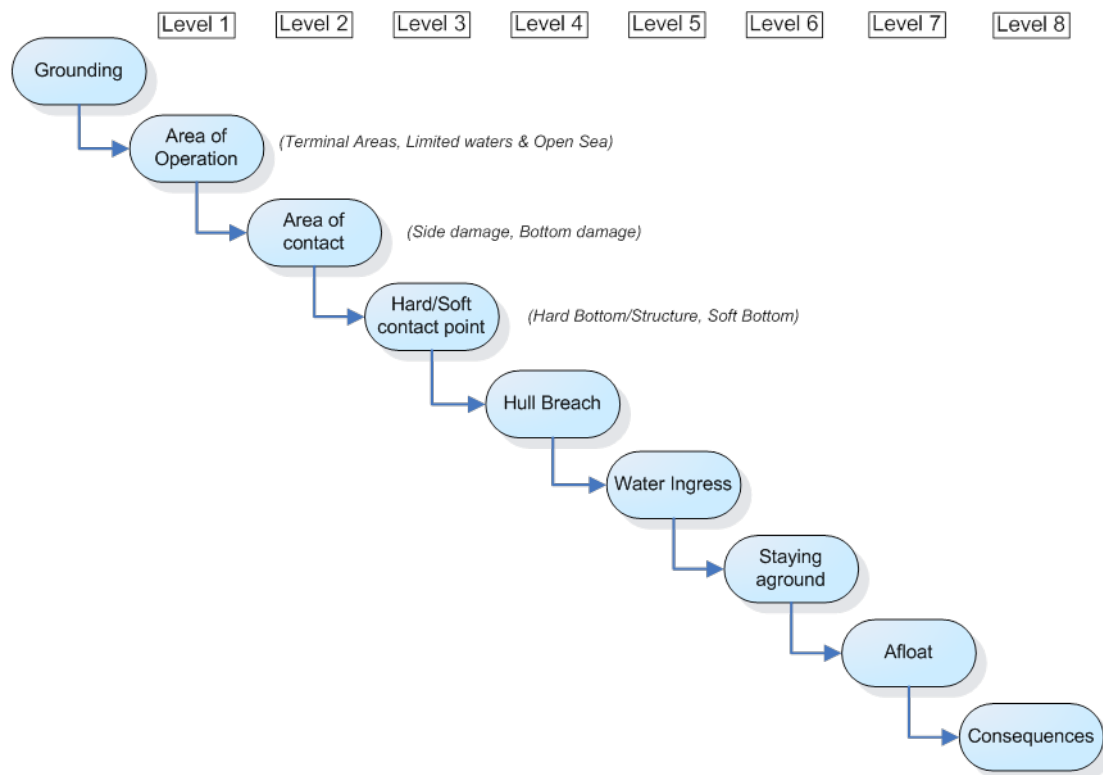
6. Staying aground (Yes/No). If immediately after the accident the ship stays aground, then no fatalities are assumed.
 7. Afloat (Yes/No). If the ship does not stay aground, two alternatives are considered: a) it may remain afloat, with a probability assumed equal to the corresponding A-Index or, b) it may sink or capsize, with a probability assumed equal to 1-A .

8. Consequences. In case the ship sinks or capsizes, the number of fatalities is calculated as a percentage of POB (Persons on Board).

Fig. 10-2 High-level event sequence for Grounding Accidents to Cruise and ROPAX ships

Therefore, the high-level event sequence and the risk model for grounding accidents need to be revisited. The high-level event sequence for grounding accidents for both Cruise and RoPax ships (Fig. 10-2) considers the following events:

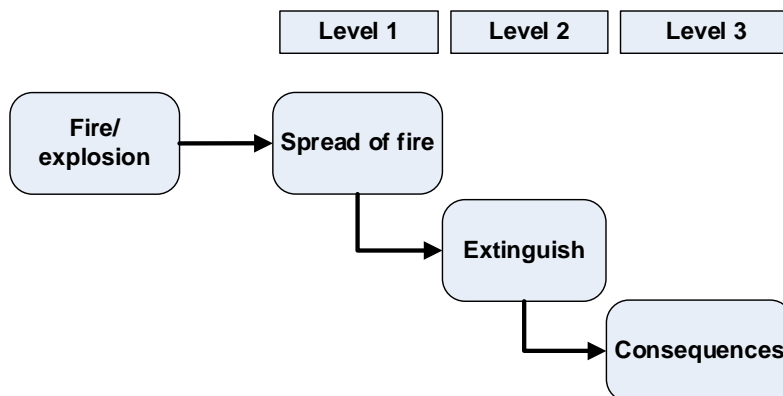
Fig. 10-3 High-level event sequence for fire/explosion on cruise ships (based on SAFEDOR FSA on Cruise)

Both high-level event sequences for fire and explosion developed in SAFEDOR showed slight differences as shown by the comparison in Fig. 10-3 (Cruise) and Fig. 10-4 (RoPax). In the event sequence for RoPax the origin of fire was considered along with extinguishing measures in the machinery, vehicle deck and accommodation area. In the risk model for Cruise the focus was put on the escalation, i.e. whether the fire can be extinguished in the compartment of origin or spread. Considering the particularities of RoPax and Cruise ships this distinction was regarded appropriate and ship category dependent risk models were developed.

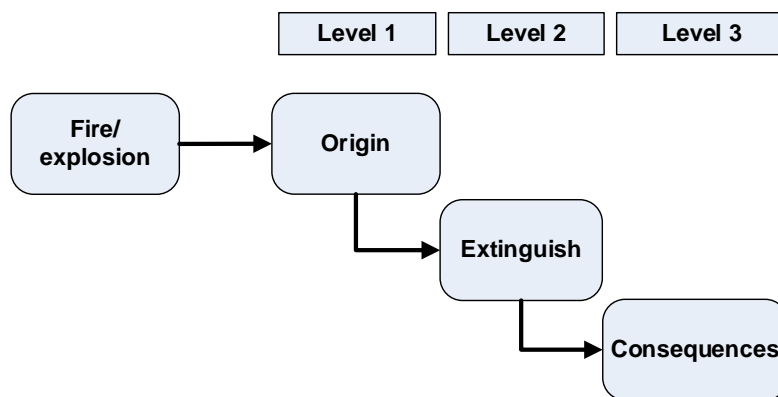
Fig. 10-4 High-level event sequence for fire/explosion on RoPax ships (based on SAFEDOR FSA on RoPax)

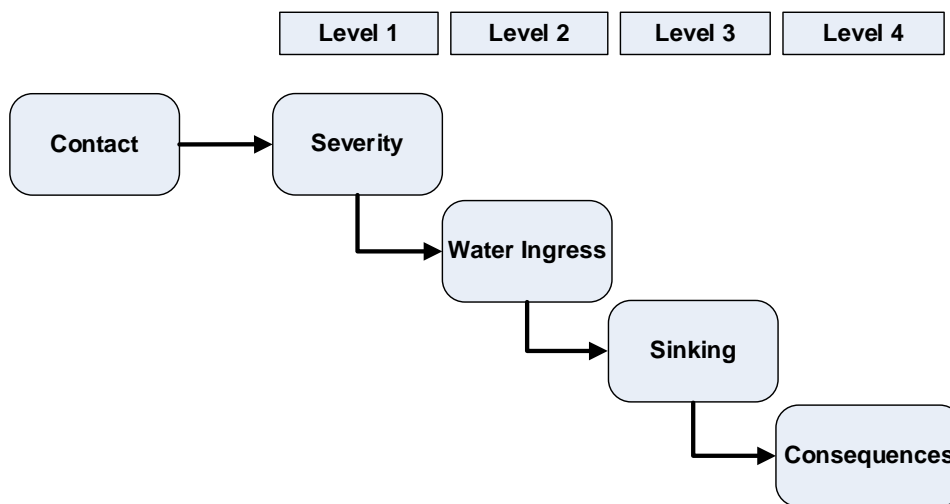
Fig. 10-5 High-level event sequence for contact/impact of RoPax ships (based on SAFEDOR FSA on RoPax)

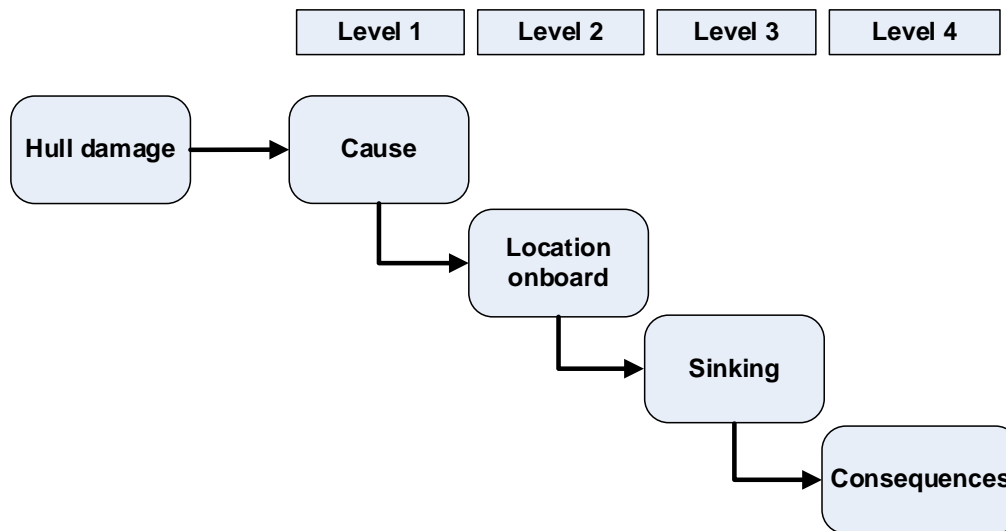
Additionally, for RoPax an independent risk model relating to the flooding hazard was developed in the SAFEDOR FSA, which considers all risks relating to loss of water tightness relating to non-accidental failures, like doors left open or wave forces leading to non-accidental structural failure or opening of bow door (Herald of Free Enterprise and M/V Estonia type of accidents). Such casualties were typically assigned to the accident categories foundering and hull/machinery accidents in the IHS Fairplay casualty database. In particular for RoPax ships, water ingress to car deck has the potential of leading to rapid loss of stability and subsequently to capsizing, with high fatality rate for person on board. Since it contributes to the risk of RoPax ships, it was considered in the present study.

Fig. 10-6 High-level event sequence for hull damage of RoPax ships (based on flooding risk model SAFEDOR FSA on RoPax)

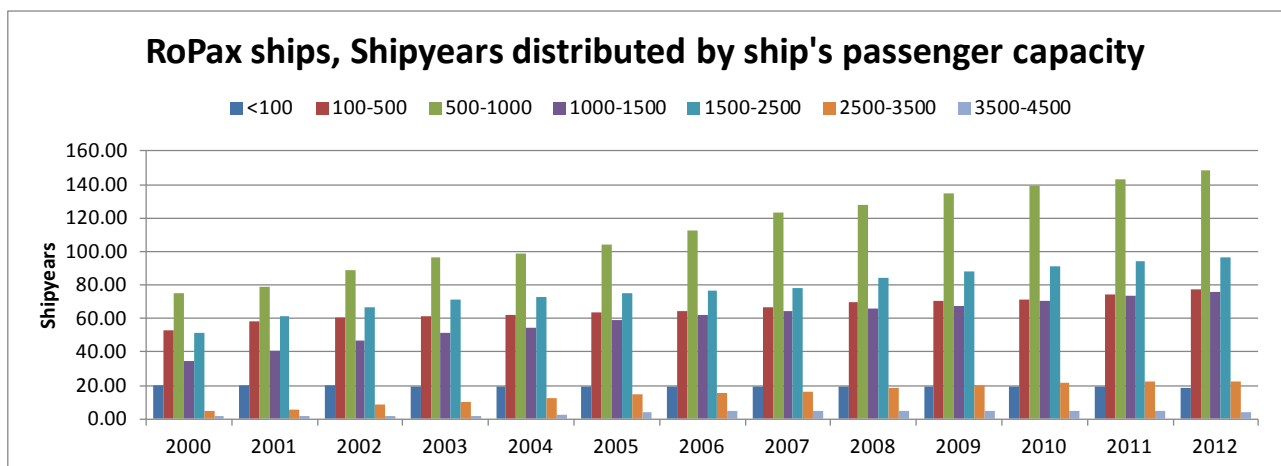
Fig. 10-13 Number of ship years per year for RoPax fleet (ships $\geq 1,000$ GT; ≥ 80 m, built after 1981, excluding HSC and only IACS class) by ship's passenger capacity.

- The larger part of RoPax fleet is coming from ships having a passenger capacity of 500-1,000 persons and it is continuously increasing over the years.
- RoPax ships carrying 1,000-1,500 passengers is the second larger part of RoPax operational ship fleet.
- Growth rates vary up to 10% after year 2005 with respect to the ships up to 2,500 passengers.
- In annual base, the largest number of passengers is carried by RoPax ships with passenger capacity in the range of 1,500-2,500.

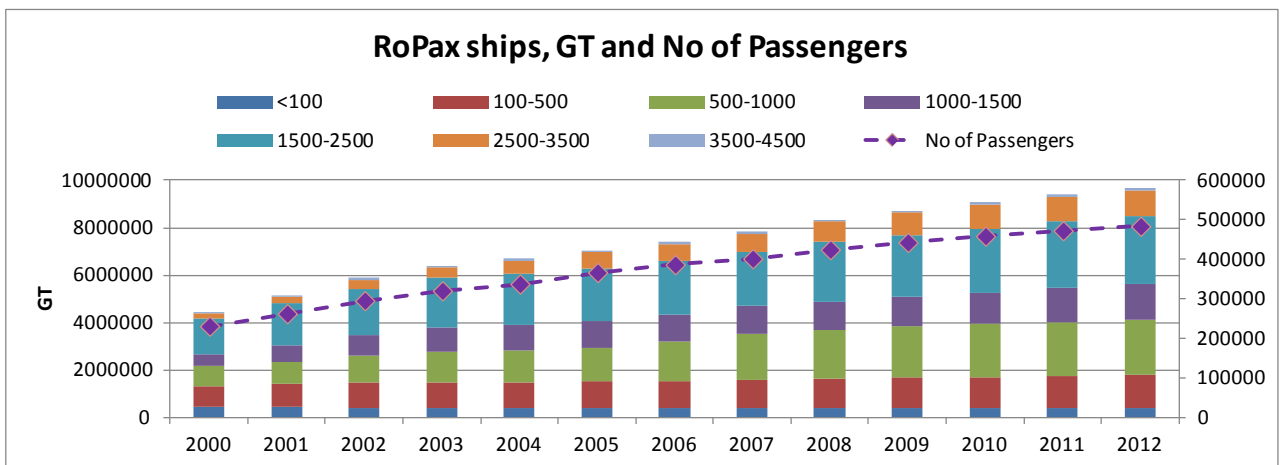
Fig. 10-15 GT and Number of Passengers per year for RoPax fleet (ships ≥ 1,000 GT; ≥ 80 m, built after 1981, excluding HSC and only IACS class) by ship's passenger capacity.

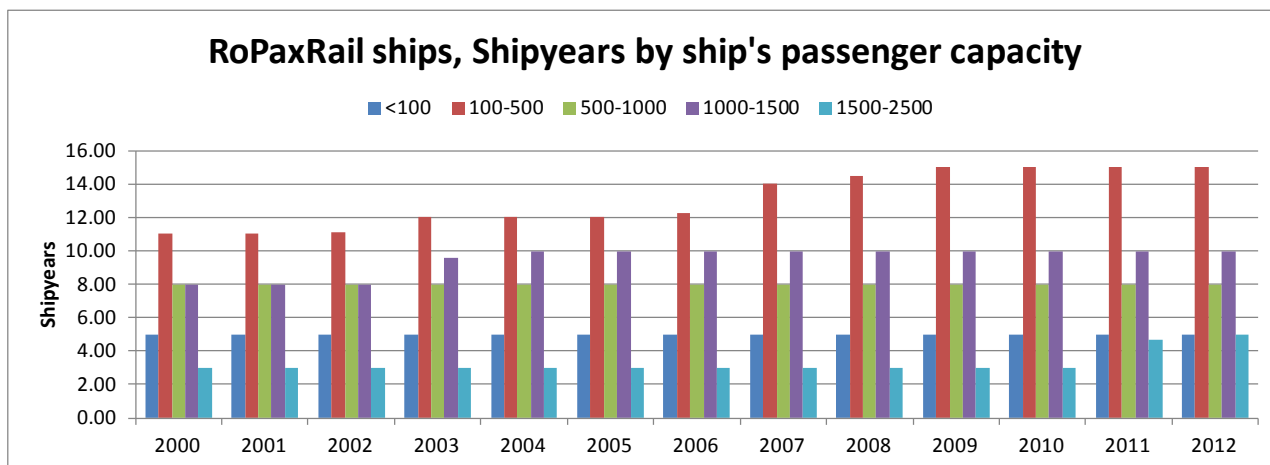
Fig. 10-17 Number of ship years per year for RoPax fleet (ships ≥ 1,000 GT; ≥ 80 m, built after 1981, excluding HSC and only IACS class) by ship's passenger capacity.

Focusing on the second decade of time period analysis, namely 2000-2012, and categorising RoPaxRail ship fleet by ship's nominal passenger capacity, the following can be observed (Fig. 10-17, Fig. 10-18 and Fig. 10-19):

- The major part of RoPaxRail fleet is coming from ships having a passenger capacity of 100-500 persons.
- The fleet of RoPaxRail ships carrying 1000-1500 passengers is the second largest part of RoPaxRail operational ship fleet.
- In annual base, the largest number of passengers is carried by RoPaxRail ships having a passenger capacity in the range of 1,000-1,500.

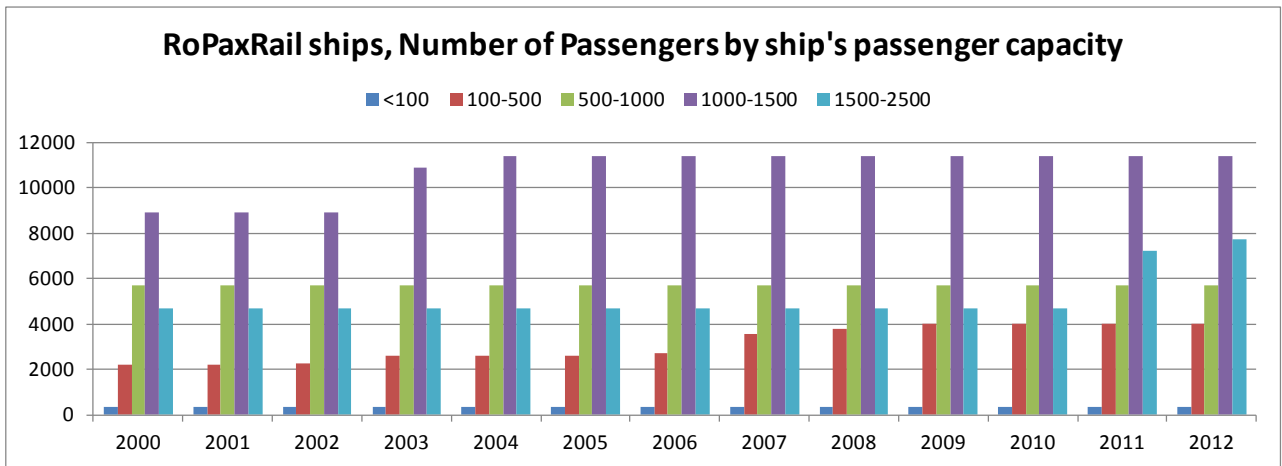
Fig. 10-18 Number of ship years per year for RoPax fleet (ships ≥ 1,000 GT; ≥ 80 m, built after 1981, excluding HSC and only IACS class) by ship's passenger capacity.

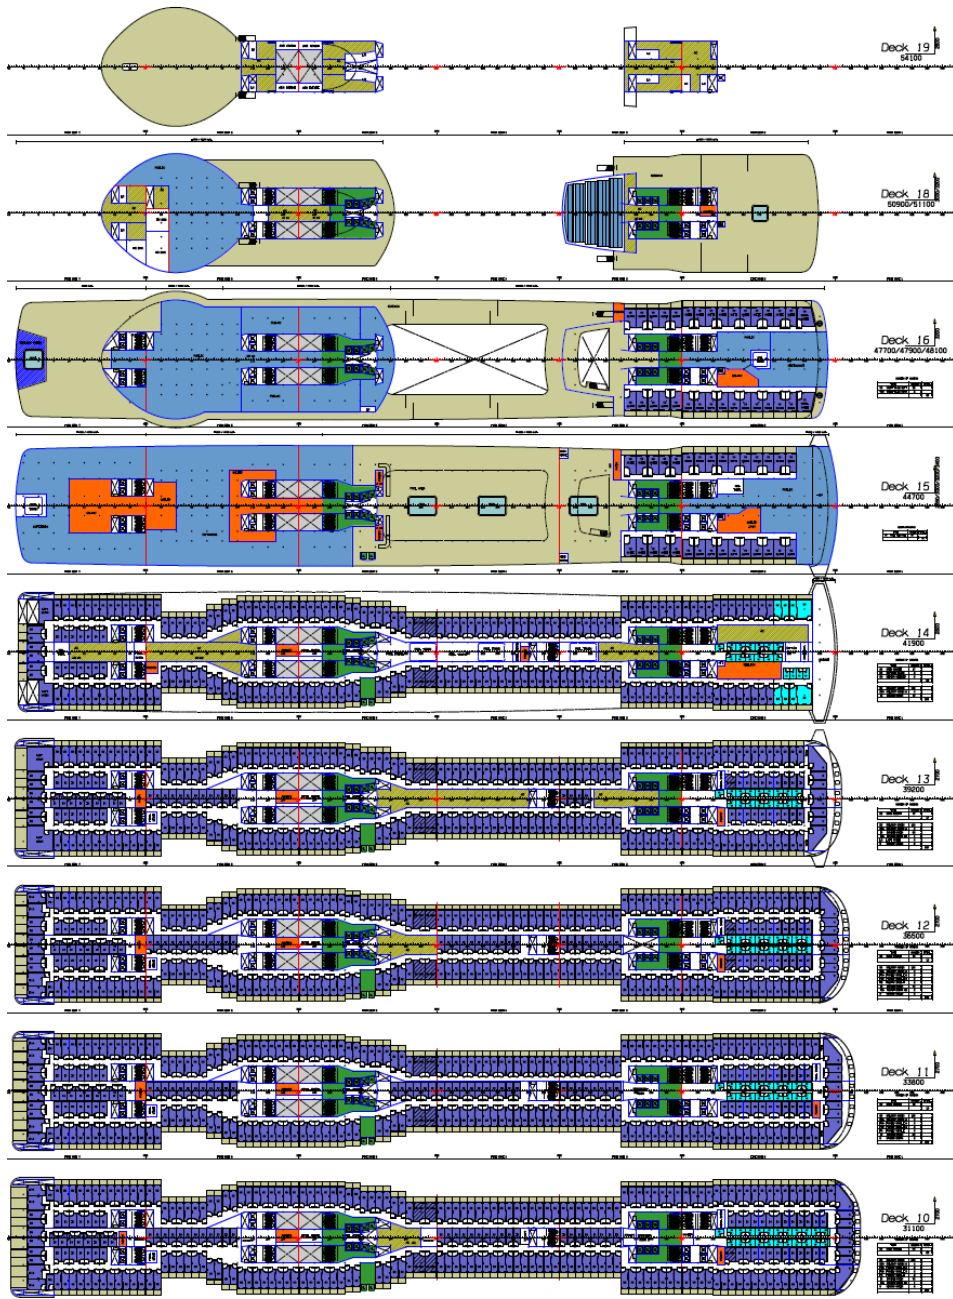
Fig. 12-4 Deck 10 – 19 – Large Cruise Vessel

The following Fig. 12-4 and Fig. 12-5, show the General Arrangement plan

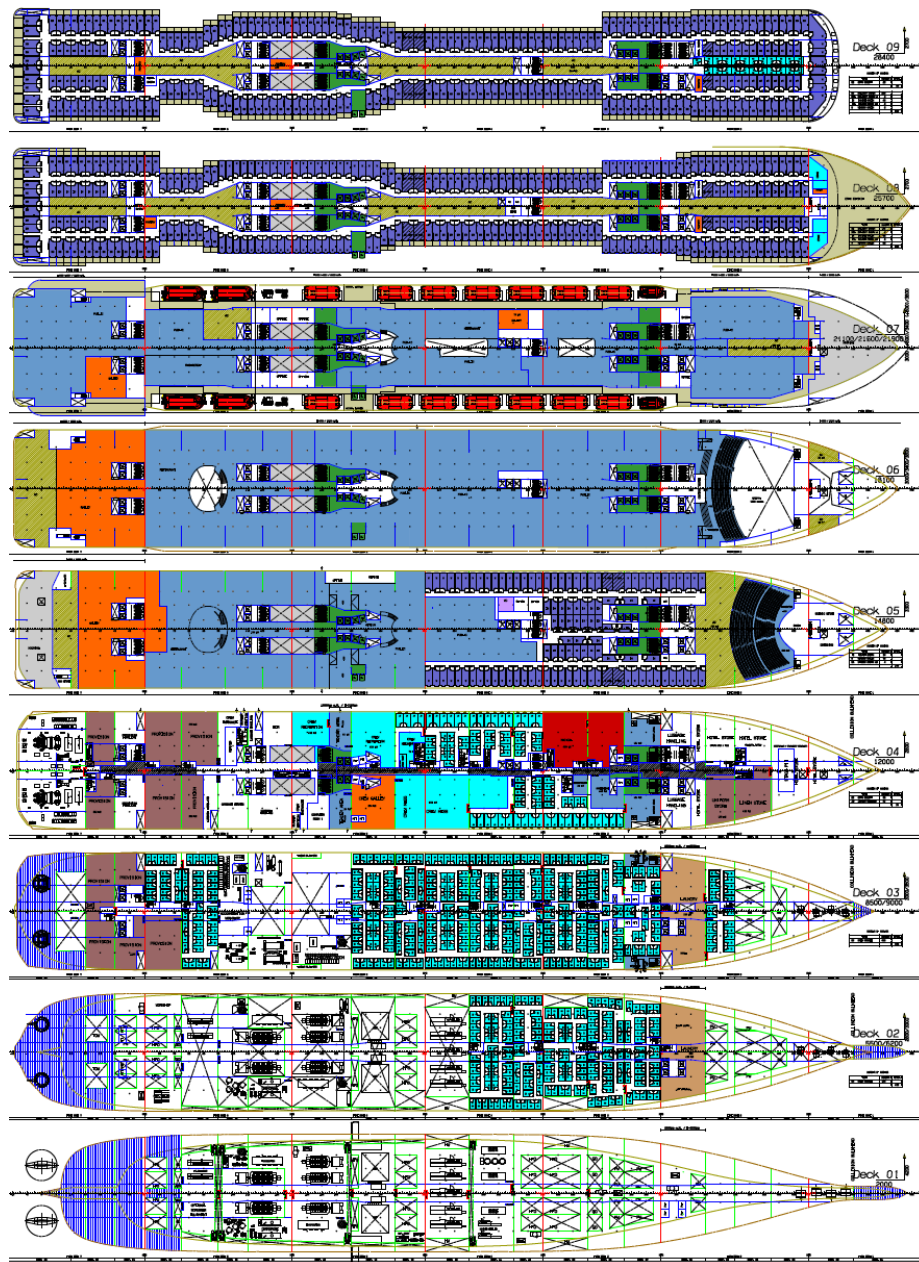
Fig. 12-5 Decks 01 – 09 – Large Cruise Vessel

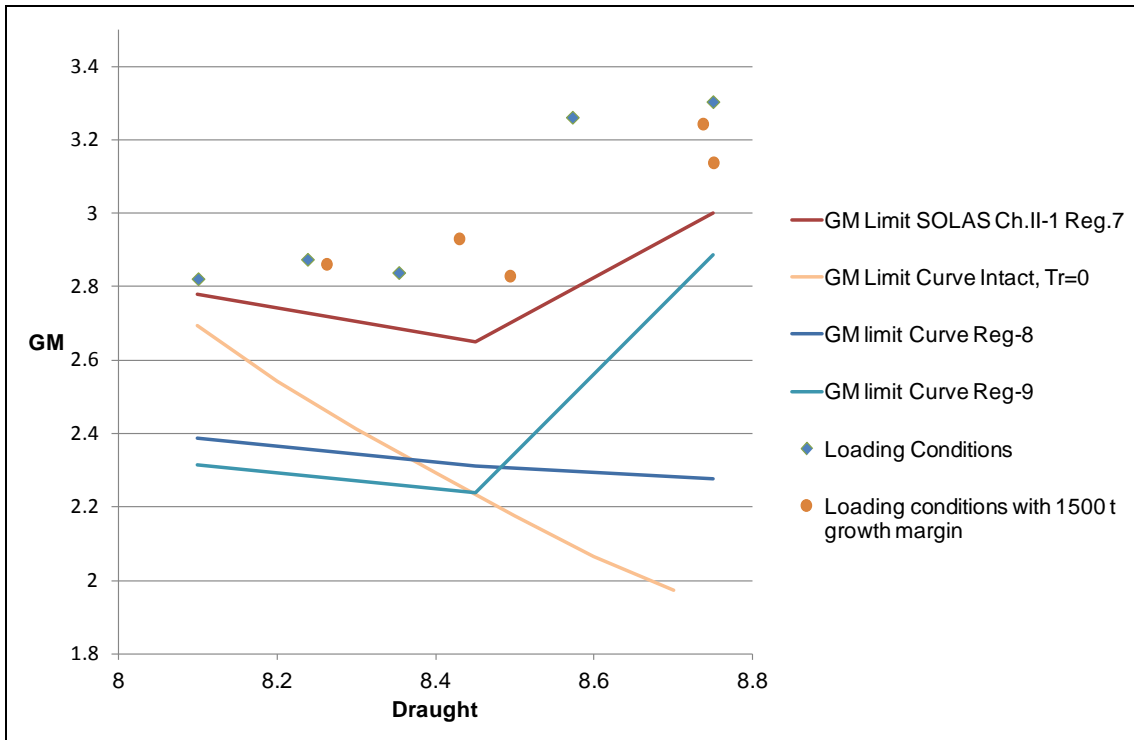
Fig. 12-10 shows the summary of the GM requirements together with the actual loading conditions.

There are various limits shown which all need to be complied with, in particular there is the limit of the intact stability criteria as defined by the IS code 2008, and 3 limits for compliance with the damage stability requirements.

Fig. 12-10 GM Limiting curves

The corresponding GM limiting curves are shown in Fig. 12-10.

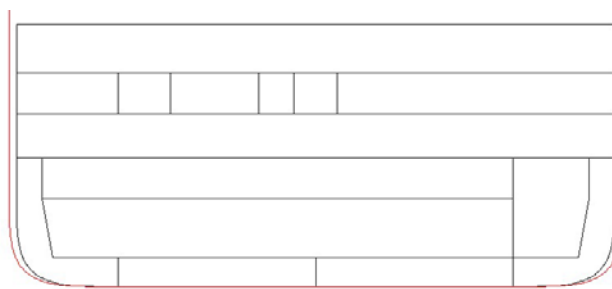
This version uses the most obvious risk control option with regard to stability and increases the breadth of the hull by 1.0m. The superstructure above the boat deck will be kept constant; the interior areas within the hull will be increased due to the changed shape.

The following figure illustrates the principle of modification

Fig. 13-2 Principle of modification

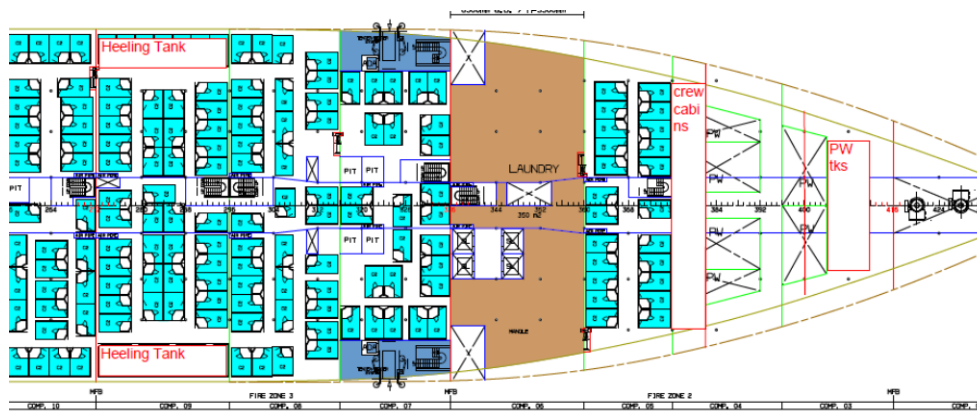
Fig. 13-15 Design modification – arrangement – K3

These changes lead only to small adjustment of the steel weight and outfitting areas. In addition the routing of pipes and ducts close to the centre line in way of the main switchboard rooms will become more complex due to the blocked passage way, which implies some additional building and design costs. No change in the engine plant has been made.

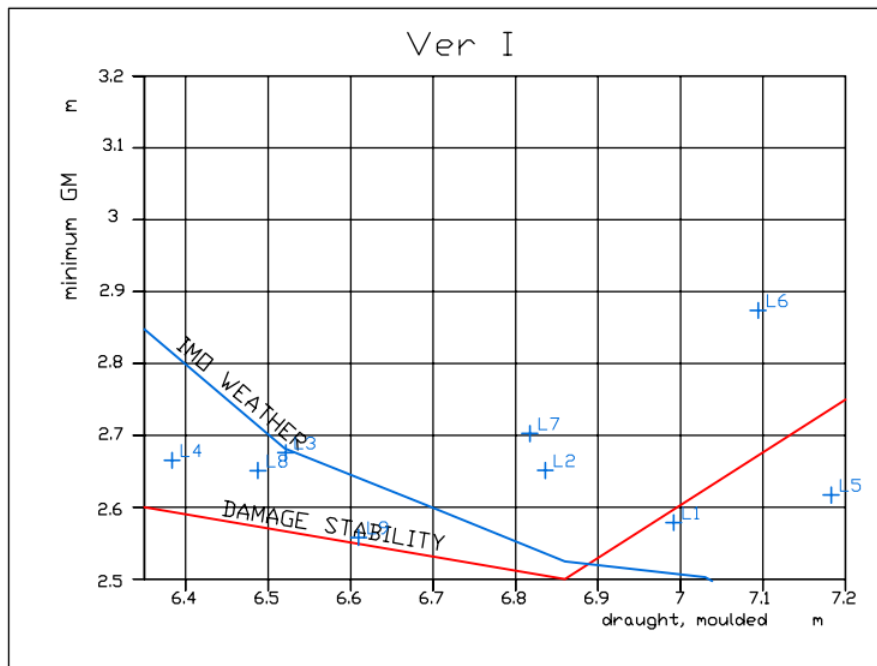
Fig. 13-54 GM Limiting curve version I

Long Lower Hold will have very negative impact on A-index. As it can be seen from GM-limiting curves shown in Fig. 13-54 most of the loading conditions will not fulfil IMO weather criterion and two cases will be below damage stability limiting curve.

In addition to reference ship also F-version is presented in combined Table 13-51. Optimized breadth/freeboard variations (+40 cm/+20cm) added with subdivided double hull will cause decrease in A-index from 8.06 % into 2.02 %, when LLH will be added and LNG tanks has been shifted upwards.

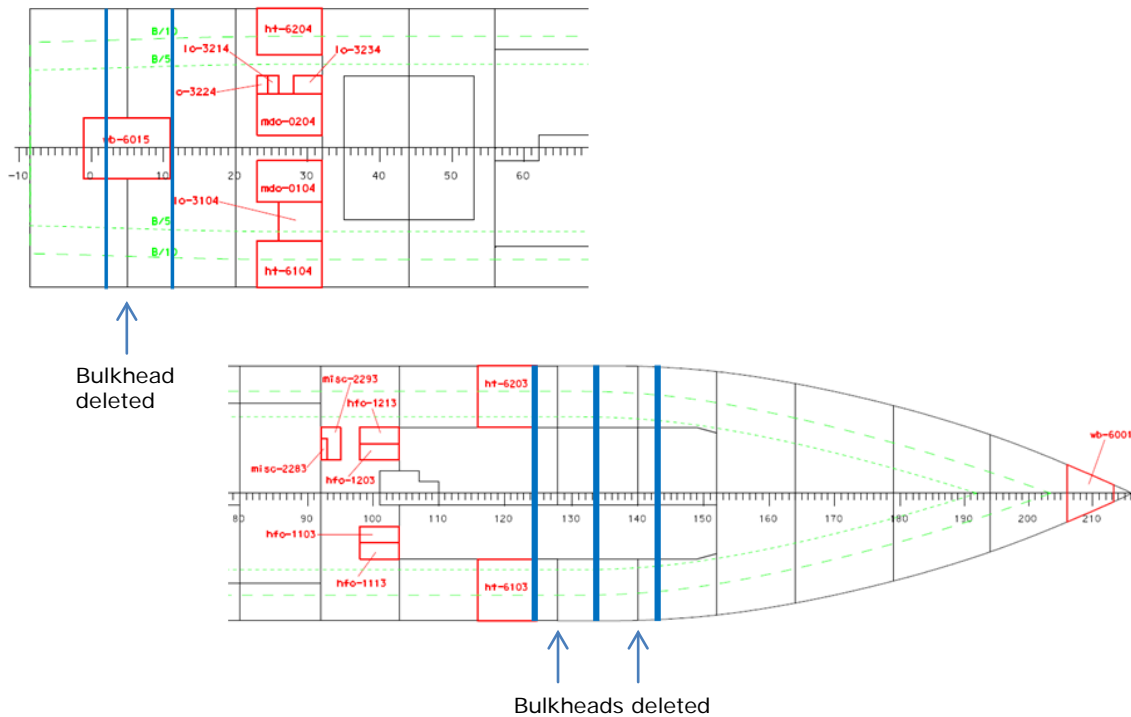
Fig. 13-66 Illustration of Design modification V12

- Addition of Watertight zone in the aft part (addition of watertight bulkhead at Frame 11 and shift of watertight bulkhead Frame 5 to 2)
- Addition of Watertight zone in the fore part (addition of watertight bulkhead at Frame 134, shift of watertight bulkheads Frame 128 to 125 and Frame 140 to 143)

The following figure illustrates the principle of this modification:

The weight increase due to these additional transversal bulkheads has been calculated, based on the areas of each bulkhead, which is about 280m² for the aft one and 180m² for the forward one. The additional outfitting weight can be neglected, compared to the additional steel weight.
