Network of Standby Oil Spill Response Vessels

Drills and Exercises

Annual Report 2014

OPERATIONAL EXERCISES 2014

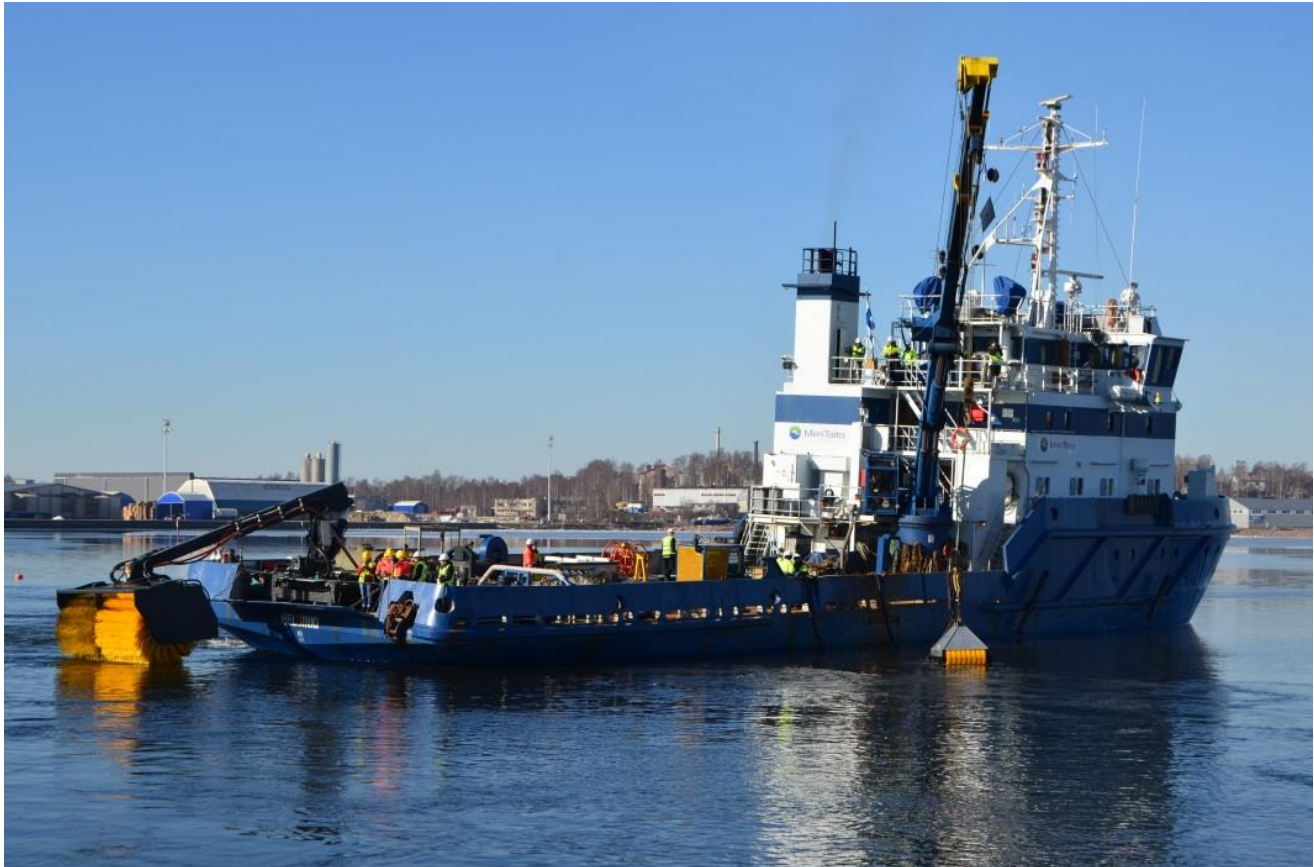
Figure 1. *Seili* with the SYKE ice skimmer (stern) and the Lamor LAS 125 Arctic Skimmer deployed.

Seili was equipped with a high capacity ice brush skimmer of (first generation of skimmers developed by SYKE) and the LAMOR Arctic skimmer LAS 125 provided by EMSA. *Louhi* was equipped with three high capacity ice skimmers (second generation of ice skimmers developed by SYKE) and a Lamor brush skimmer.

The LAMOR Arctic skimmer LAS 125 provided by EMSA performed well.

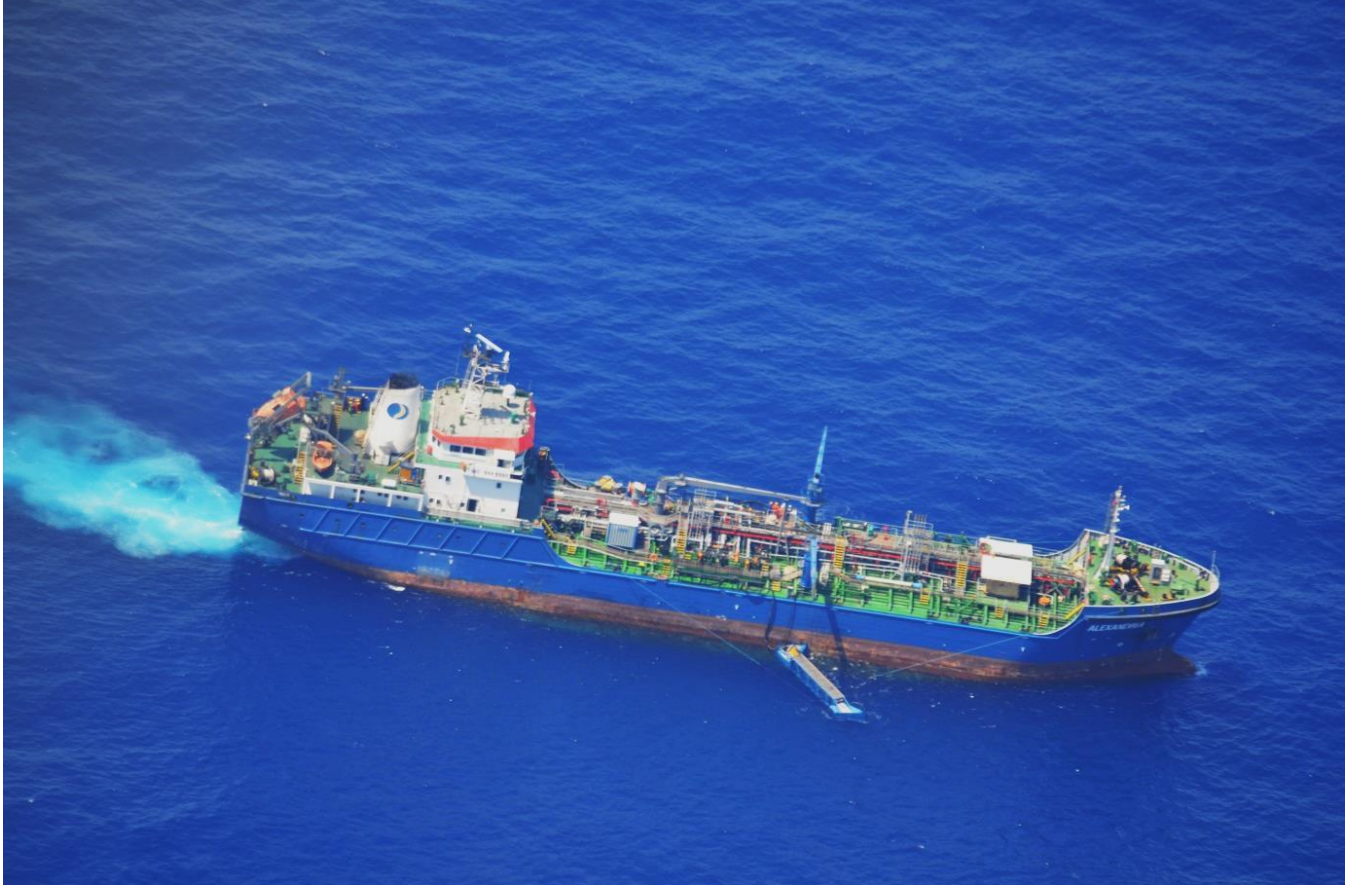
Figure 2. *Alexandria* performing oil recovery with the sweeping arm system.

The task of *Alexandria* was to perform mechanical oil recovery with the sweeping arms system in the assigned area.

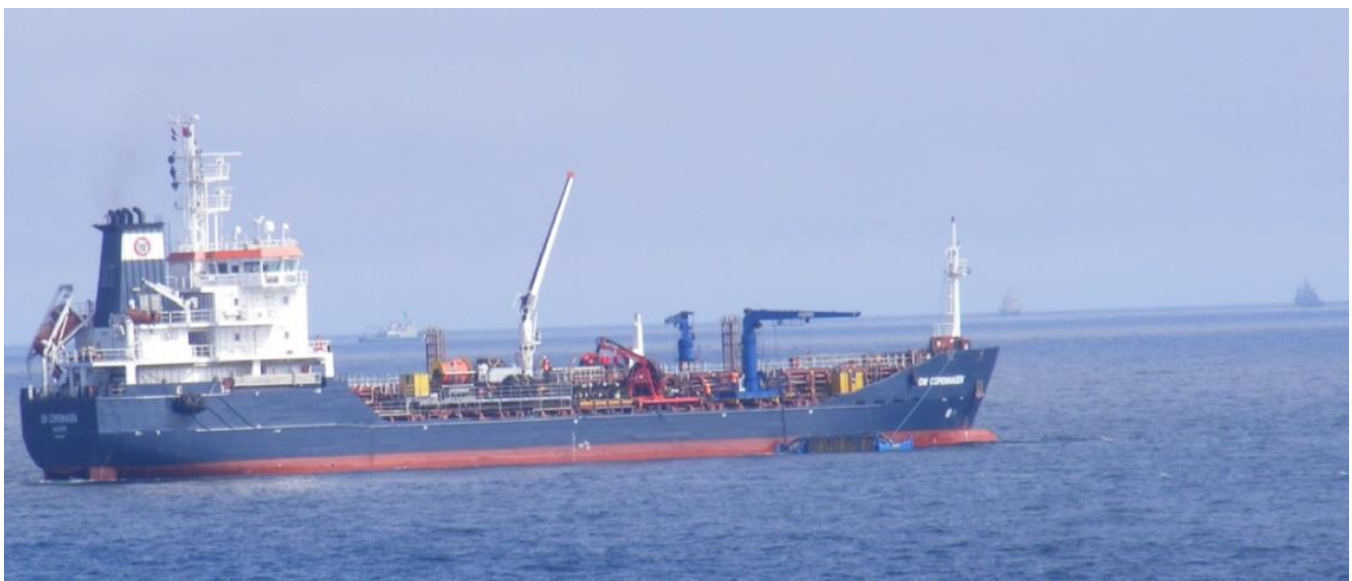
Figure 3. *OW Copenhagen* during Balex Delta 2014 Exercise

At-sea oil recovery operations: *OW Copenhagen* deployed her sweeping arms and Normar 250 TI skimmer undertaking “oil recovery” operations. *OW Copenhagen* was appointed as a group NOSC and lead successfully operation of the strike team Bravo. The EMSA vessel fulfilled the role assigned by the Member State (Latvia) organising this exercise and also met the expectations of the Agency.

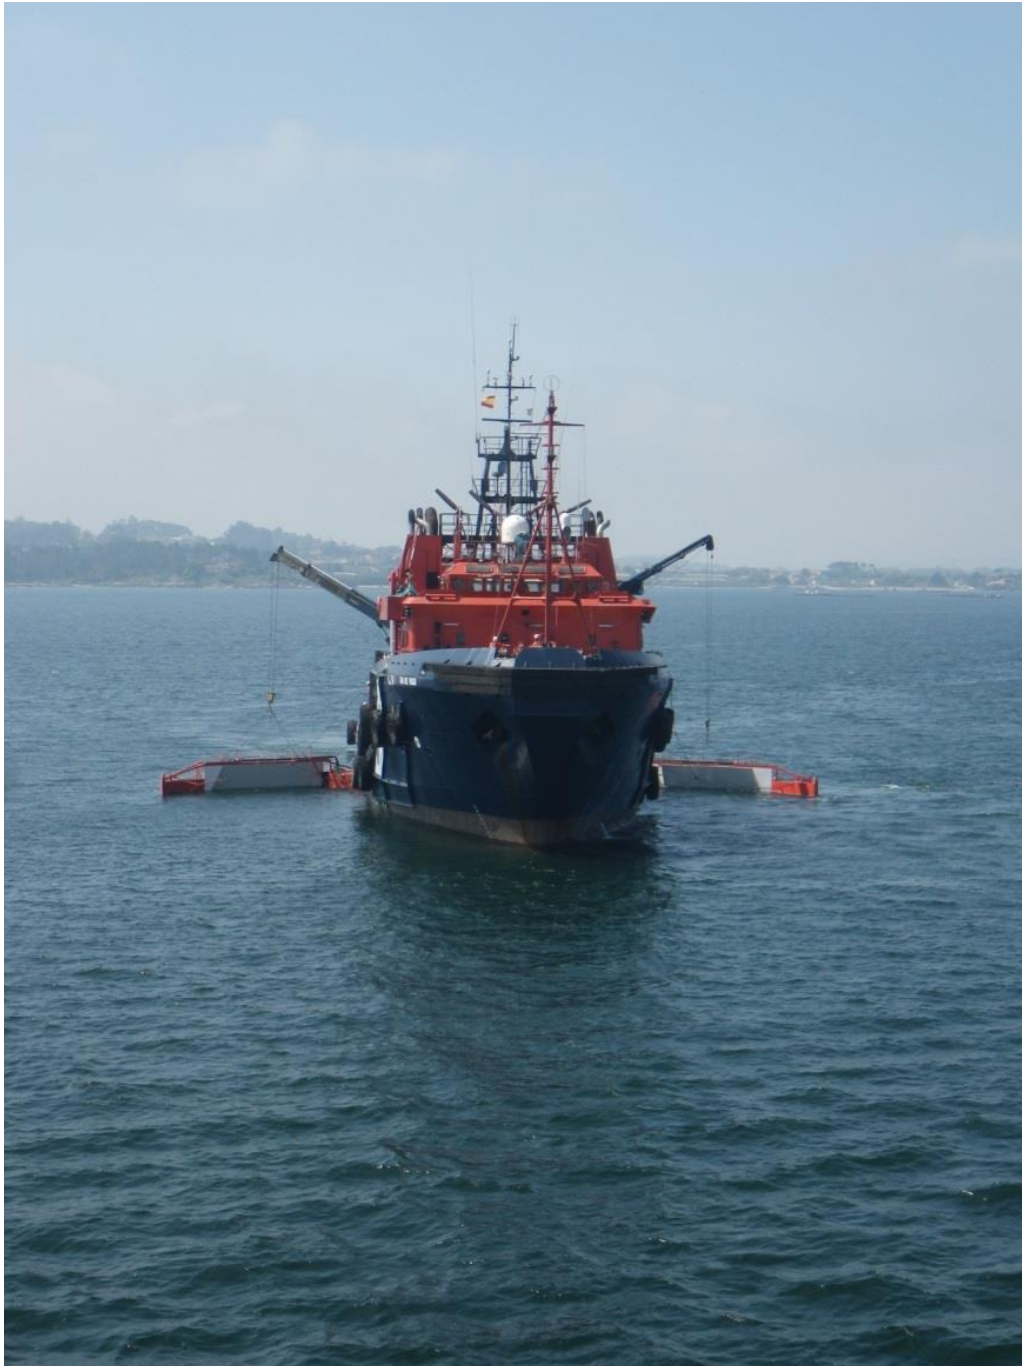
Figure 4. *Ría de Vigo* with the sweeping arms deployed

The organisers were satisfied with the performance of the participants of the exercise. The *Ria de Vigo*, her crew and equipment performed well during the exercise. The equipment (250 metres boom and sweeping arms system) was successfully tested.

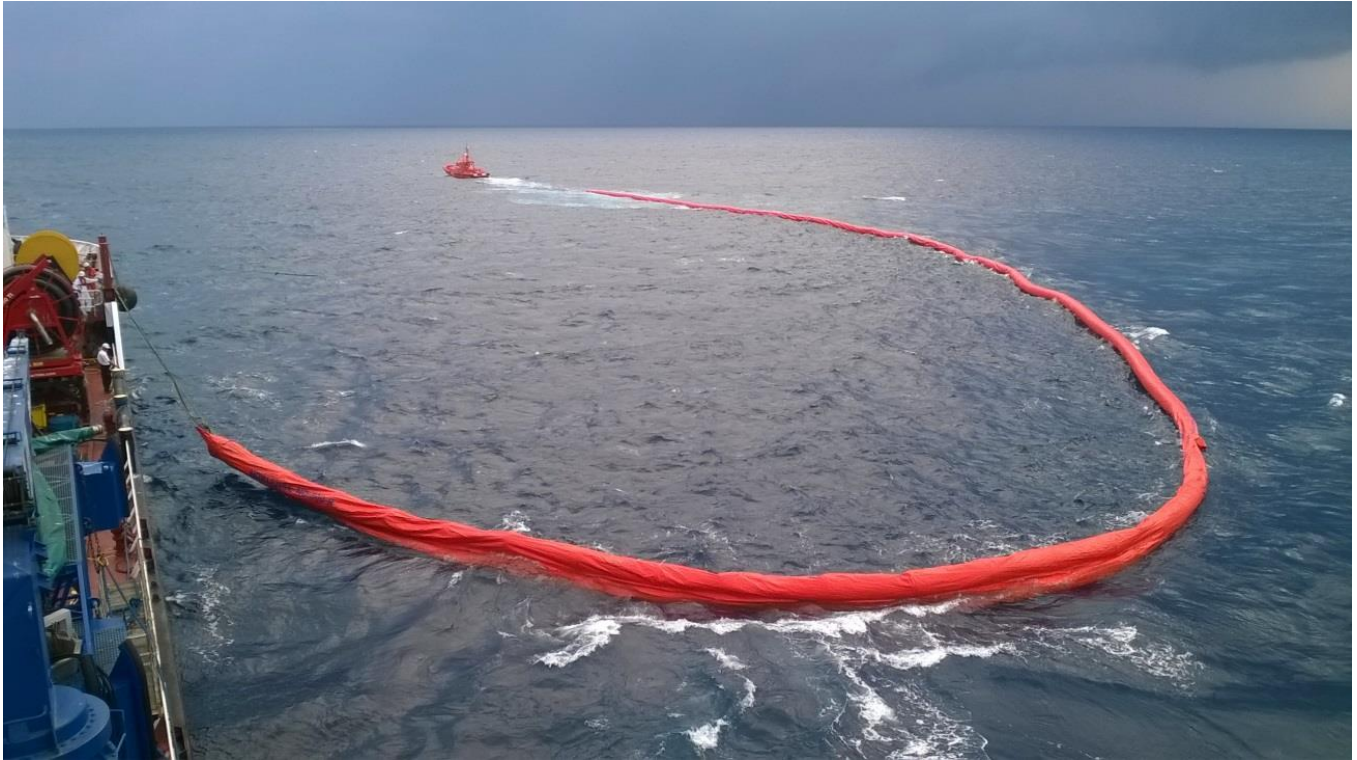
Figure 7. “J”-formation with tugs *Monte Anaga* and *Salvamar Mimosa*

The NOSC on board the *Clara Campoamor* instructed the *Monte Anaga* to deploy the sweeping arms and conduct recovery of oil. After fulfilling this task the *Monte Anaga* was ordered to deploy the oil boom (250 metre starboard boom) and to maintain the “J” configuration with the assistance of *Salvamar Mimosa*. It was noted that two sections of the boom were detached. In order to prevent additional damage to the boom it was decided that the towing operation should stop and that the boom should be taken on board for further inspection and repairs. As the next task the *Monte Anaga* deployed the NORMAR high capacity skimmer. *Monte Anaga* fulfilled the role assigned by the Member State organising this exercise (Spain) and also met the expectations of the Agency. The EMSA contracted vessel and its crew performed well.

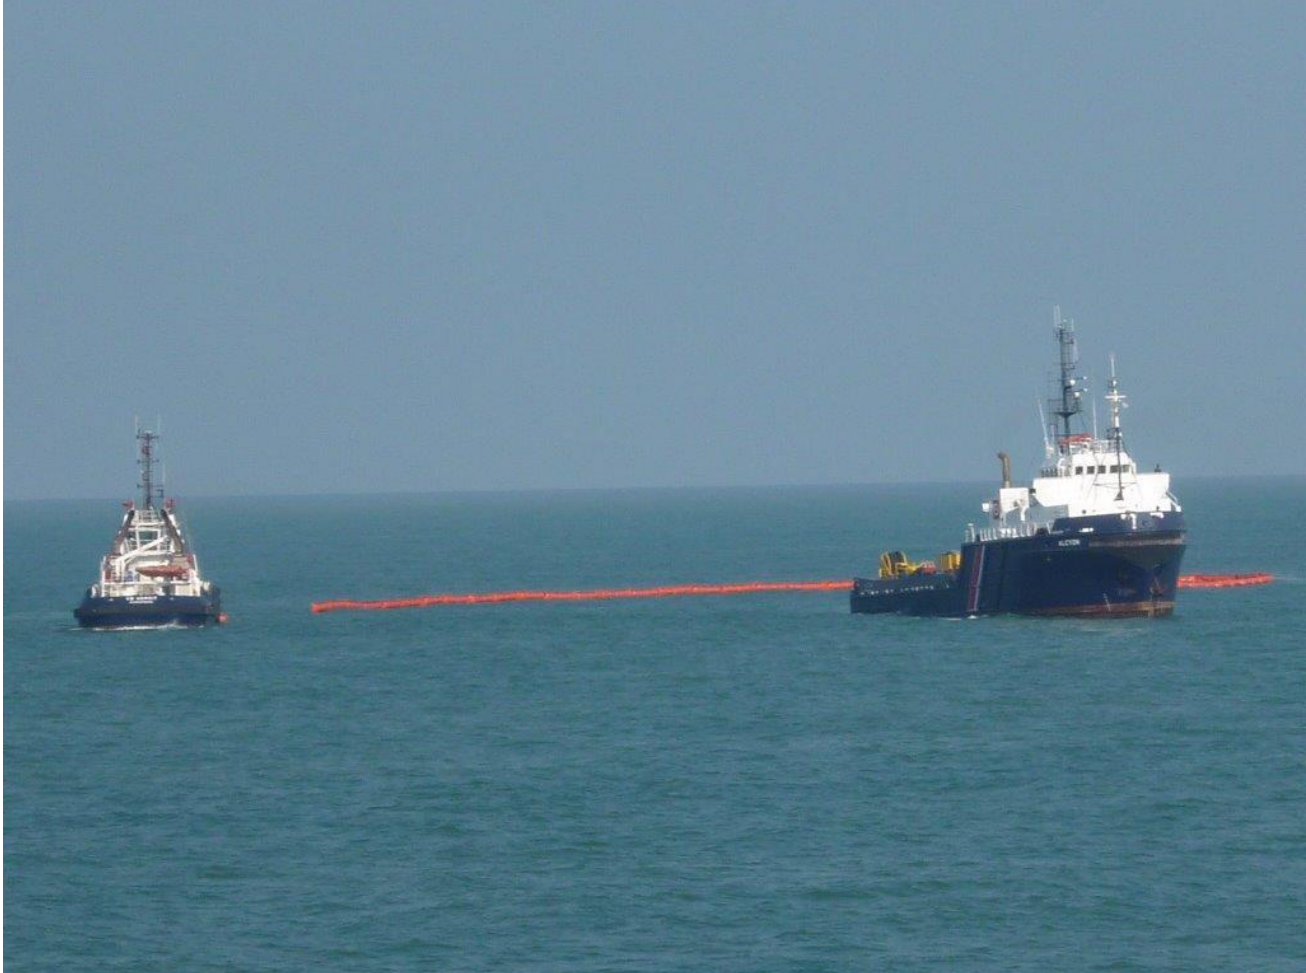
Figure 8. “U”-formation with *Alcyon* and *Zeetiger*

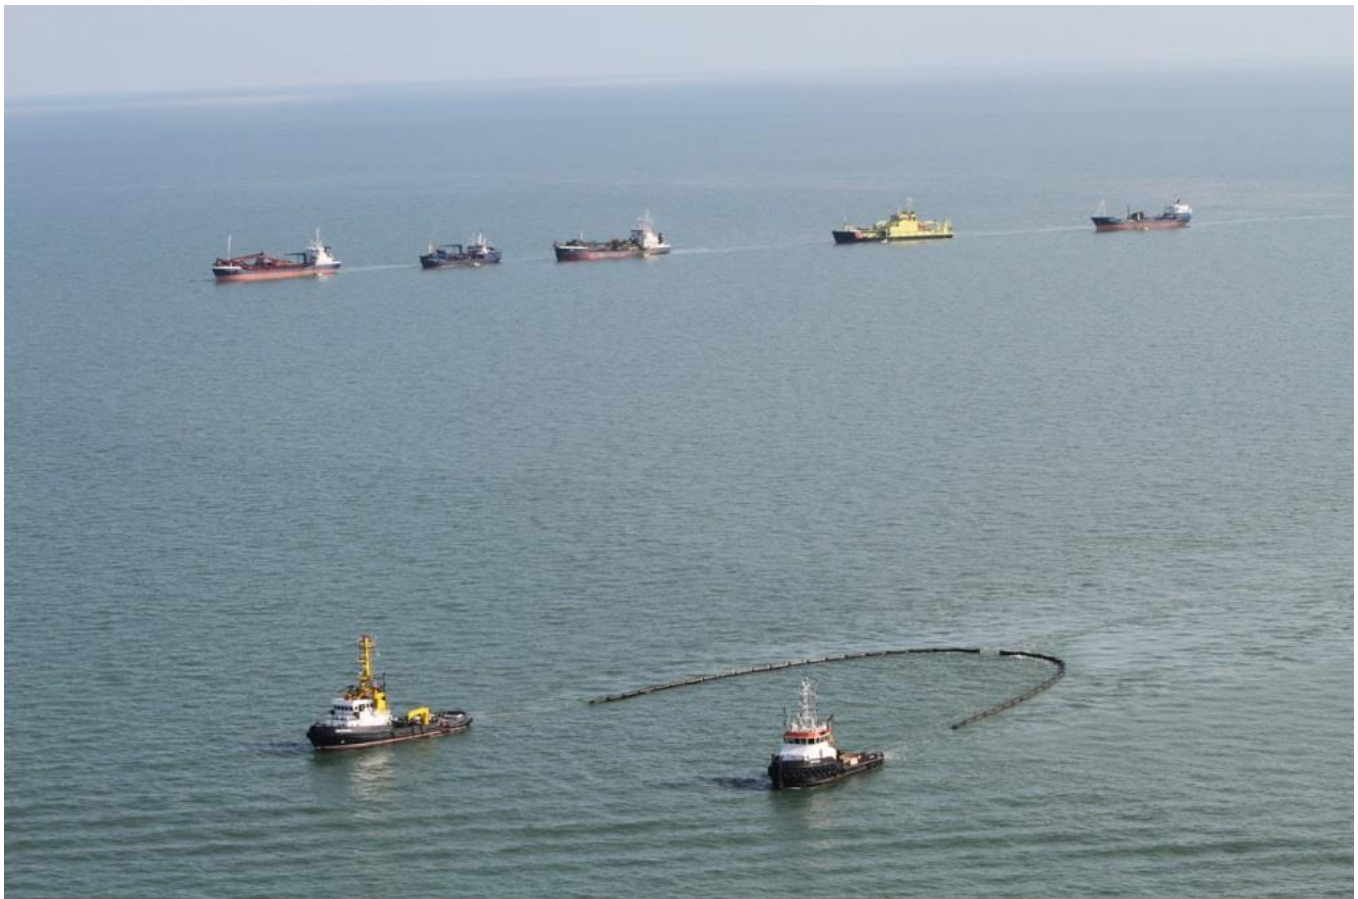
Figure 9. Tugs *Zeehound* and *Zetiger* towing boom in "U" formation. Vessels in column (from the left): *DC Vlaanderen 3000*, *Interballast III*, *Rio*, *Arca* and *Interballast I*

- All vessels made rendez-vous in agreed area;
- *DC Vlaanderen 3000* deployed both sweeping arms;
- *Interballast III* deployed both sweeping arms and took position behind *DC Vlaanderen 3000*, 10 metres to port side;
- *Interballast I* deployed sweeping arms and took position behind *Interballast III* with 10 metres to port side;
- *Rio* deployed sweeping arm taking position behind *Interballast I* with 10 metres to port side;
- *Arca* deployed 200 metres Ro-boom, picked up by BE tugs *Zeehond* and *Zeetiger*;
- *Arca* and other vessels manoeuvred behind the Open-U configuration;
- Sailing speed: 1,5 knts.

The formation of five oil recovery vessels in a column following an open U formation was exercised for the first time with the EMSA vessels participation. The formation is very impressive and proved to be effective.

The exercise scenario was realistic and the manoeuvring of the hopper-dredgers with their sweeping arms behind the Open-U boom configuration was successfully conducted. The cooperation with the Netherlands and Belgium for organising and executing an operational pollution response exercise at sea was very efficient.
