Drills & Exercises

Annual Report 2018

EMSA Pollution Response Services

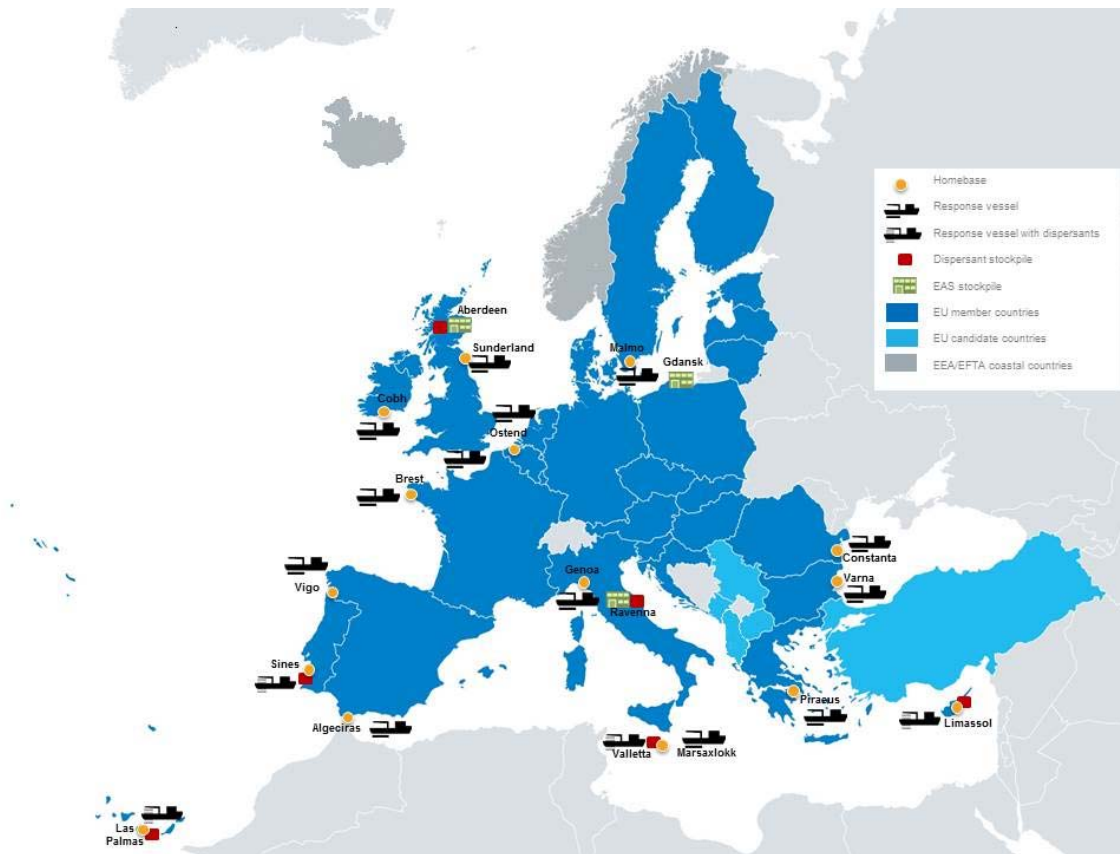
Map 1 Distribution of EMSA's contracted vessels and EAS arrangements at the end of 2018

At the end of 2018, 17 fully equipped oil spill response vessels were available for pollution response, with 11 of these 17 vessels certified for recovery of oil with flashpoints < 60°C. All the contracted vessels based in areas with the presence of oil and gas installations are now certified for recovery of oil with flashpoint < 60°C. Main activities related to the Vessel Network in 2018 included:

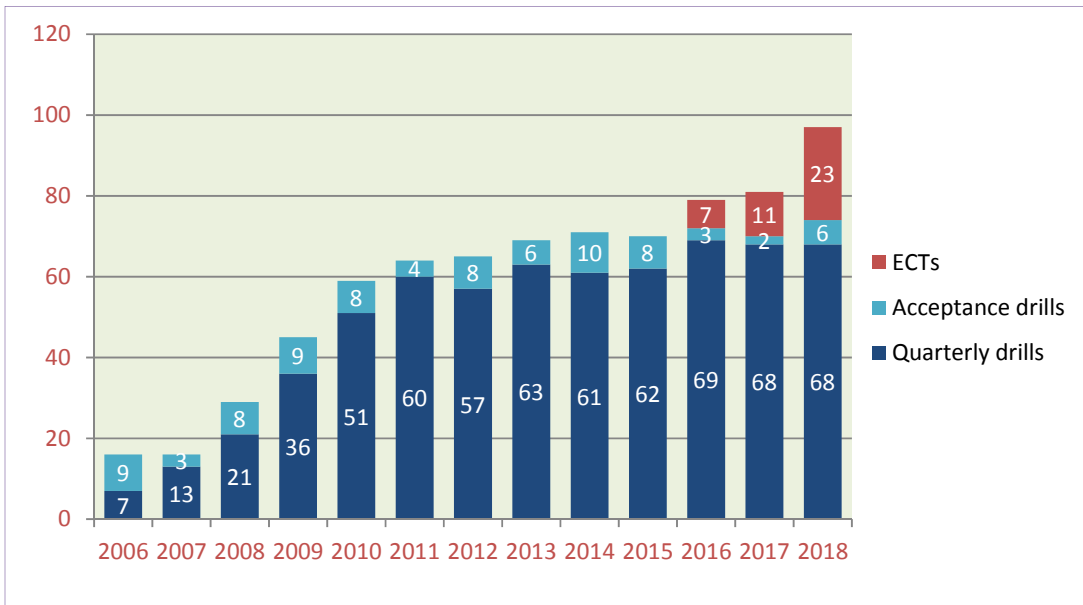
Chart 1 Number of drills and ECTs 2006 – 2018

In 2018, a total of 68 quarterly drills, 6 acceptance drills and 23 equipment condition tests (ECTs) were performed by the vessels and the EAS arrangements under contract to the Agency. The acceptance drills are of particular importance as they are the major milestone for new vessels, new equipment as well as the overhauled equipment to enter into the pollution response service.

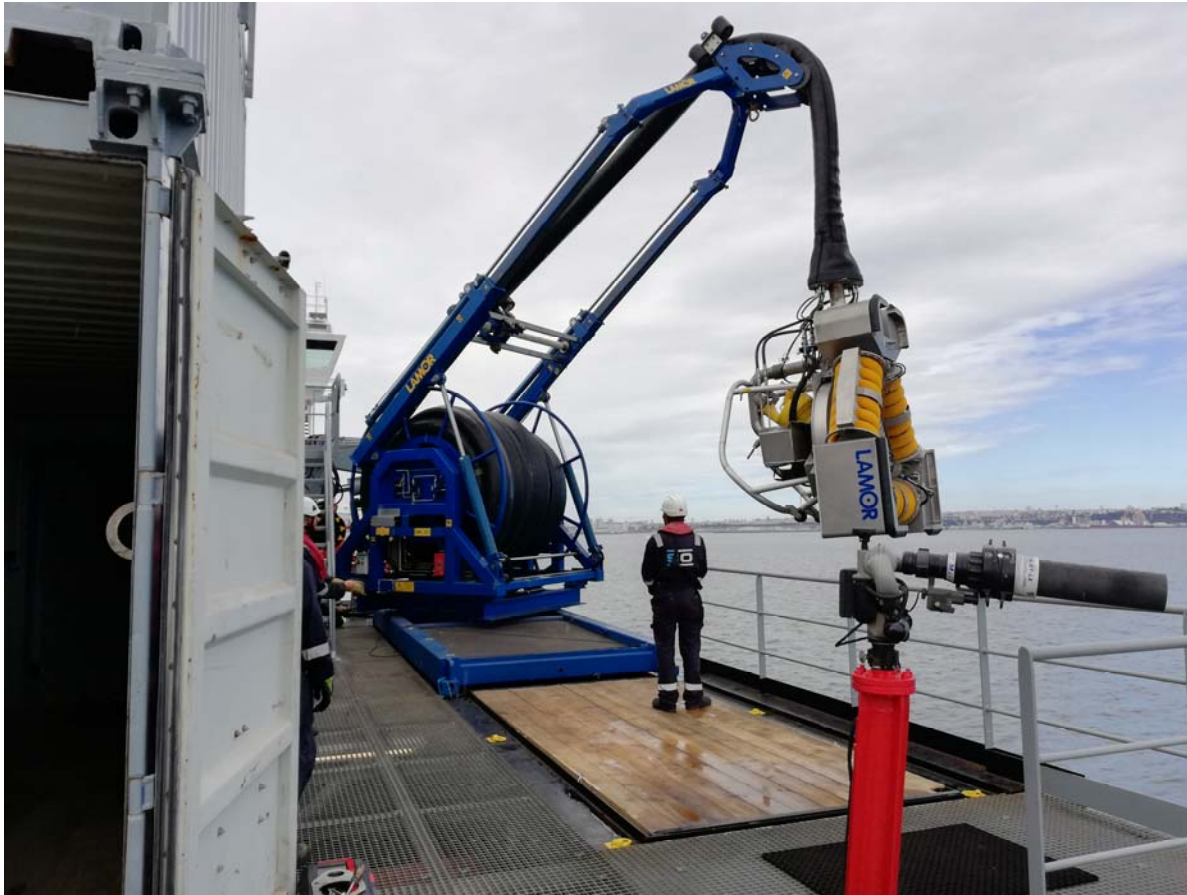
Fig. 1 Acceptance drill on board VN Partisan. High capacity skimmer test.

- The OSR vessel *VN Partisan* contracted at the end of 2017 based in Brest, France, providing replacement capacity in the Biscay Bay, successfully completed the acceptance drill and became fully operational in September 2018.
- The contractor James Fisher Everard replaced the vessel *Forth Fisher* operating under EMSA contract in the North Atlantic with the vessel *Corrib Fisher*. The *Corrib Fisher* after the successful acceptance drill joined the service in November 2018.

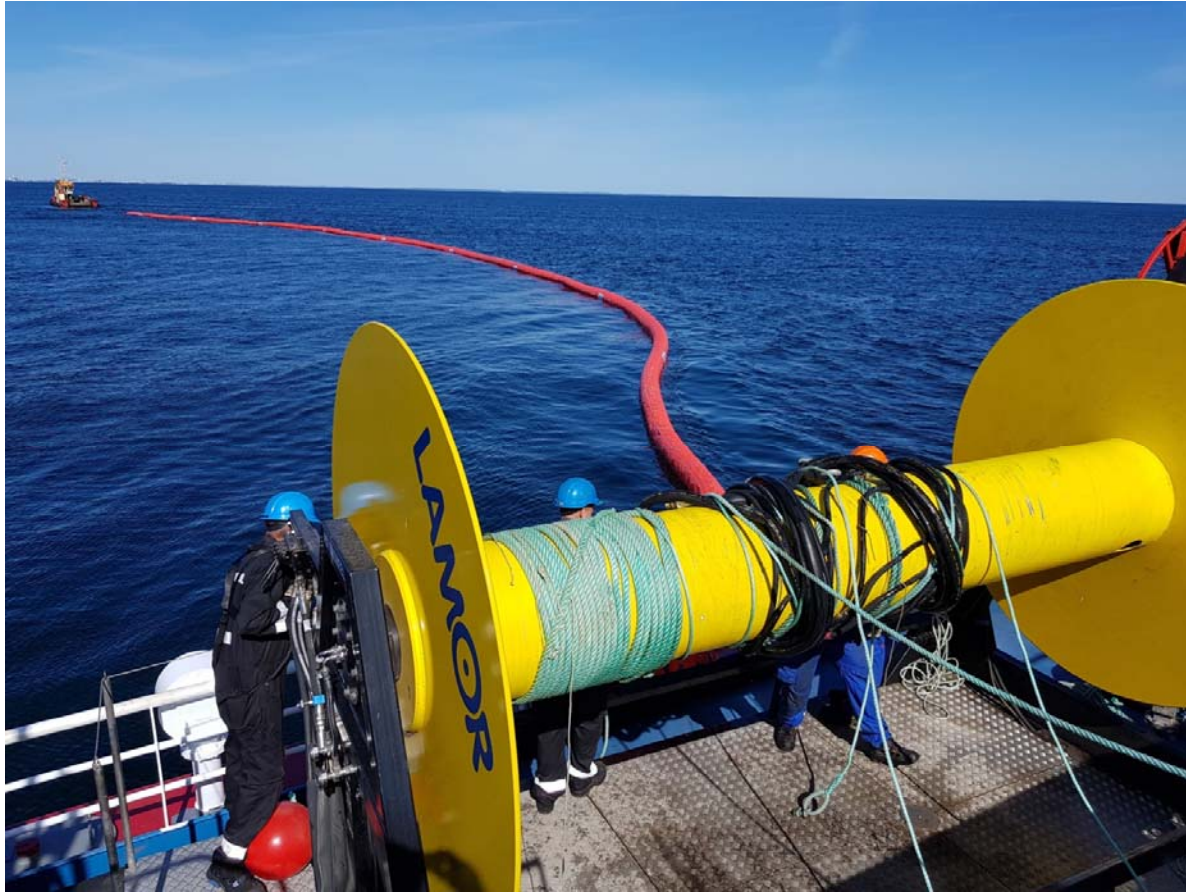
Fig. 2 2nd Quarterly drill on board Norden. Boom deployment

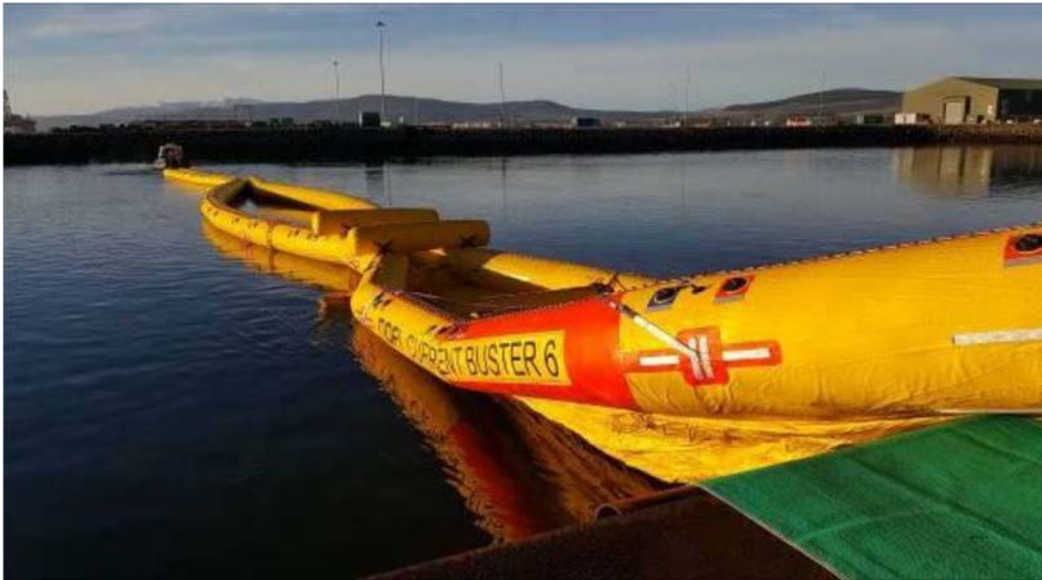
Fig. 3 Equipment Condition Test. Deployment of the Current Buster 6 in Oldmeldrum (EAS North Sea)

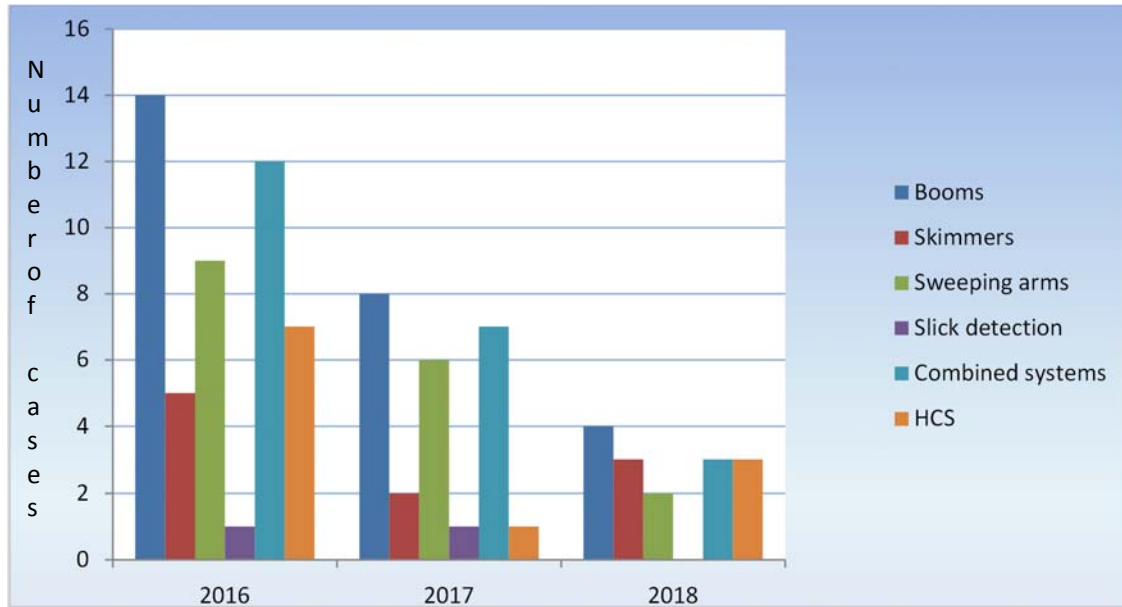
Chart 2 Number of Technical issues 2016 -2018

For both services, Vessel Network and EAS, 27 equipment technical issues (dropping down from 47 in 2017 and 84 in 2016) were recorded in 2018 as follows: 3 related to skimmers, 2 to sweeping arms, 7 to combined systems (current buster, trawl net) and 4 to booms. Decreasing total number of the equipment technical issues is related to a successful programme of the equipment overhauling and replacement as well as to increased focus on the equipment maintenance and improvement of skills of personnel deploying EAS equipment.

Booms incidents encountered were mainly due to defaults in the inflating system in one specific type of boom which has progressively been phased out from EMSA equipment. For the other types of incidents, the main difficulties encountered were lack of flotation of the device (addressed by the manufacturer) or difficulty to start the engine (on several different devices using the same type of starting device). This last issue has also been addressed by the manufacturers.

Few damages, recorded during the periodic drills and ECTs, were caused by weather conditions and/or human factor. Regular training of the personnel for the correct use of the equipment is a key component for a prompt response to offshore oil pollution and the Agency will continue to support this aspect.

Generally, the technical issues were dealt with in an efficient and effective way and the equipment was brought back to the operational state as quickly as possible. Preventive measures, such as overhauling

and/or replacement of the aging equipment are being implemented in order to increase the reliability of the equipment and to minimise the number of failures.

Based on the equipment records, the overhauling or replacement plan is being established in order to improve services and reduce the probability of equipment failure.

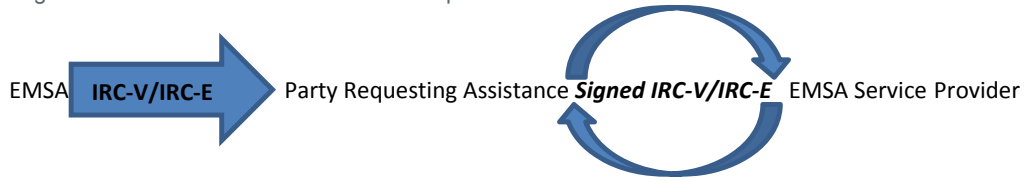
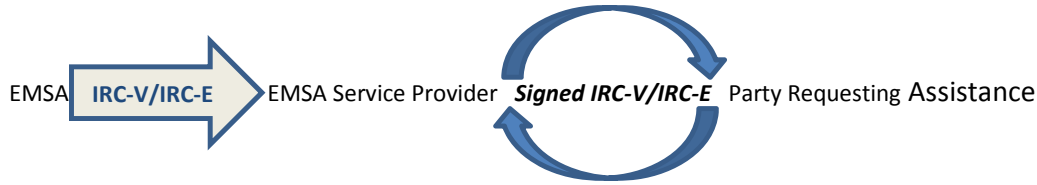
In 2018 EMSA participated in 8 operational and 14 notification exercises. The Agency is implementing a procedure for the internal/external exercise coordination in order to provide the full set of services (Vessels, EAS, Mar-ICE, CleanSeaNet and others) in a harmonised manner as well as to provide/receive feedback to and from the Member States after the performance of the exercises. In 2018 EMSA modified also the response service mobilisation procedure in order to enhance and speed up the service mobilisation process. The sequence of the parties signing the contract has been reverted so the EMSA contractor

receives contract signed by the requesting party in the first place. The change is described by the figure below.

Fig. 4 Modified service mobilisation procedure

This new process is more effective and quicker as it is for the requesting party to identify which type of equipment or vessel configuration she wants before sending the contract signed to EMSA contractor.

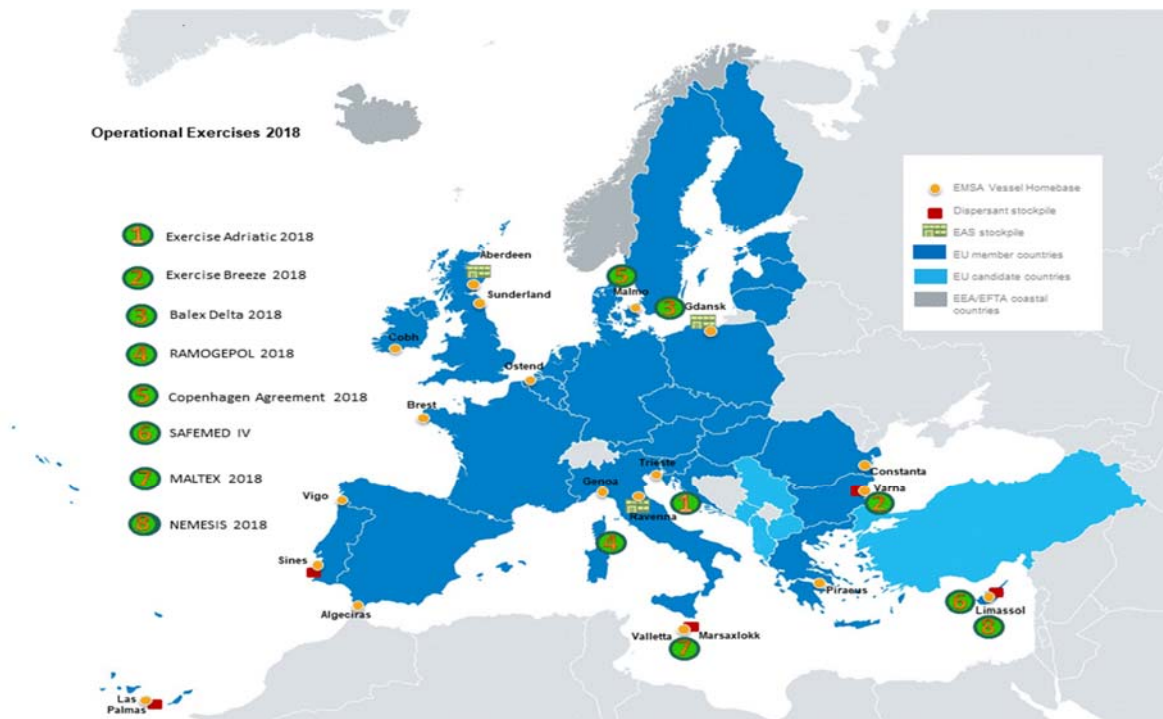
Map 2 Geographical Coverage of Operational Exercises 2018

These events took place in European Regional sea basins, covering the Baltic Sea, North Sea, Mediterranean Sea and Black Sea. This year majority of exercises were performed in the Mediterranean Sea. In general, the results of these exercises showed that EMSA vessels were well integrated into the pollution response mechanisms of Member States and Regional Agreements. Reports of EMSA observers indicate that all vessels participating in the operational exercises successfully completed the tasks assigned by the pollution response command of the country hosting the exercise.

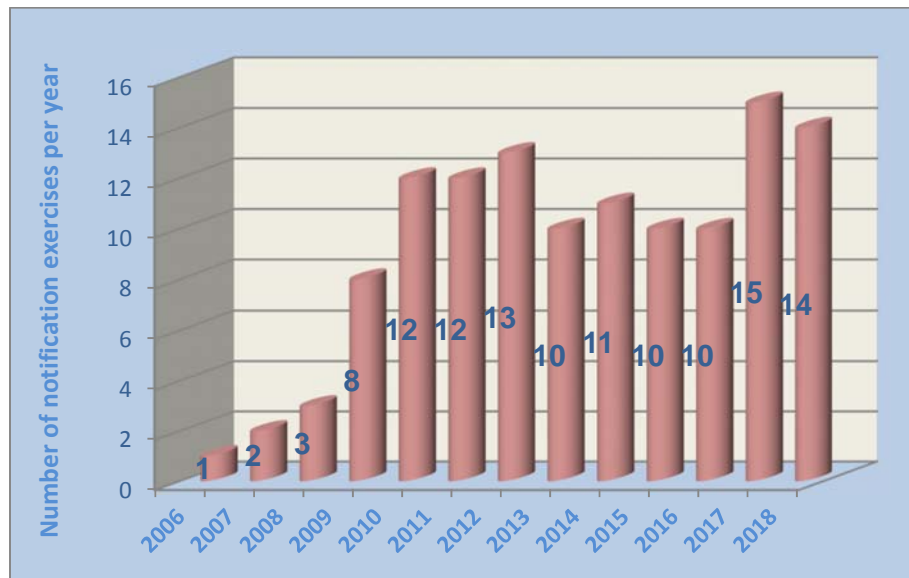
Chart 3 Number of notification exercises 2006 – 2018

During the notification exercise, the time counting starts at the moment when the formal assistance request is received by EMSA. Taking into account variables such as the time of day, the day of the week, the contractor's location and other factors, 6 hours is considered as an acceptable target deadline for all parties to complete the mobilisation process, including signature of the Incident Response Contract (IRC). During the exercise, the Agency provides any assistance necessary to the Member State for facilitating the process of completing and signing the IRCS.

It must be noted that out of the 14 notification exercises carried out in 2018, only 7 exercises included the full procedure of EMSA Vessel and/or EAS mobilisation. This was a result comparable to that achieved in previous years. EMSA Contractors reacted immediately and in line with standards set by EMSA. However, some Member States terminated the procedure prior to the signature of the IRC Form. It has to be stressed that the mobilisation of EMSA means is based on the signing of the Incident Response Contract and its annex the IRC Form. The contract contains important provisions related to the respective obligations of the Requesting Party and the Contractor. Exercises are a good opportunity to ensure that response authorities are made aware of all clauses of this contract. It has to be reiterated that for exercises signing the IRC does not trigger the payment of any fee by the Requesting Party.
